The Cause of Cracking in Post-Tensioned Concrete Box Girder Bridges and Retrofit Procedures

Walter Podolny, Jr.

Bridge Division
Office of Engineering
Federal Highway Administration
Washington, D.C.

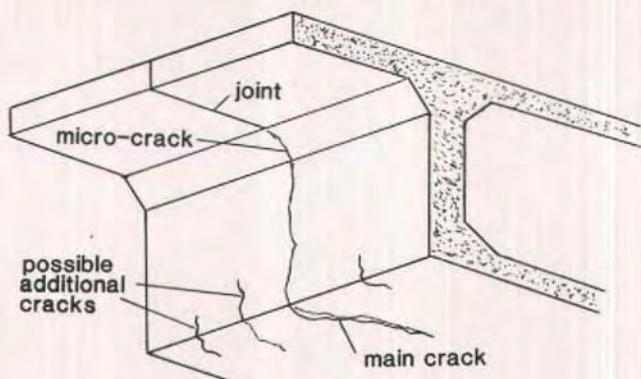
In segmental box girders, flexure cracks will generally occur in or near the segment joints (Fig. 2). The crack width at the bottom can be on the order of 0.004 to 0.008 in. (0.1 to 0.2 mm). As the cracks propagate up to the top flange, they will become fine microcracks.

Fig. 2. Flexural cracks.

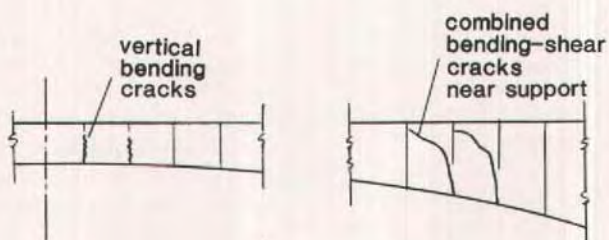
In areas near the support the effect of shear will be superimposed upon the flexural stresses producing, after initial vertical cracking, cracks that are inclined and become more and more diagonal in the webs, which may indicate insufficient shear strength (Fig. 3).

Fig. 3. Flexural cracks.

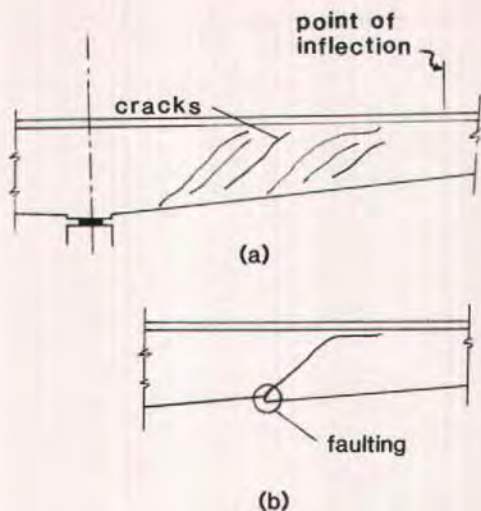
Fig. 5. Shear cracking.

Shear cracks occur in the webs and are perceptibly inclined at approximately a 45 deg angle. They normally manifest themselves in a zone between the support and an inflection point (Fig. 5a). The web reinforcement traversing these cracks is subject to stress variations which can cause bond failure and fatigue damage. In addition, at the limit, the reinforcement can yield. This may result in the faulting of the intrados which is usually not visible to the eye (Fig. 5b), but can be instrumentally measured.

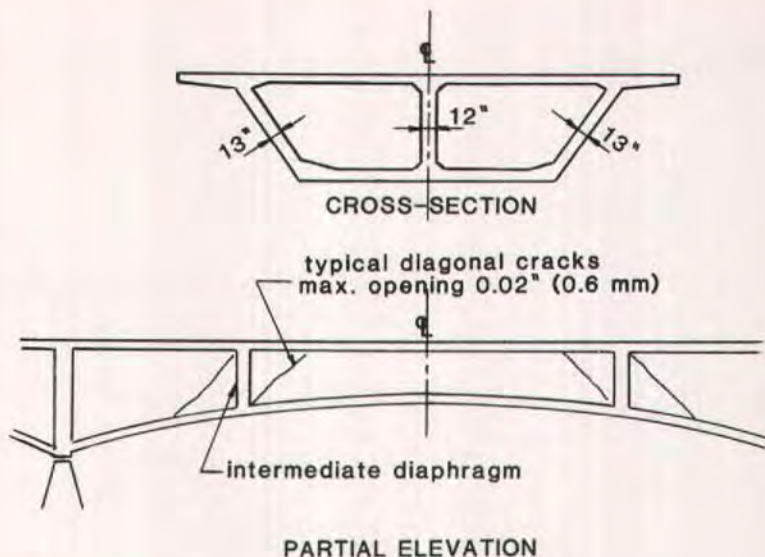
Fig. 7. Web cracking of center web.

vertically curved tendons in the bottom flange. Vertical prestress was applied in the webs to control shear stresses. Diagonal cracking was observed in the center web, only near the intermediate diaphragms, with a maximum crack opening of 0.02 in. (0.6 mm). In addition there was cracking in the bottom flange.

A complete investigation of the problems encountered revealed that cracking was the result of the superposition of several adverse effects, any of which might have been harmless if considered separately:

1. The computation of shear stresses failed to take into account the adverse effect (usually neglected) of the vertical component of continuity prestress in the bottom flange of a girder with variable depth. The curvature of continuity tendons distributed in the bottom flange is such that a downward reaction is produced at the webs that is additive to the shear in the web (see above).

Repair of shear cracks in the web of the structure illustrated in Fig. 7 was accomplished by adding vertical prestress

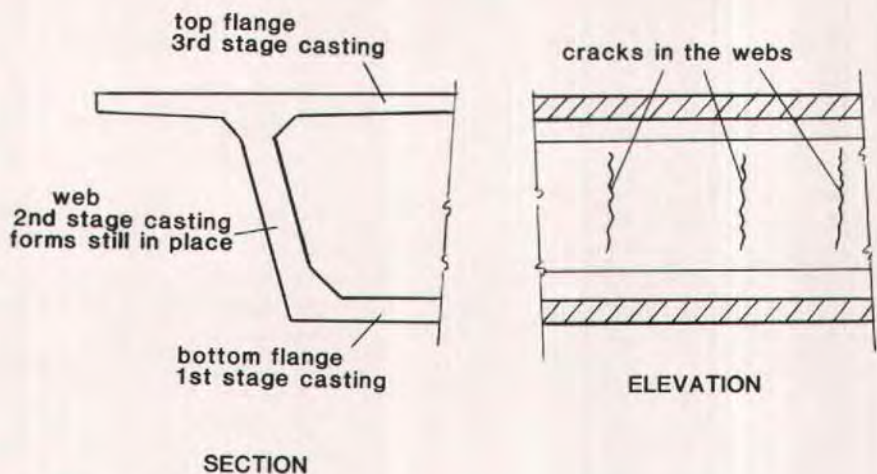
Fig. 18. Web shrinkage cracks.

straint to shrinkage produced by the older concrete and cracking of the younger concrete will occur. If the forms are left in place too long, they will present a large surface area of friction that will also hamper the shrinkage of the new concrete and thus cause cracking (Fig. 18).¹

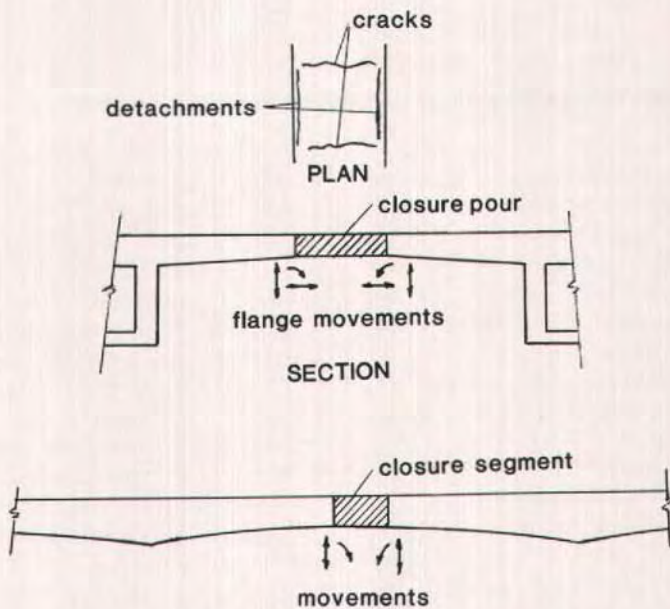
Fig. 24. Closure pour cracks.

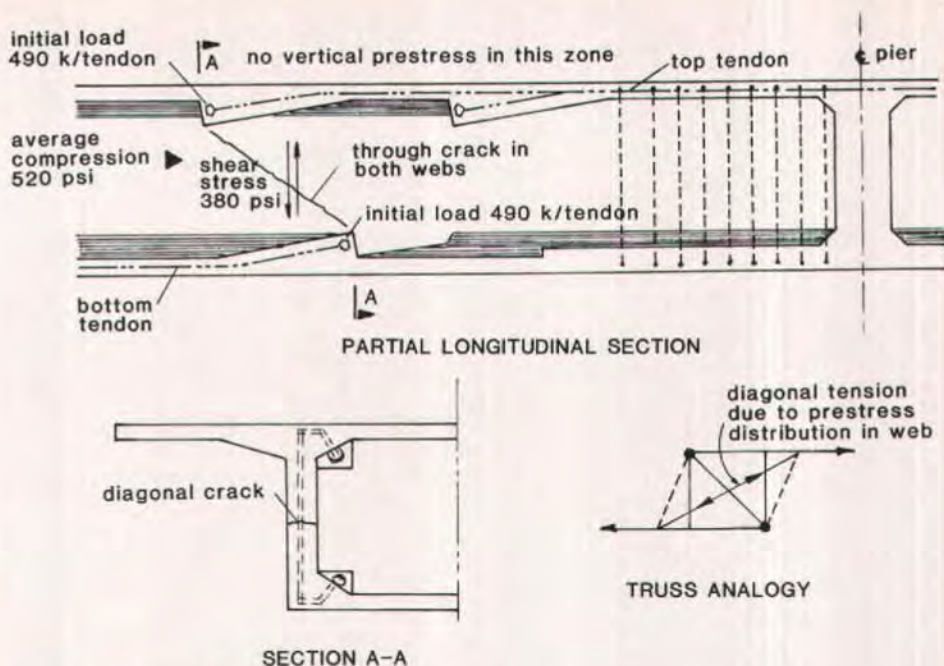
This situation occurred in a box girder constructed by incremental launching³ (Fig. 32). Permanent prestress was achieved by straight tendons placed in the top and bottom flanges, as required

Fig. 32. Web cracking under high prestress force.

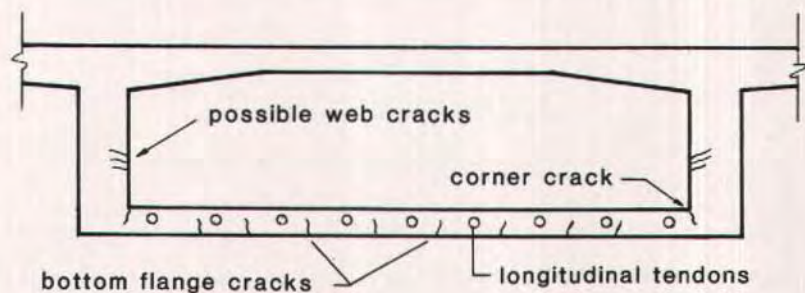
At this stress level the tensile strength of the concrete would be exceeded, producing the longitudinal cracks depicted in Fig. 34.

Fig. 34. Cracking from curved soffit tendons.

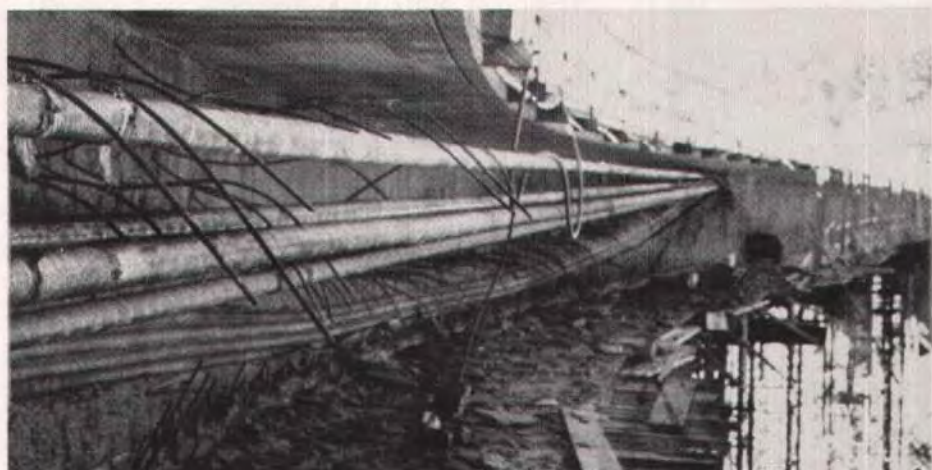
Fig. 39. Horizontal pullout of curved tendons (courtesy of T. Y. Lin).

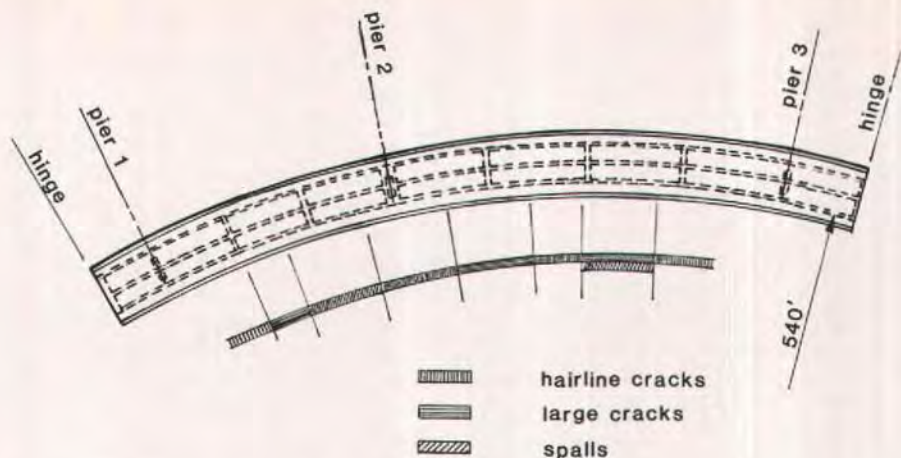
Fig. 43. Failure of south web.

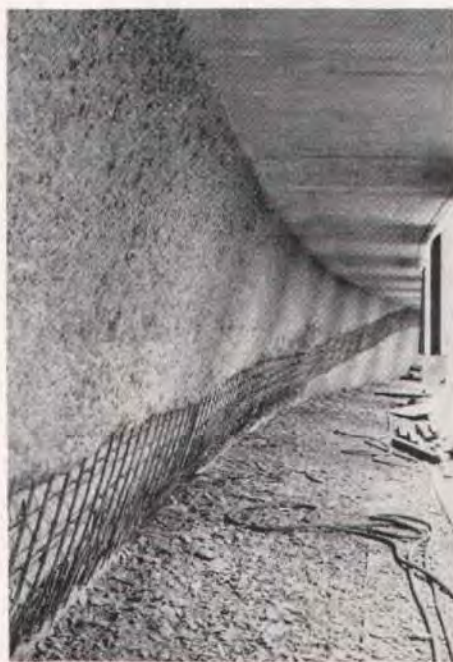
Fig. 44. Web spalling (courtesy of Clarence R. Yamamoto).

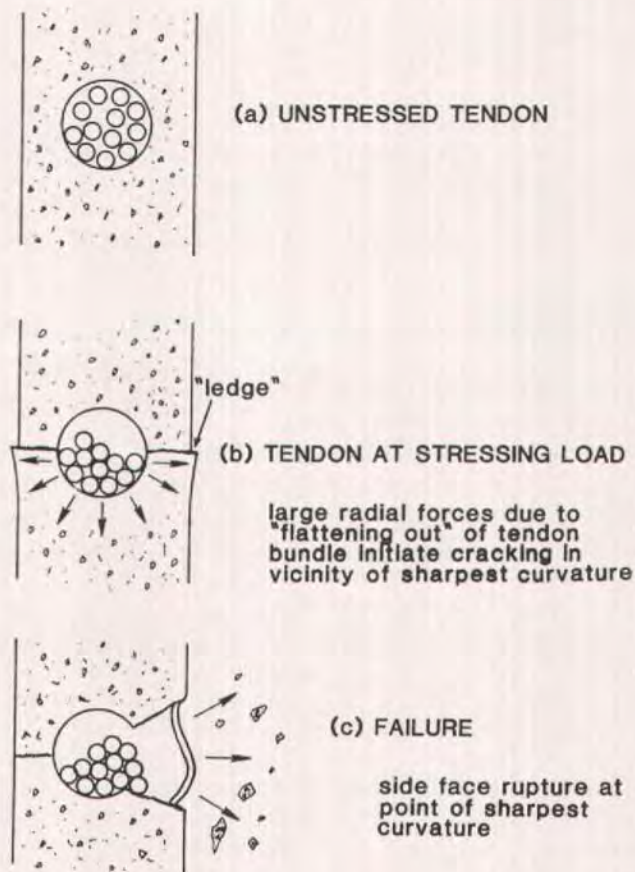
Fig. 53. Multistrand failure in a curved tendon.

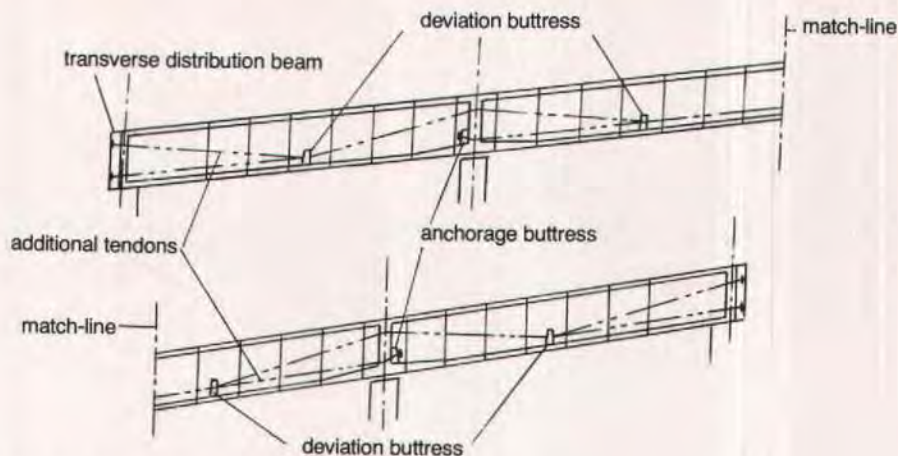
Fig. 64. Additional prestressing retrofit.

A recent application of this system in the United States (Fig. 64) used the transverse distribution member at the abutments and a concrete buttress for a deviation saddle that was keyed and doweled into the existing flange and web (Fig. 65). Where tendons were anchored to existing diaphragms, the diaphragm was locally reinforced by a sim-
