Fabrication and Shipment Cracks in Prestressed Hollow-Core Slabs and Double Tees

**PCI Committee on Quality Control
Performance Criteria**

Reprinted from the copyrighted
JOURNAL of the Prestressed Concrete Institute,
V. 28, No. 1, January-February 1983.

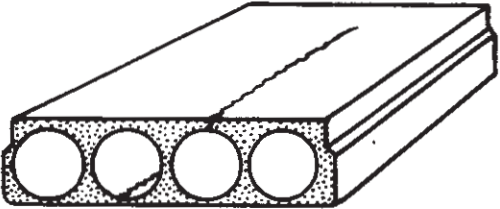
1. Longitudinal Crack at Void

Description — Longitudinal crack in either the top or bottom flange, or in both flanges at the end of the member.

CAUSE	PREVENTION	EFFECT	REPAIR
<p>A. Transverse shrinkage</p> <ol style="list-style-type: none"> 1. Excess water in concrete 2. Rapid moisture loss 3. Heat applied too early 4. Excessive curing temperatures. 5. Differential in curing temperature side to side 	<p>A. Proper mix and curing</p> <ol style="list-style-type: none"> 1. Reduce water content. 2. Cover product completely and as soon as possible (especially in windy, hot, or dry exposures). In extreme cases, spray product with mist or curing compound before covering. 3. Increase preset time before curing temperature rise begins 4. Reduce curing temperatures 5. Check for uneven curing temperature and make appropriate corrections 	<p>Severe cracks such as a crack through the full depth of the member in an untopped system can affect load distribution where there are concentrated loads, openings, or transverse cantilevers.</p>	<p>Voids may be grouted solid or the crack may be epoxied. Repair may not be required especially if member is used in a topped system.</p>

<p>B. Improper handling</p> <ol style="list-style-type: none"> 1. Uneven dunnage 2. Settlement of stack 	<p>B. Proper handling</p> <ol style="list-style-type: none"> 1. Use dunnage which provides uniform bearing 2. Use heavier dunnage at bottom of stack to prevent settlement. Reduce height of stack

<p>C. Lack of or differential compaction</p>	<p>C. Improve vibration</p>		
<p>D. Placement and eccentricity of prestressing steel</p> <ol style="list-style-type: none"> 1. Prestressing steel moved or displaced during casting 2. Imbalance of prestress force about vertical axis 3. Improper cutting sequence of prestressing steel 	<p>D. Proper positioning and design of prestressing steel</p> <ol style="list-style-type: none"> 1. Exercise care during casting to prevent displacement of prestressing steel 2. Balance prestress about vertical axis, or minimize eccentricity 3. Cut prestressing strand symmetrically from center to outside

<p>E. Flange too thin due to movement or misalignment of void forms</p>	<p>E. Correct and maintain void form position</p>		
<p>F. Over-inflation of rubber void forms</p>	<p>F. Maintain proper inflation</p>

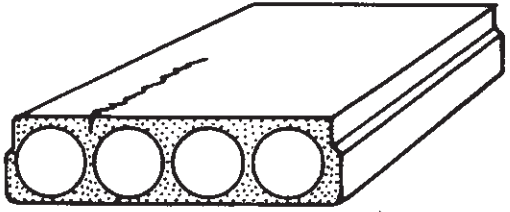
2. Longitudinal Crack at Web

Description — Longitudinal crack in top surface over the web. Cracks are not limited to ends of member, but can start and stop intermittently along the length of the member.

CAUSE	PREVENTION	EFFECT	REPAIR
<p>A. Subsidence over void</p> <ol style="list-style-type: none"> 1. Excess water in concrete 2. Bleeding rubber void forms too soon <p>B. Shrinkage due to improper curing and mix proportions</p> <ol style="list-style-type: none"> 1. Excess water in concrete 2. Rapid moisture loss 	<p>A. Prevent subsidence over void</p> <ol style="list-style-type: none"> 1. Reduce water content 2. Delay bleeding of rubber void forms <p>B. Improve curing procedures and mix</p> <ol style="list-style-type: none"> 1. Reduce water content 2. Cover product completely and as soon as possible (especially in windy, hot, or dry exposures). In extreme cases, spray product with mist or curing compound before covering 	<p>Minor cracking should have little effect; however, it may create problems with concentrated load distribution in untopped system.</p>	<p>If crack is severe member may be cut to a narrower width or used in a topped system.</p>

<ol style="list-style-type: none"> 3. Heat applied too early 4. Excessive curing temperatures 5. Differential in curing 	<ol style="list-style-type: none"> 3. Increase preset time before curing temperature rise begins 4. Reduce curing temperatures 5. Check for uneven curing temperature and make appropriate corrections

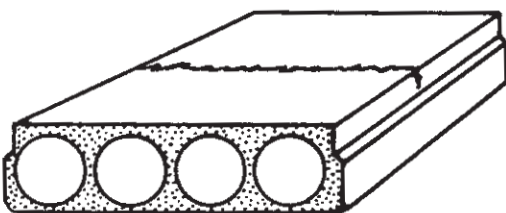
3. Transverse Crack

Description — Crack across the member, predominately occurs in the top, but can extend completely through the member in severe cases.

CAUSE	PREVENTION	EFFECT	REPAIR
<p>A. Longitudinal shrinkage</p> <ol style="list-style-type: none"> 1. Excess water in concrete 2. Rapid moisture loss 	<p>A. Proper mix and curing</p> <ol style="list-style-type: none"> 1. Reduce water content 2. Cover product completely and as soon as possible (especially in windy, hot or dry exposures). In extreme cases, spray product with mist or curing compound before covering 	<p>Potential shear capacity reduction if crack occurs at end. Can have a significant effect on shear and moment capacities of cantilevers. Reduction of moment of inertia in center of member can cause camber differentials and excessive deflections.</p>	<p>For minor cracks epoxy can be effective, and shear capacity can be increased by grouting voids solid at crack.</p> <p>Minor cracks in the top flange at areas of positive moment or in bottom flange at areas of negative moment may not require any repair.</p>

<ol style="list-style-type: none"> 3. Heat applied too early 4. Excessive curing temperatures 5. Uneven heating along length of bed <p>B. Contraction due to delayed detensioning after uncovering heat cured product</p>	<ol style="list-style-type: none"> 3. Increase preset time before curing temperature rise begins 4. Reduce curing temperatures 5. Check heat distribution system <p>B. Detension as soon as strength is verified, before product cools</p>

CAUSE	PREVENTION	
<p>C. Excessive top fiber tension</p> <ol style="list-style-type: none"> 1. Cantilever loading by misplacement of dunnage 2. Inadequate or misplaced tension reinforcement in cantilevers 3. Strand pattern too low <p>4. Low release strength</p> <p>D. Insufficient cover on transverse reinforcing bar (when required for special designs)</p>	<p>C. Reduce top fiber tension</p> <ol style="list-style-type: none"> 1. Maintain proper dunnage location 2. Install adequate reinforcement at proper position <p>3. Check placement of strand and consider debonding at end of members</p> <p>4. Increase release strength to accommodate top fiber tension</p> <p>D. Increase reinforcing bar cover</p>

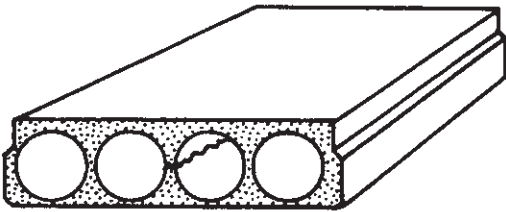
4. Web Crack Above the Strands

Description — A horizontal crack in one or more webs located above the strands. Crack widths can vary from hairline up to 1/4 in. (6.3 mm) or more in severe cases.

CAUSE	PREVENTION	EFFECT	REPAIR
<p>A. Excessive prestress force relative to cross section of member</p> <p>B. Insufficient release strength</p> <p>C. Expansion of rubber void forms due to increased temperature</p> <p>D. Bottom surface of member sticking to form during stripping</p> <p>E. Saw-cut not deep enough</p> <p>F. Lifting inserts or end stirrups misplaced</p> <p>G. Mix too wet or too dry</p> <p>H. Insufficient vibration</p>	<p>A. Reduce shear lag through webs</p> <ol style="list-style-type: none"> 1. Increase web width or produce with solid voids 2. Debond strands at ends of members 3. Add top strands 4. Reinforce webs 5. Reduce prestress force if ultimate strength design controls and check service load requirements <p>B. Increase release strength</p> <p>C. Bleed rubber void forms earlier</p> <p>D. Clean and oil form properly or ensure a dry contact surface when stack casting</p> <p>E. Cut completely through strands and as close as possible to the bottom of the member</p> <p>F. Place lifting inserts and stirrups properly</p> <p>G. Adjust water content</p> <p>H. Improve vibration</p>	<p>Can reduce shear capacity because shear stress must be resisted by undamaged webs. Analysis should be conservative because shear failure is not ductile.</p>	<p>For minimal cracks epoxy may be effective, and shear capacity can be increased by grouting voids solid.</p>

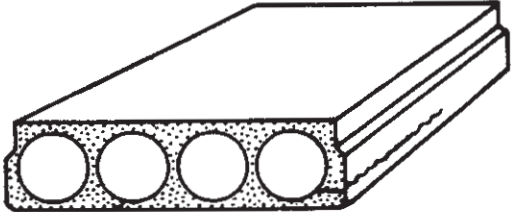
5. Web Crack at or Near the Strands

Description — Horizontal cracks in webs parallel to member length located at or near the strand.

CAUSE	PREVENTION	EFFECT	REPAIR
<p>A. Excessive bursting stresses</p> <ol style="list-style-type: none"> 1. Web not thick enough for transfer of prestress force 2. Strand diameter too large for transfer through thin webs 3. Lateral strand drift 4. Low release strength 	<p>A. Reduce bursting stresses</p> <ol style="list-style-type: none"> 1. Increase web width if possible 2. Provide equivalent prestress force with strands of smaller diameter 3. Check strand guides on machine 4. Increase release strength 	<p>Can reduce shear capacity because shear stress must be resisted by undamaged webs. Evaluation must include the effect of the associated strand slippage.</p>	<p>Repair of this member to account for the strand slippage which has occurred is not feasible; however, the shear capacity can be improved by grouting voids solid, or epoxying the cracks.</p>
<p>B. Lack of concrete consolidation around strands</p> <p>C. Strand masking improperly placed</p> <p>D. Layers not bonded</p> <p>E. Saw-cut not deep enough or not complete across sides</p>	<p>B. Improve consolidation around strands</p> <p>C. Secure masking to prevent movement</p> <p>D. Revise production procedures to avoid cold joints</p> <p>E. Saw completely through or across member</p>

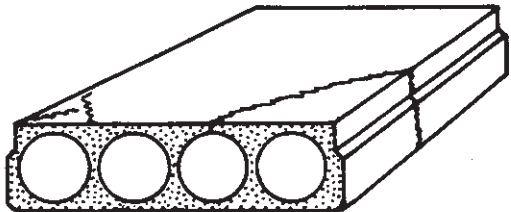
6. Corner Cracks

Description — Diagonal crack starting at the end of the slab possibly extending to the edge. May be in just the top or bottom flange, but could extend completely through the section.

CAUSE	PREVENTION	EFFECT	REPAIR
<p>A. Saw blade pinches when member cambers</p> <p>B. Saw-cut not deep enough</p>	<p>A. Place weight on member to restrict camber</p> <p>B. Cut completely through strands and as close as possible to the bottom of the member</p>	<p>Usually minimal, but can reduce shear capacity if webs are damaged. Evaluated similar to opening occurring at the end of the member.</p>	<p>Cracks may not need to be repaired depending on shear requirements. Epoxy may be used on cracks. Voids may be grouted solid.</p>
<p>C. Saw blade "wobble" due to excessive use</p> <p>D. Uneven dunnage</p> <p>E. Support blocks not providing even distribution of load during storage</p> <p>F. Uneven handling due to pick-up devices not being level</p> <p>G. Excessive tension stress during stripping</p>	<p>C. Proper saw maintenance</p> <p>D. Provide level supports</p> <p>E. Make sure support blocks do not transfer loads through flanges</p> <p>F. Use spreader beams to minimize uneven handling</p> <p>G. Anneal strand and employ proper cutting sequence</p>

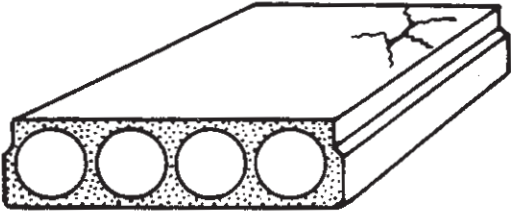
7. Miscellaneous Cracks

Description — Fine, shallow cracks in top surface of the slab occurring in a random pattern.

CAUSE	PREVENTION	EFFECT	REPAIR
<p>A. Surface shrinkage</p> <ol style="list-style-type: none"> 1. Excess water in concrete 2. Rapid moisture loss <p>3. Heat applied too early</p> <p>4. Excessive curing temperatures</p> <p>B. Improper troweling</p> <p>C. Improper mixes</p> <p>D. Improper operating of equipment</p>	<p>A. Proper mix and curing</p> <ol style="list-style-type: none"> 1. Reduce water in concrete 2. Cover product completely and as soon as possible (especially in windy, hot or dry exposures). In extreme cases, spray product with mist or curing compound before covering. Use retarding admixtures. 3. Increase preset time before curing temperature rise begins 4. Reduce curing temperatures <p>B. Reduce troweling</p>	<p>Minor, but can be serious in a severe exposure situation.</p>	<p>None</p>

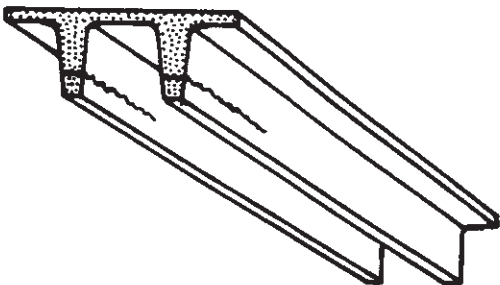
1. Horizontal End Crack in Stem

Description — This crack usually begins at the end of a double tee and extends horizontally for a distance of from several inches to a few feet. It is often located in the horizontal plane of a strand.

CAUSE	PREVENTION	EFFECT	REPAIR
<p>A. Improper design</p> <ol style="list-style-type: none"> 1. Inadequate confining reinforcement 2. Excessive eccentricity 3. Excessive prestress force or concentration of prestress force <p>B. Improper release</p> <ol style="list-style-type: none"> 1. Improper procedure for cutting strands 2. Low release strength 3. Slippage and impact from dirty strand 4. Improperly masked strand 5. Improper cutting sequence 	<p>A. Improve design</p> <ol style="list-style-type: none"> 1. Use adequate end reinforcement. 2. Be sure end stresses are within allowable limits. 3. Properly space and distribute strand at the ends of members. <p>B. Proper release</p> <ol style="list-style-type: none"> 1. Anneal strand prior to cutting. 2. Achieve proper strength prior to releasing strand. 3. Keep strands clean. 4. Masking must allow for expansion and twisting of masked strands. 5. Keep prestress force balanced while cutting strands. 	<p>If the plane of the crack coincides with a strand there is a possibility of loss of bond. This could reduce the shear and moment capacity of the member due to increased development length.</p> <p>If the plane of the crack does not coincide with a strand, the consequences are less severe.</p> <p>The end reaction does provide a clamping force for this type of crack.</p>	<p>If required, repair member using epoxy injection to prevent deterioration.</p>

CAUSES	PREVENTION	
<p>C. Improper stripping and handling</p> <ol style="list-style-type: none"> 1. Strand not completely cut 2. Strand caught in header 3. Improper header removal <p>D. Improper production</p> <ol style="list-style-type: none"> 1. Indentations or joint offsets in forms 2. Excessive bleeding at headers 3. Improper end curing 4. Binding in forms 	<p>C. Better stripping and handling techniques</p> <ol style="list-style-type: none"> 1. Insure that all strands are fully cut. 2. Allow member to drift away from headers when lifting. 3. Separate header from concrete before lifting. <p>D. Improve production methods</p> <ol style="list-style-type: none"> 1. Keep forms in good repair. 2. Replace damaged and worn out headers. 3. Prevent heat loss at headers. 4. Keep forms clean and properly oiled.

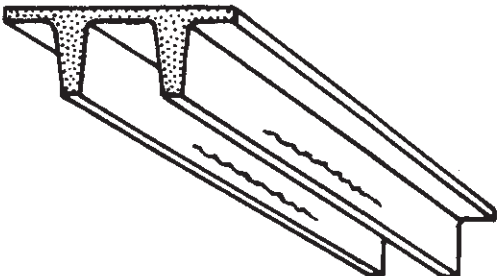
2. Horizontal Crack in Stem

Description — This crack occurs at or between hold-down devices. If this crack branches upwards near its center it is probably caused by top fiber tension (see Crack 3). Absence of this vertical branch indicates that the horizontal crack is probably the result of vertical tensile stresses.

CAUSE	PREVENTION	EFFECT	REPAIR
<p>A. Excessive draping of strands. Vertical component of the prestressing force induces excessive tension.</p> <p>B. Improper stripping</p> <ol style="list-style-type: none"> 1. Hold-down released prior to developing release strength 2. Hold-down not released before stripping 3. Member twisted during stripping causing it to bind in the form <p>C. Improper production</p> <ol style="list-style-type: none"> 1. Indentations in form 2. Binding in forms 3. Joint offsets in form 	<p>A. Avoid draping too many strands at same hold-down and hold-up devices.</p> <p>B. Use proper stripping and handling techniques.</p> <ol style="list-style-type: none"> 1. Do not release hold-downs until proper release strength has been attained. 2. Release hold-downs before lifting the member. 3. Keep the double tee transversely level when lifting. <p>C. Improve production methods</p> <ol style="list-style-type: none"> 1. Keep forms in good repair. 2. Keep forms clean and properly oiled. 3. Fabricate forms with even joints. 	<p>Hairline horizontal cracks are seldom serious. It is desirable to prevent cracks from growing.</p>	<p>Pressure inject with epoxy.</p>

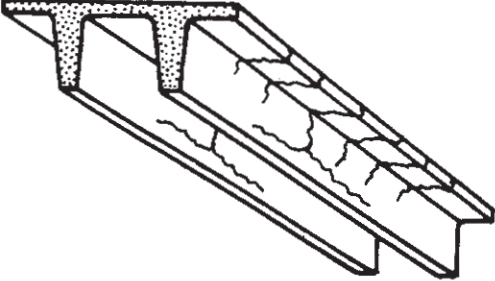
3. Vertical Crack at Top of Member

Description — Crack starts at the top of the member and extends downward through the flange and into the stem. It is not uncommon for these cracks to fork horizontally when they reach the neutral axis.

CAUSE	PREVENTION	EFFECT	REPAIR
<p>A. Excessive cantilevers</p> <ol style="list-style-type: none"> 1. Additional top fiber tension because of position of lifting points or dunnage 2. Top fiber tension at mid-span is too high because of reduced positive moment <p>B. Excessive eccentricity due to draped or general position of strand results in excessive top fiber tension</p> <p>C. Vibration or harmonic motion when hauling on rough roads</p> <p>D. Hold-down device released prior to cutting strand (when vertical force component exceeds member weight)</p>	<p>A. Proper placement of dunnage and lifting points</p> <ol style="list-style-type: none"> 1. Add negative reinforcement or use strand hold-ups. 2. Place dummy load at mid-span if temporary excessive cantilever is required. <p>B. Check top fiber tension and do not over-depress strands. Place dummy load above hold-down devices when releasing.</p> <p>C. Check hauling procedures including:</p> <ol style="list-style-type: none"> 1. Road conditions 2. Member length 3. Member design 4. Tie-down locations <p>D. 1. Preferable method is: Increase release strength if required and provide dummy loads.</p> <p>2. Alternate method is: Apply prestress force in stages by annealing strand prior to releasing hold-down. Protect heel if necessary.</p>	<p>These cracks are of little consequence in compressive areas, but they represent loss of stiffness in cantilevers.</p>	<p>Pressure inject with epoxy horizontal cracks in the stem and cracks in areas of negative moment.</p>

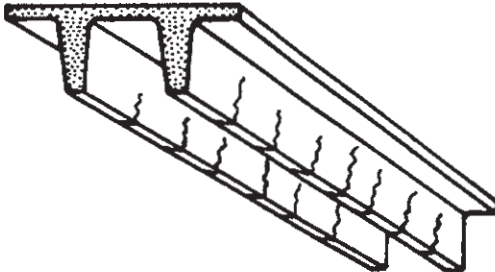
4. Vertical Crack at Bottom of Stem

Description — These cracks are usually predominant and more closely spaced in areas of greatest positive moment.

CAUSE	PREVENTION	EFFECT	REPAIR
<p>A. Improper production</p> <ol style="list-style-type: none"> 1. Indentations in form 2. Binding in forms 3. Joint offsets in form <p>B. Improper storage or handling of members designed to be cantilevered</p> <p>C. Improper prestress</p> <ol style="list-style-type: none"> 1. Strand location 2. Harping 3. Tensioning 4. Design 5. Losses underestimated <p>D. Bond failure at end of member</p> <ol style="list-style-type: none"> 1. Foreign matter on strands 2. Insufficient vibration <p>E. Incomplete design</p>	<p>A. Improve production methods</p> <ol style="list-style-type: none"> 1. Keep forms in good repair. 2. Keep forms clean and properly oiled. 3. Fabricate forms with even joints. <p>B. Lift and support cantilever members as close to bearing points as possible.</p> <p>C. Verify that the correct prestressing force is being applied.</p> <ol style="list-style-type: none"> 1. Check strands for correct location. 2. Check hold-down point for proper location and depth. 3. Compare measured strand elongation versus computed elongation. 4. Check design calculations for possible error. 5. Recompute losses. <p>D. Prevent bond failures</p> <ol style="list-style-type: none"> 1. Keep strands clean. 2. Vibrate properly. <p>E. Consider erection stresses due to dynamic loads. Can be 25 to 50 percent of dead load.</p>	<p>If no bond failure has occurred at ends, the flexural strength is not affected.</p> <p>If strand slippage has occurred, check deflections based on a cracked section and reduced prestress. Member is not serviceable unless its capacity is verified by test or calculations. A reduced service load may be considered in some cases.</p>	<p>If the crack or cracks are due to either Cause A or B, then epoxy injection can restore the member to an uncracked section.</p> <p>If they are due to Causes C or D, then epoxy injection will have little or no effect.</p>

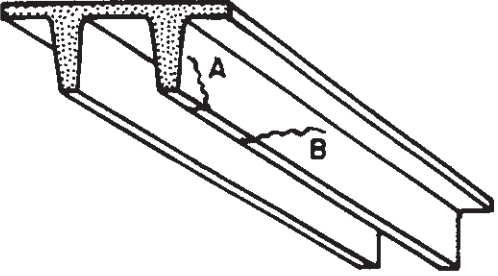
5. Diagonal Cracks in Stem

Description — These cracks usually begin near the bottom of the stem and progress diagonally upwards. Crack "A" extends towards the end and Crack "B" extends towards the center of the member.

CAUSE	PREVENTION	EFFECT	REPAIR
<p>A. Diagonal tension caused by sliding of member as prestress is released</p> <p>B. Excessive bearing stress on heel of member as it cambers out of form</p> <p>C. Sudden expansion of form due to rapid heating</p> <p>D. Transverse movement of member while setting it down or dragging it sideways</p> <p>E. Improper production</p> <ol style="list-style-type: none"> 1. Indentations in form 2. Binding in forms 3. Joint offsets in form 	<p>A. Cut strands at each end simultaneously. Anneal if necessary.</p> <p>B. Use bearing plates or large chamfers at ends of stems. Check to see if confining reinforcement is required.</p> <p>C. Allow temperature to rise slowly. Check to see if confining reinforcement is required. Consider lengthening preset time.</p> <p>D. Handle members carefully so that lateral forces are not applied to stems.</p> <p>E. Improve production methods</p> <ol style="list-style-type: none"> 1. Keep forms in good repair. 2. Keep forms clean and properly oiled. 3. Fabricate forms with even joints. 	<p>Cracks crossing strands near the end of a member can be very serious because of the possibility of loss of bond between the end of the member and the crack as well as the increased transfer length beyond the crack. Shear is very much a problem unless member has stirrups or confining reinforcement.</p>	<p>Epoxy injection can restore the shear strength of the concrete if there is sufficient, bonded, positive reinforcement. Epoxy injection will not restore loss of bond or substitute for insufficient reinforcement.</p>

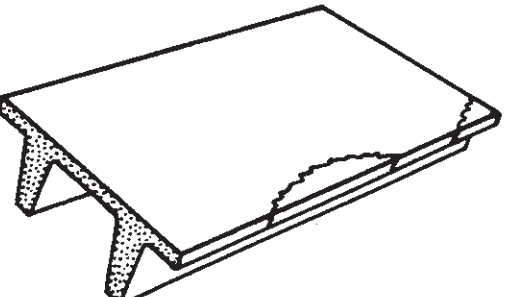
6. Flange Cracks Outside of Stems

Description — These cracks have the appearance of isolating a portion of the flange from the rest of the member.

CAUSE	PREVENTION	EFFECT	REPAIR
<p>A. Insufficient flange reinforcement or reinforcement in improper position</p> <p>B. Binding at edge of form during stripping</p> <p>C. Bumping edges or corners when handling</p> <p>D. Improper dunnage transmits load to unsupported flange</p> <p>E. Binding mechanism bears against flange</p>	<p>A. Use a sufficient mesh reinforcement in proper position.*</p> <p>B. Properly clean and oil edges of form.</p> <p>C. Provide extra lateral reinforcement at the ends of the member.</p> <p>D. Place dunnage properly.</p> <p>E. Properly position binding mechanism.</p> <p><small>*Refer to PCI JOURNAL, V. 21, No. 4, June 1976, p. 30 for recommended flange reinforcement.</small></p>	<p>If mesh is too low, the capacity in the isolated area may be severely reduced.</p> <p>If mesh is in the proper location, these cracks will have virtually no effect upon the member's capacity unless vertical separation occurs.</p> <p>Roofing adhesive can seep through and contaminate exposed areas.</p>	<p>If a composite concrete topping is to be applied, just provide whatever shoring is necessary to support the concrete.</p> <p>If mesh is too low and no topping is to be used, added support must be provided.</p> <p>Epoxy injection or simply surface epoxy that only penetrates about 1/4 in. (6.3 mm) will take care of seepage problem.</p>

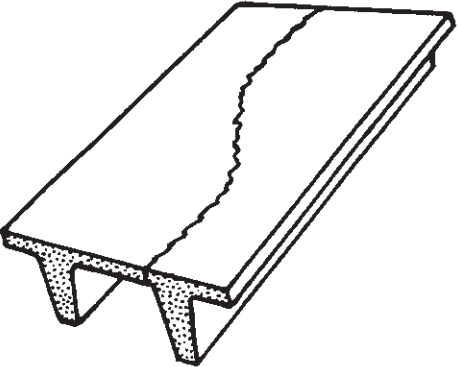
7. Flange Crack Between the Stems on Opposite Sides

Description — These cracks begin at opposite ends of the double tee flange and progress along the inside face of the stems crossing over to meet each other at the center of the member.

CAUSE	PREVENTION	EFFECT	REPAIR
<p>A. Torsional stresses due to twisting or racking of member</p> <p>1. During stripping</p> <p>2. During handling</p> <p>3. During storage</p> <p>4. During shipping</p>	<p>A. Employ handling techniques which will minimize twist.</p> <p>1. Equalize lifting loads by making all lifting devices of equal projection, using proper spreader or equalizer beams, and/or sheaves.</p> <p>2. Provide extra lateral reinforcement at ends of the member in the flange.</p> <p>3. Employ level, rigid blocking.</p> <p>4. When rough or uneven roads must be traveled, keep loads light with a low center of gravity and use a pivoting fifth wheel.</p>	<p>This type of crack usually has no effect upon the load carrying capacity.</p> <p>Roofing adhesive can seep through and contaminate exposed areas.</p>	<p>When a composite concrete topping is to be applied, no repair is necessary.</p> <p>Epoxy injection or simply surface epoxy that only penetrates about ¼ in. (6.3 mm) will take care of seepage problem.</p>

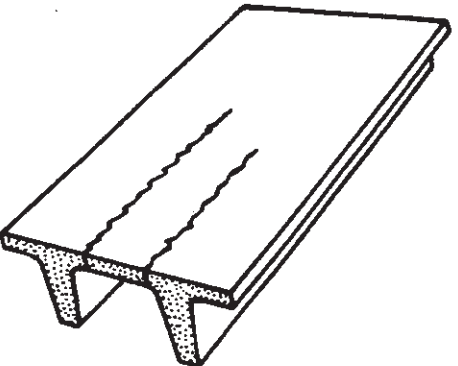
8. Flange Cracks Each Side of Stem

Description — Longitudinal cracks that occur on each side of a stem and usually originate at the end of the member.

CAUSE	PREVENTION	EFFECT	REPAIR
<p>A. Improper and incomplete consolidation</p> <p>B. Improper stripping so that member is tilted</p> <p>C. Volumetric change</p> <p>1. Uneven curing</p> <p>2. Uneven drying out</p> <p>3. Heat curing too rapidly</p>	<p>A. Compact concrete properly.</p> <p>B. Lift member in level position so weight is not transferred to flange.</p> <p>C. Employ proper curing methods</p> <p>1. Check heat distribution system.</p> <p>2. Cover product completely and as soon as possible (especially in windy, hot or dry exposures). In extreme cases, spray member with mist or curing compound before covering.</p> <p>3. Reduce rate of rise of curing temperatures.</p>	<p>This type of crack usually has no effect upon the load carrying capacity.</p> <p>Roofing adhesive can seep through and contaminate exposed areas.</p>	<p>When a composite concrete topping is to be applied, no repair is necessary.</p> <p>Epoxy injection or simply surface epoxy that only penetrates about ¼ in. (6.3 mm) will take care of seepage problem.</p>
