# Corrosion risk of bonded, post-tensioned concrete elements

Rubén M. Salas, Andrea J. Schokker, Jeff S. West, John E. Breen, and Michael E. Kreger

Corrosion protection for bonded, internal, post-tensioning tendons can be effective. Within structural elements, post-tensioning tendons can be well protected by a multilayer system, which includes sound design of surface treatments; high-quality concrete; corrosion-resistant ducts; high-quality cementitious grout, coatings, and other internal barriers in the prestressing steel; and superior anchorage protection measures (for example, encapsulated systems and electrically isolated systems). Potential weaknesses exist in the protection system, however, when the concrete has high permeability (due to mixture proportions, construction techniques, and/or service and exposure conditions) or when the concrete is cracked (due to shrinkage or service loading). Additional weaknesses can occur when the post-tensioning ducts are not adequately spliced and lack adequate impermeable concrete cover or when the portland cement grout contains voids, bleed water, or cracks. Finally, the prestressing steel may be more susceptible to corrosion if it is

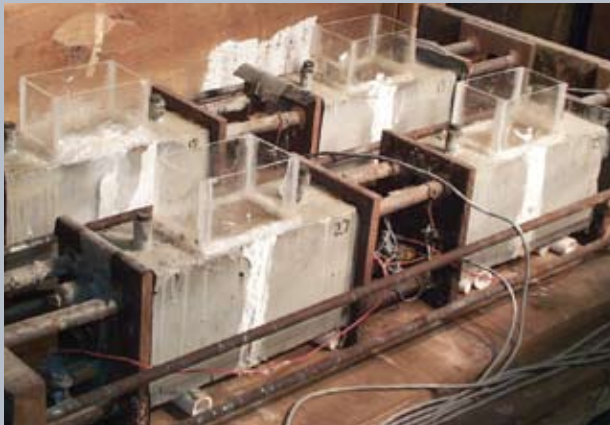
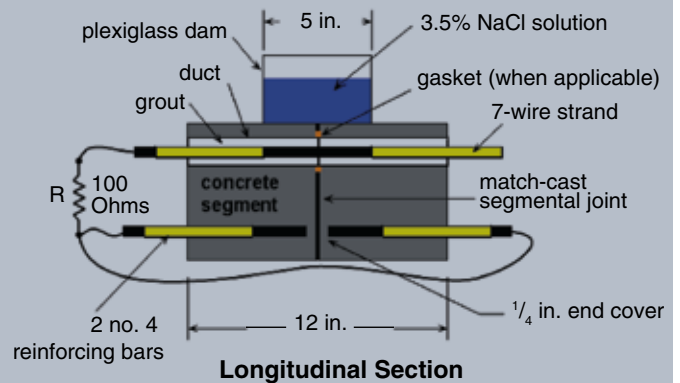
**Figure 1.** Pictured are the test setup and specimen details of the macrocell corrosion test series. Note: 1 in. = 25.4 mm; no. 4 = 13M.

Thirty-eight macrocell specimens developed by Vignos<sup>9</sup> were used to investigate the corrosion protection of internal tendons at segmental joints. The testing method was based on ASTM G109,<sup>10</sup> which was modified to examine post-tensioning tendons in grouted ducts and to simulate segmental joints.

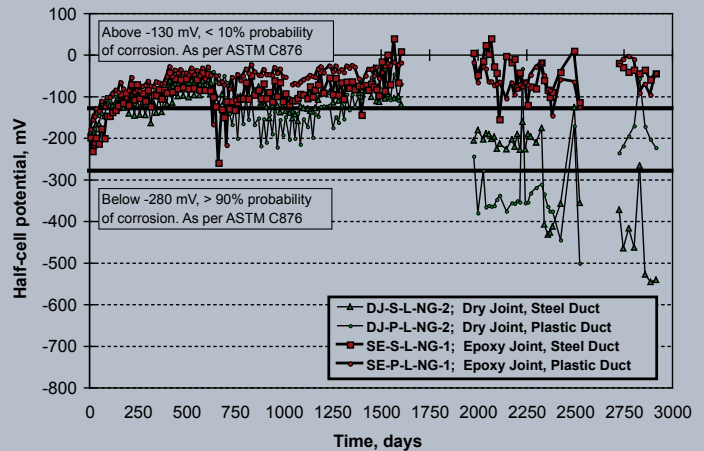
**Figure 2.** Shown is an example of half-cell potential plots for the macrocell corrosion test series.

Exposure conditions during testing consisted of two-week-long wet cycles using a 3% sodium chloride solution followed by two-week-long dry cycles. Two forms of regular measurements were taken to evaluate specimen performance during testing: macrocell corrosion currents and half-cell (HC) potential measurements. **Figure 2** shows sample HC potential readings.

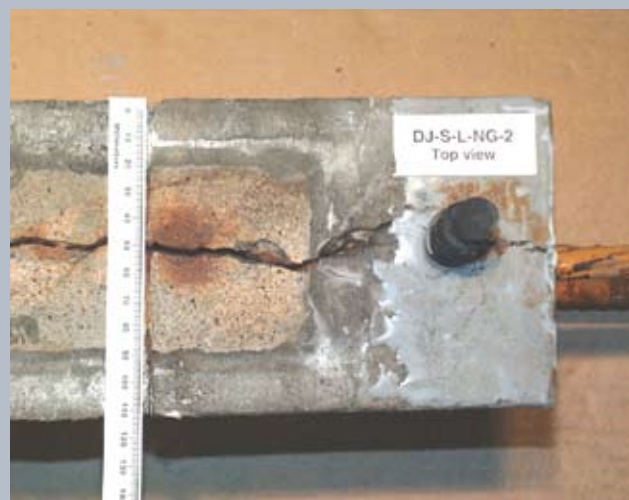
**Figure 3.** Pictured is an example of specimen condition prior to internal examination for the macrocell corrosion test series. Note: Table 1 defines specimen notations. 1 mm = 0.03937 in.

A detailed visual inspection was performed before internal examinations on all specimens after their respective duration of aggressive exposure testing, either four years and five months or eight years. **Figure 3** shows an example of specimen condition prior to internal examination.

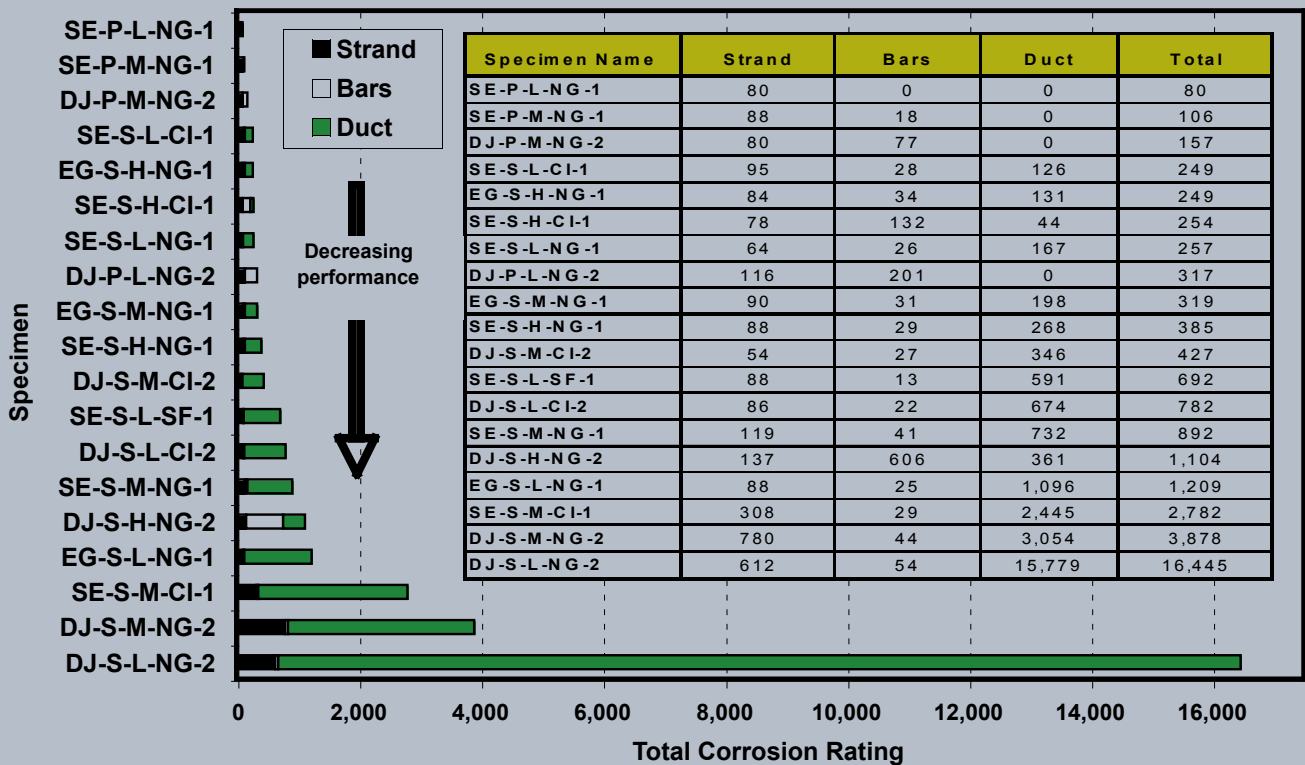
Figure 4. Shown are the macrocell corrosion test series' eight-year corrosion-rating results according to performance. Note. Table 1 defines the specimen notations.

**Table 2** shows the corrosion rating results for the macrocell series. **Figure 4** shows the total corrosion rating results in graphical form ordered according to performance at either four years and five months of exposure or at eight years of exposure.

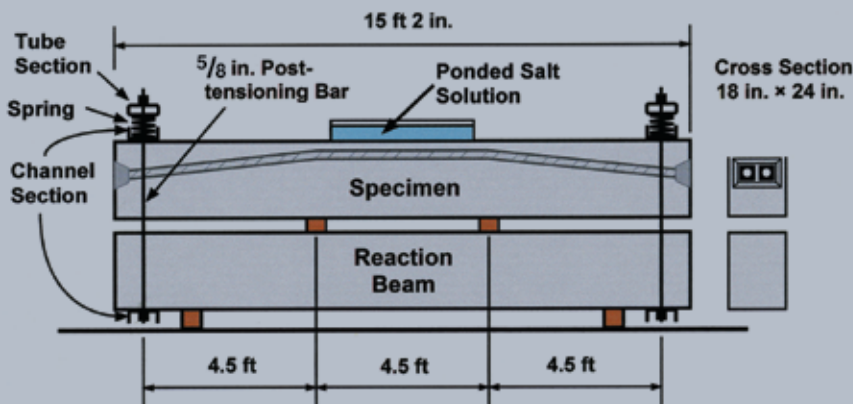
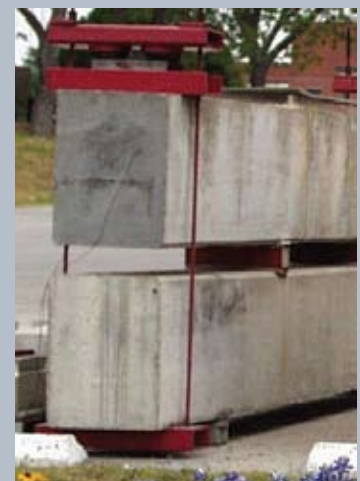
Figure 5. Shown are the beam-specimen details and test setup for the beam corrosion test series. Note: 1 in. = 25.4 mm; 1 ft = 0.3048 m.

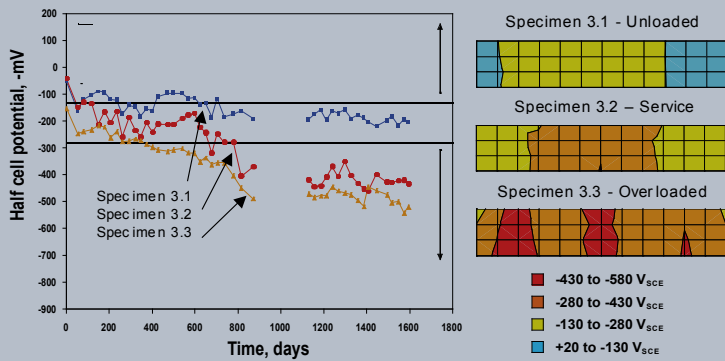
**Figure 6.** This is an example of half-cell potential readings and contour maps at 1594 days of testing for the beam corrosion test series.

Note: Discontinuities in the graph are due to interruptions in the data acquisition process; nonetheless, specimens remained under continuous exposure. In the graph,  $V_{SCE}$  means voltage at a saturated calomel electrode. Probabilities of corrosion were based on ASTM C876<sup>13</sup> and are indicated on the graph with horizontal lines. There is less than 10% probability of corrosion within the specimen with values less than -130mV, and more than 90% probability of corrosion with values greater than -280 mV.

To monitor the corrosion activity of the specimens during exposure, multiple non-destructive methods were used: visual inspection, crack-width measurements, HC potential readings, corrosion-rate measurements, and chloride-penetration measurements. **Figure 6** shows an example of HC potential readings. The specimens received continuous exposure, but there were interruptions in the data-acquisition process. Probabilities of corrosion were based on ASTM C876,<sup>13</sup> which formed the basis for the horizontal lines in Fig. 6. There was less than 10% probability of

corrosion within the specimen if the HC potential reading was less than -130 mV and more than 90% probability of corrosion if the reading was greater than -280 mV.

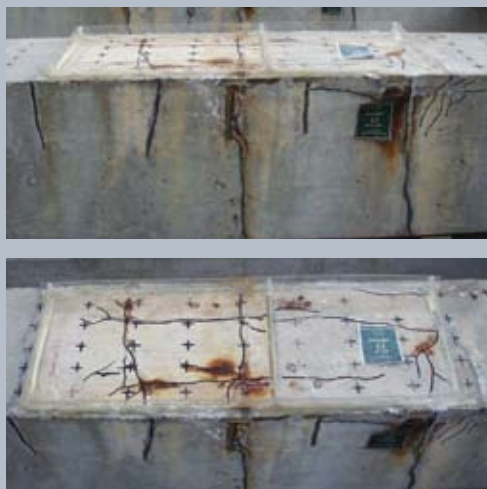
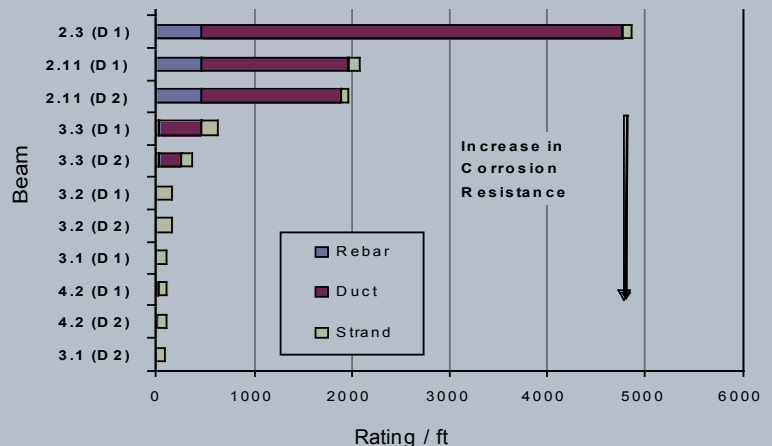
**Figure 7.** Shown is a beam corrosion test series example of specimen condition prior to internal examination and generalized corrosion ratings for phase I internal examination beams. Note: 1 ft = 0.3048 m.

**Figure 7** shows an example of specimen condition prior to internal examination.

Tables 4 and 5 show the corrosion-rating results. Reference 7 includes a detailed set of corrosion-rating graphs for all specimens. Figure 7 shows the general corrosion ratings for phase I beams after internal examination. The two ducts in each specimen are indicated by D1 and D2.

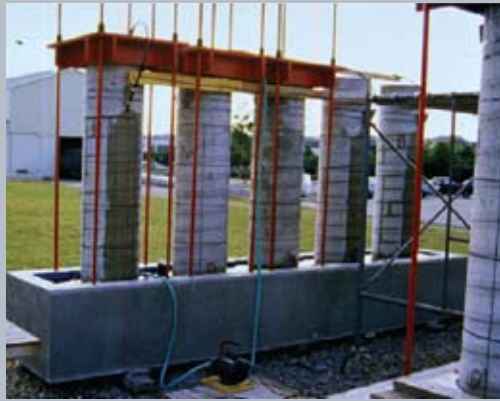
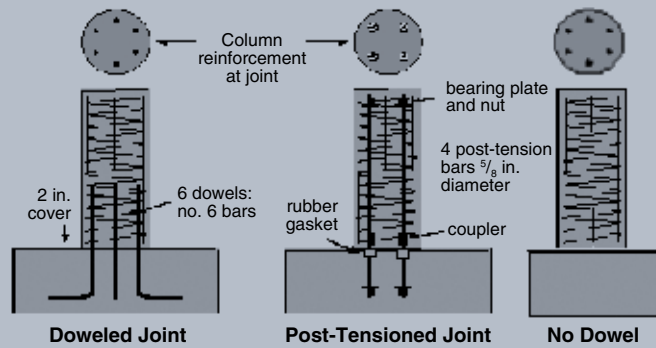
**Figure 8.** Shown are the test setup and column-specimen details for the column corrosion test series. Note: 1 in. = 25.4 mm; no. 6 = 19M.

Ten column specimens were used to investigate corrosion mechanisms and chloride ion transport (wicking effect) in various column-connection configurations and to evaluate column-corrosion-protection measures. **Figure 8** shows the column-specimen details and test setup.

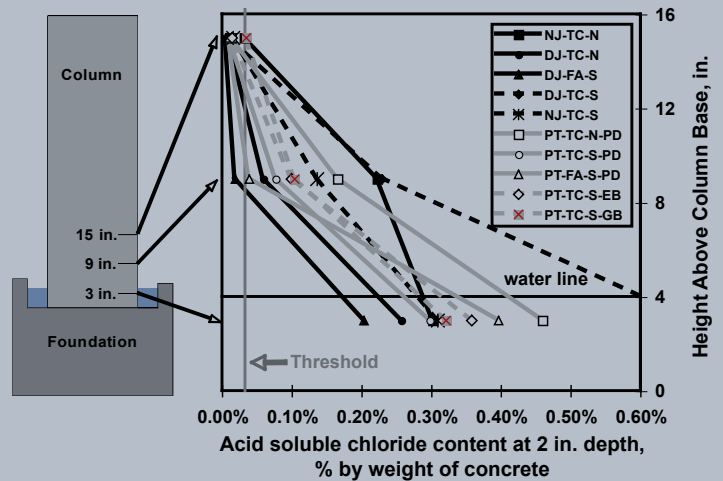
**Figure 9.** Shown is concrete chloride penetration at 2 in. for all columns in drifter side at end of testing for the column corrosion test series. Chloride threshold value is indicated in the figure at 0.033%. This value, intended as a guide only, is based on the widely accepted chloride threshold value of 0.2% of the weight of cement (Source: *Corrosion of Metals in Concrete*).

Note: Table 6 defines specimen notations. 1 in. = 25.4 mm.

samples. Chloride samples were taken directly from the concrete-column specimens at three depths ( $\frac{1}{2}$  in., 1 in., and 2 in. [13 mm, 25 mm, and 50 mm]) from three locations (3 in., 9 in., and 15 in. [75 mm, 225 mm, and 380 mm] from the base of the specimens), and on both the spray and the non-spray side. The acid-soluble-chloride content was measured from these powder samples collected after 20 months, 32 months, and 78 months (end of testing). **Figure 9** shows an example of chloride-content graphs. Chloride threshold value is indicated in the figure at 0.033%. This value, intended as a guide only, is based on the widely accepted chloride threshold value of 0.2% of the weight of cement.<sup>14</sup>

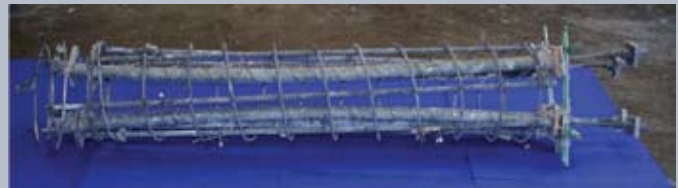
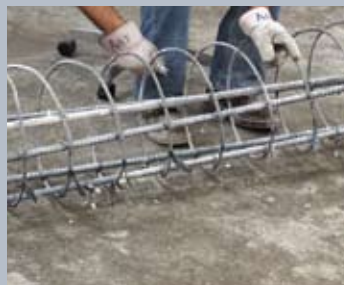
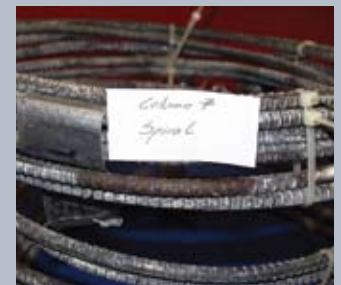
**Figure 10.** Shown is the column concrete removal and dismantling of reinforcement for the column corrosion test series.

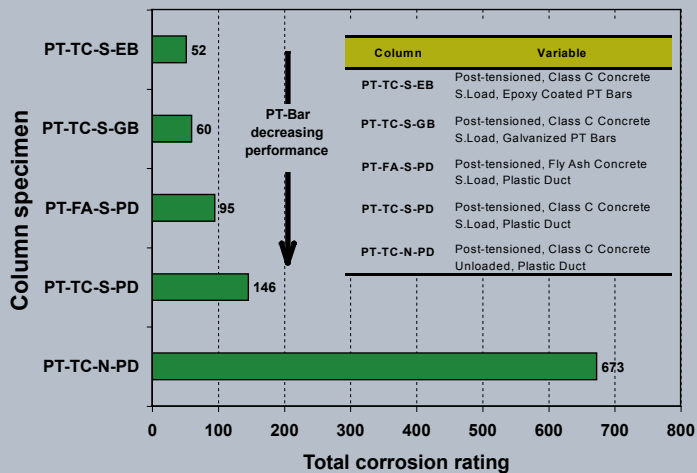
Figure 11. This graph shows post-tensioned bar corrosion ratings at six and a half years of exposure testing, ordered according to performance for the column corrosion test series. Note: Table 6 defines specimen notations.

Tables 7 and 8 show the corrosion-rating results, and Fig. 11 illustrates the post-tensioning bar corrosion ratings.

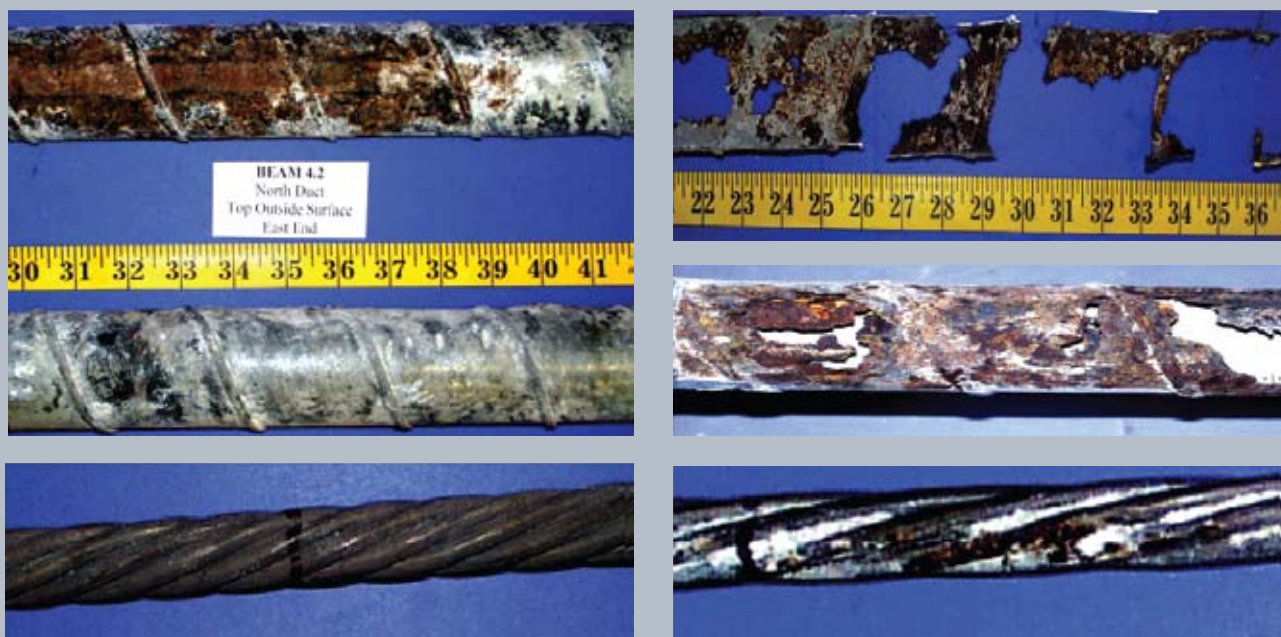
Figure 12. Pictured is corrosion in galvanized-steel duct in beams with different levels of post-tensioning from the beam corrosion test series. Note: 1 in. = 25.4 mm.

Extremely severe duct corrosion occurred in  $\frac{2}{3}$ PS specimens, which was due to a higher frequency of cracking in these specimens. In general, severe duct destruction and pitting were found in most specimens with metal ducts.

The prestressing level had an inverse relationship with the corrosion activity. As the amount of prestressing increased, the severity and extent of corrosion decreased. In the beam corrosion test series, the  $\frac{2}{3}$ PS beams showed substantially more localized and generalized corrosion than fully prestressed members (Fig. 12). Prestressed concrete was a definite factor in reducing corrosion risk. Lower permeability due to increased prestressing also provided better resistance to wicking effects, as shown in the column specimens.

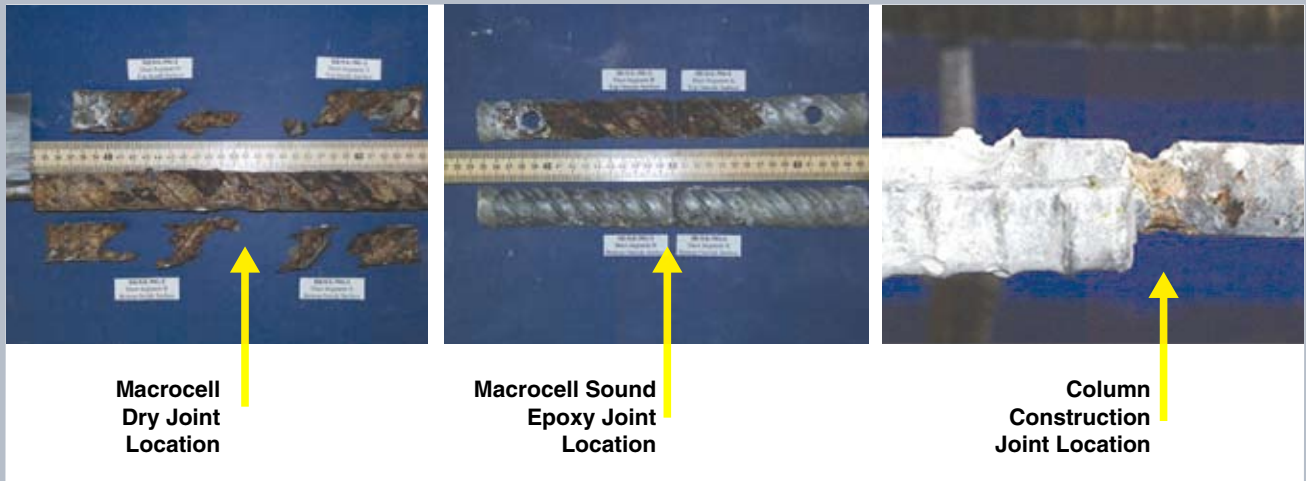
Figure 13. Pictured is segmental or construction joint performance from the macrocell and column corrosion test series. Note: 1 in. = 25.4 mm.

moisture and chloride ingress. Dry joints, which behaved like preset cracks, performed poorly in the macrocell specimens (**Fig. 13**). Similar results were observed in the column tests at the column bases for the nondoweled specimens.

The use of gaskets in the joints was detrimental to the performance of the specimens. The gaskets prevented complete epoxy coverage of the joints and allowed moisture and chloride ingress. They also trapped moisture at the duct ends and produced crevice corrosion in the galvanized-steel ducts. The incompletely filled-epoxy-joint performance was similar to that of a dry joint. Test results showed that poor epoxy filling at the joint was detrimental to the performance of the duct, the prestressing strand, and the mild-steel reinforcement.

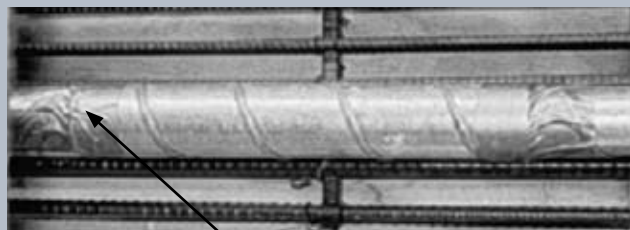
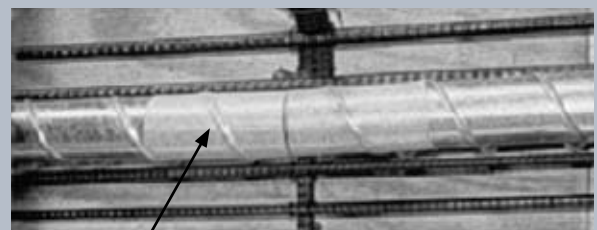
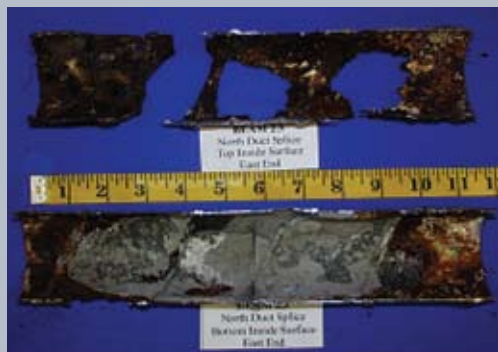
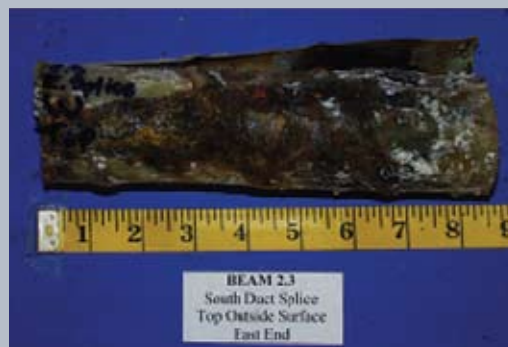
duct tape

heat shrink tubing

Figure 14. Shown is duct-splice performance from the beam corrosion test series. Note: 1 in. = 25.4 mm.

Both the industry-standard duct-taped splice and the heat-shrink splice used for the galvanized-steel ducts in the beam test series were unsatisfactory. Neither prevented moisture nor chloride ingress to the grout that was intended to provide corrosion protection to the strand (**Fig. 14**). Duct and strand corrosion were less severe away from the duct splice. Development of a more effective duct-splicing technique should be a high priority. There were no plastic duct splices to evaluate in the beam series because they were continuous along the beams.

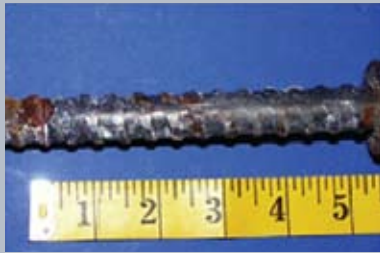
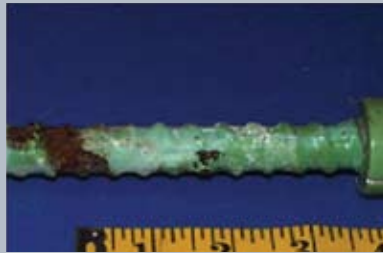
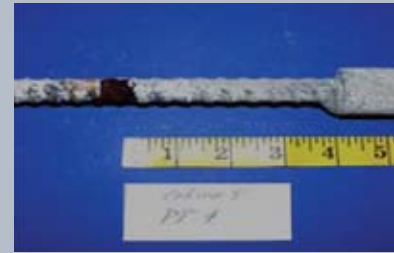
Uncoated post-tensioning bar

Epoxy post-tensioning bar

Galvanized post-tensioning bar

**Figure 15.** Shown is bar-coating performance from a column when subjected to localized attack from the column corrosion test series. Note: 1 in. = 25.4 mm.

Both the epoxy and galvanized coating for post-tensioning strands enhanced general corrosion protection relative to uncoated strands. Under severe localized attack, however, such as at a crack or joint location, corrosion activity is severe regardless of coating, which may result in unexpected failure (**Fig. 15**).

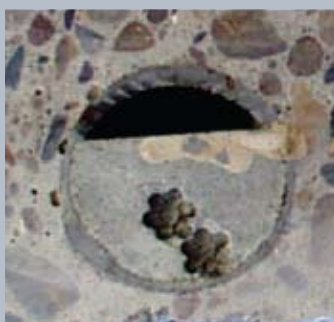
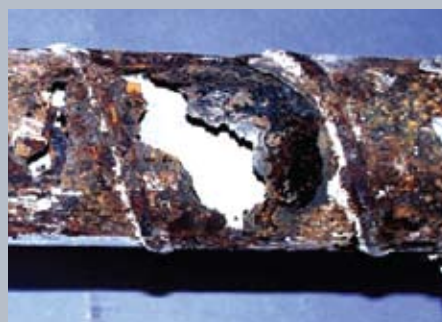
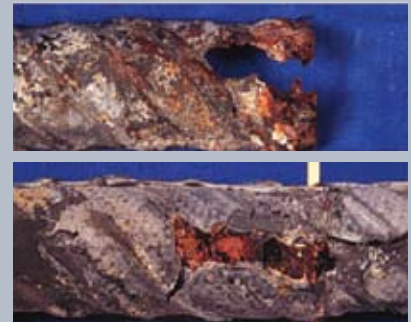
**Figure 16.** Pictured are bleed-water voids and duct corrosion from the beam corrosion test series.

The standard TxDOT Class C grout performed poorly in all specimens that were evaluated. Better results were obtained from grout with fly ash or corrosion inhibitor added, but grout voids were not eliminated in any of the grout mixtures. Grout voids due to entrapped air, bleed water, incomplete grout filling, or a lack of grout fluidity were detrimental not only to the prestressing strand but also to the galvanized-steel duct. In addition, bleed water was found to be detrimental to the galvanized ducts when using heat-shrink or industry-standard splices, as shown in **Fig. 16**. Antibleed and better thixotropic grouts, such as those reported by Schokker,<sup>4</sup> should be considered.

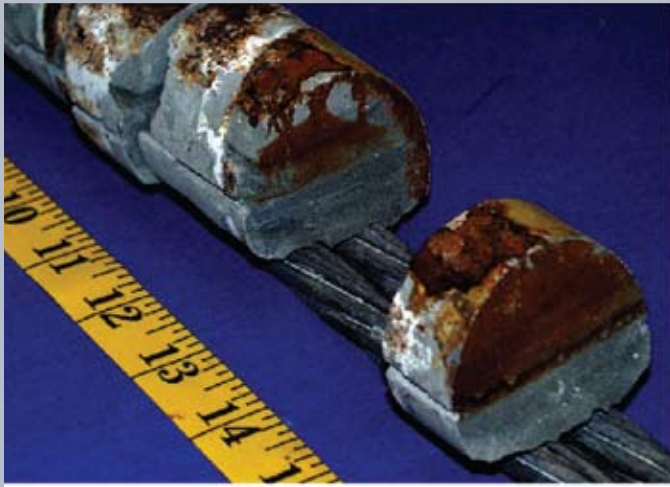
**Figure 17.** Pictured is the effect of grout cracking from the beam corrosion test series.  
Note: 1 in. = 25.4 mm.

Because it is injected after post-tensioning of the element, the grout is not prestressed and is susceptible to cracking due to applied loads, deflections from loading, and vibrations. Cracks in the grout may serve as direct paths for moisture and chloride ingress to the strands. **Figure 17** shows the effect of grout cracking. Moisture and corrosion stains from the galvanized duct were present in many grout transverse slices. At the time of the internal examination, it appeared that with a little more time,

moisture would have reached the strand. Stringent grouting procedures must be enforced, such as those recommended in Schokker et al.<sup>4</sup>

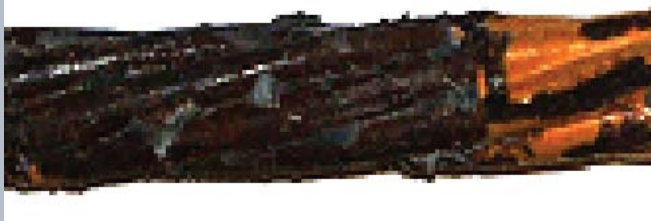
**DJ-S-L-NG-2**  
Strand-Segment A Top Surface

**Figure 18.** This strand from the macrocell corrosion test series was removed from the beam in Fig. 3, which experienced longitudinal cracking thereby facilitating severe corrosion of the strand.

Transverse cracking due to loading had a direct relationship with corrosion damage. As cracking increased, reinforcement corrosion increased. Larger crack width and crack density were found to be the cause of severe localized and uniform reinforcement-corrosion activity. Longitudinal or splitting cracks always indicated severe corrosion within a member (**Fig. 18**).
