The Islington Avenue Bridge

J. A. B. Lovell

Planmac Consultants Ltd.
Consulting Engineers & Planners
Toronto, Ontario

Describes the design considerations and the production and erection techniques used in building the Islington Avenue Bridge—a 491 m (1610 ft) long precast prestressed segmental structure recently completed in Toronto, Ontario.

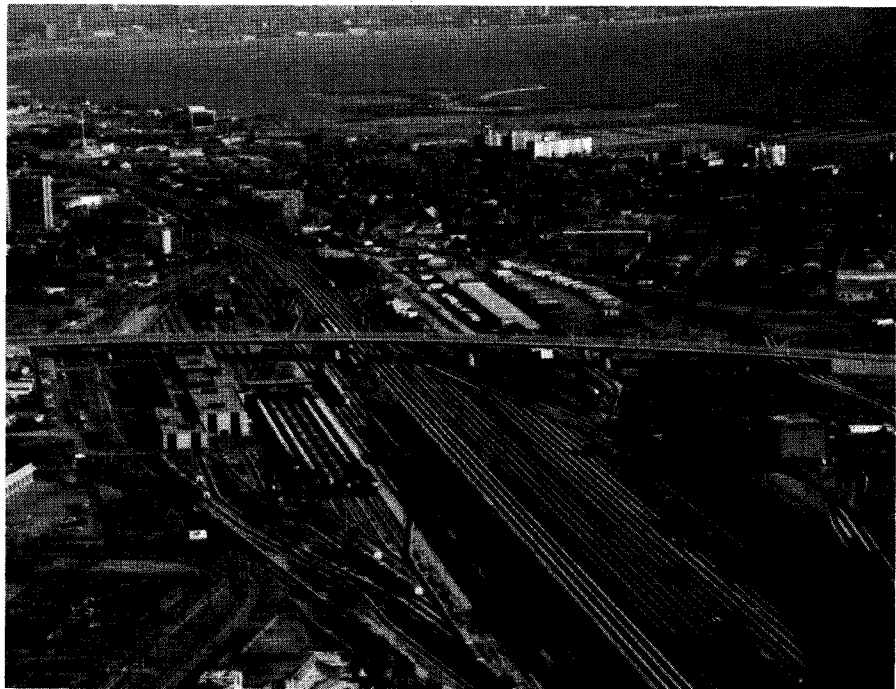
Fig. 18. Aerial view looking east at finished structure.

Figs. 18 and 19 show two aerial views of the completed bridge.

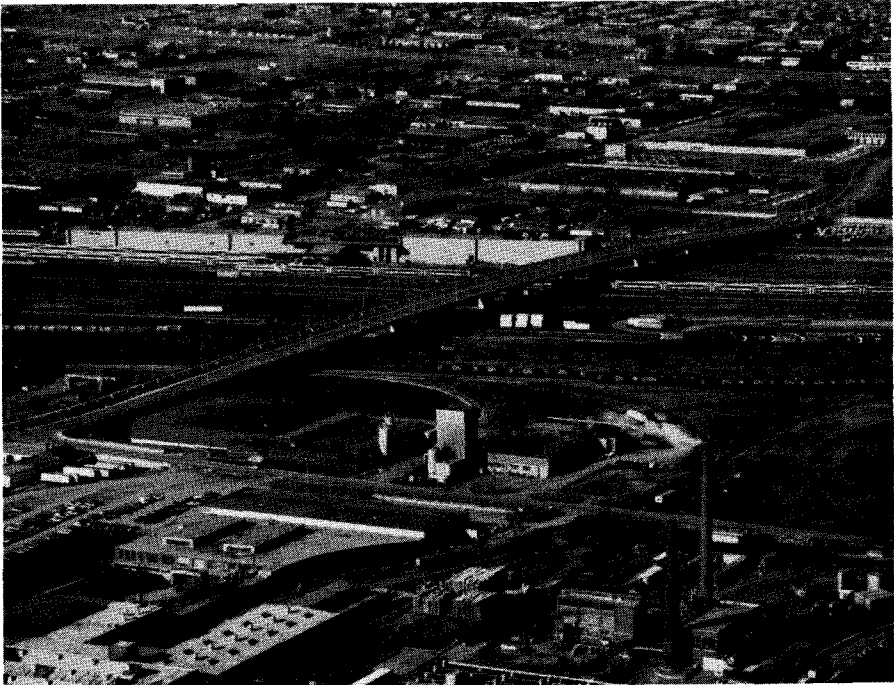
Fig. 19. Aerial view looking northwest at finished structure.
