The Twelve Mile Creek Precast Prestressed Segmental Bridges

Describes the overall design of the bridges plus the fabrication and erection of the segments. A special feature of these structures is the use of transverse ribs along both segment faces to accommodate the deck flare. Problems encountered during construction and their method of solution are also discussed.

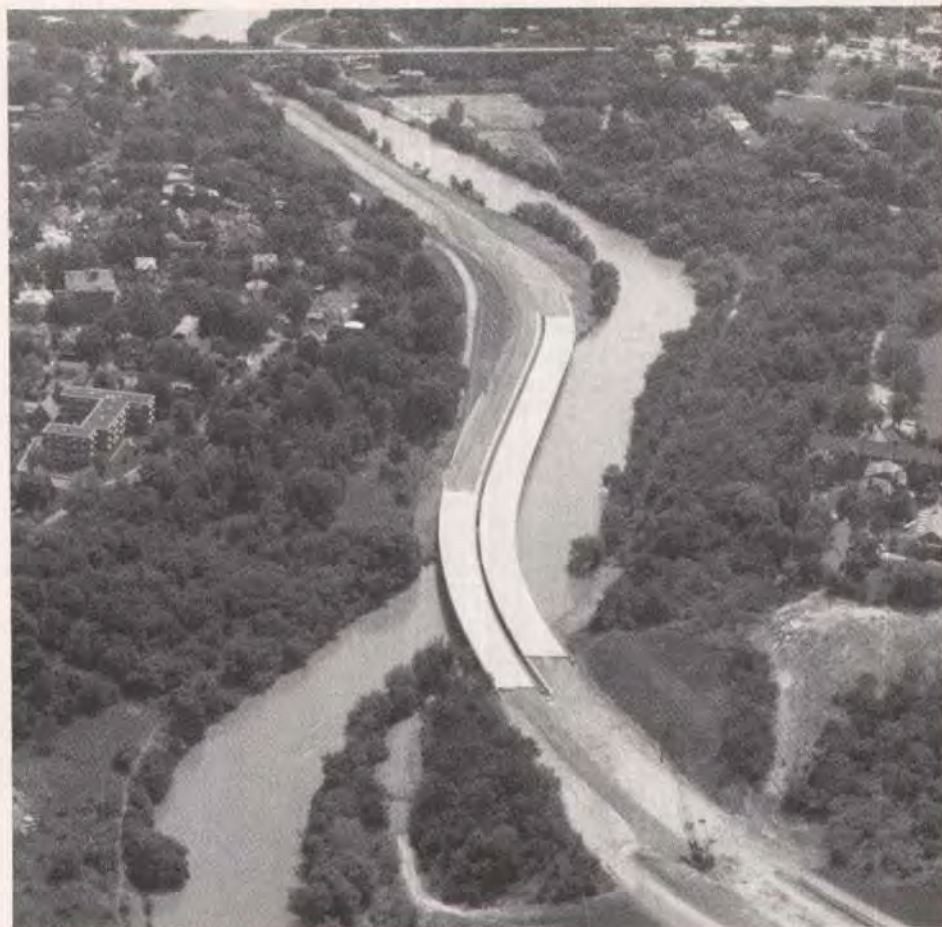
Fig. 1. Aerial view of the completed bridges.

The route of the new highway, which follows the valley through which the creek flows (as shown in Fig. 1), was selected for economy and minimum social and environmental impact. The Twelve Mile Creek originally formed part of the Welland Canal, connecting Lake Erie to Lake Ontario. Today, it is part of a fast flowing tailrace for a generating station.

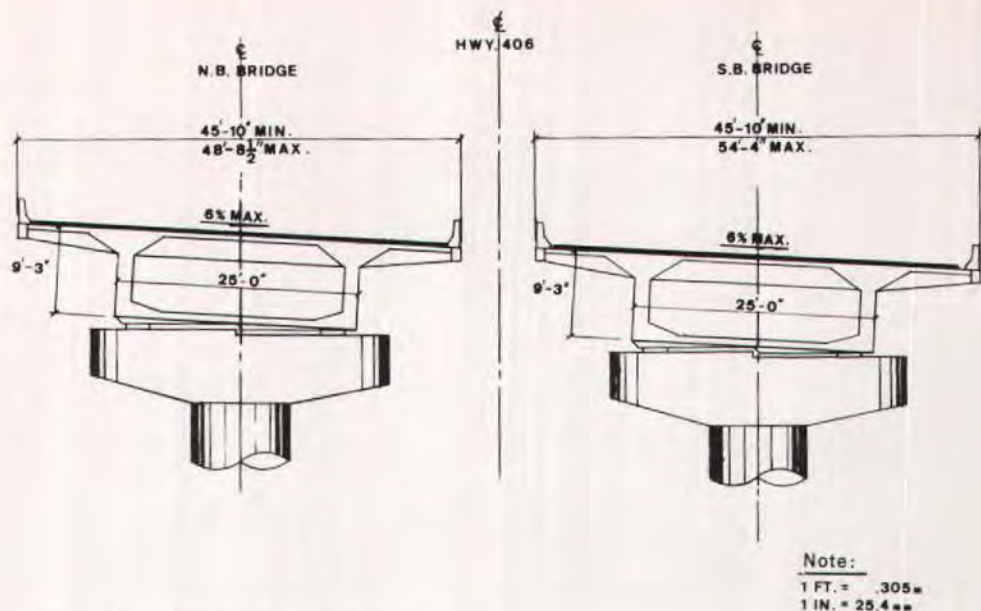
Fig. 3. Typical cross section of bridges.

Each bridge consists of a single cell box girder having a constant depth of 9 ft 3 in. (2.82 m) and a constant out to out web width of 25 ft (7.62 m). The cross section of the superstructure is given in Fig. 3. The extremely shallow construction depth (span to depth ratio of 27:1) was dictated by the roadway profile which was controlled by both the

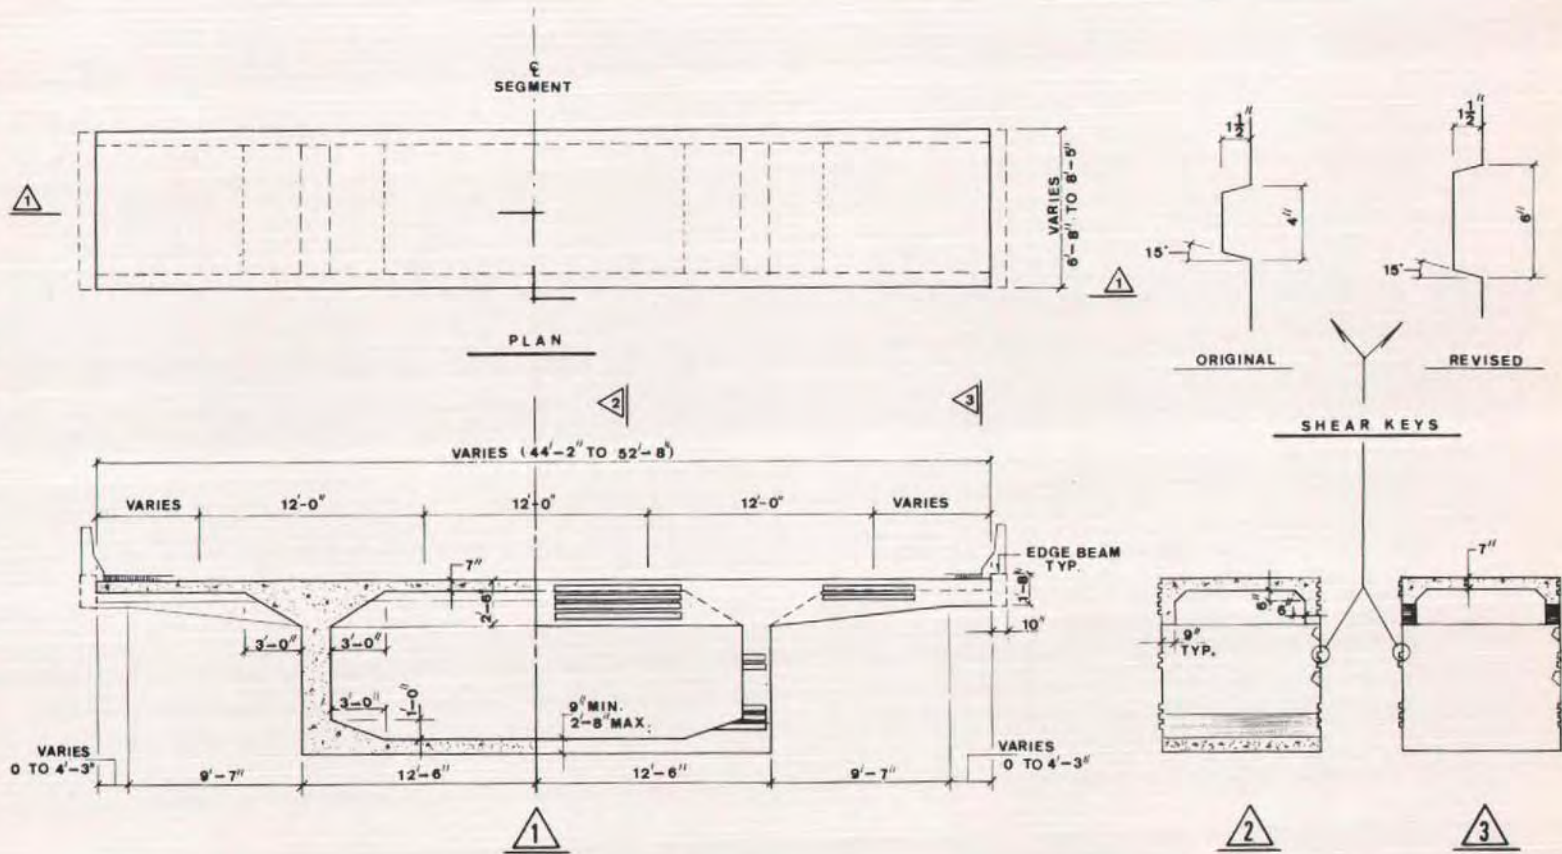
35 Fig. 4. Details of segment showing shear keys.

A special design feature of the bridges is the transverse ribs located along both segment faces as shown in Fig. 4. The decision to use transverse ribs was primarily due to the need to flare the decks towards the north abutments

Multiple shear keys without any reinforcement and spread over the segment faces were provided to resist the vertical shear forces during construction. They were chosen over a single large shear key due to the lack of space in the shallow webs where anchorages for the draped longitudinal tendons also were located.

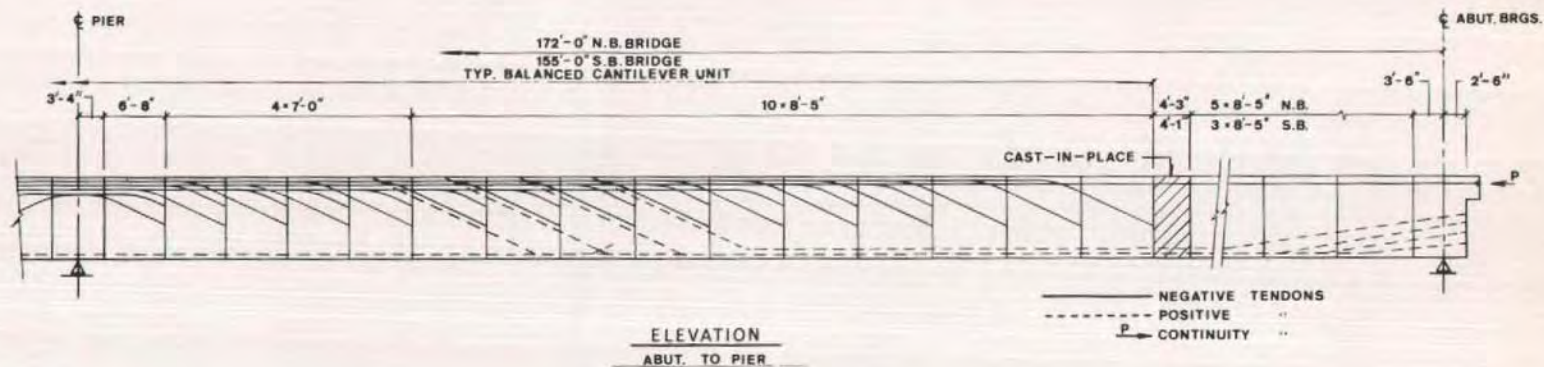
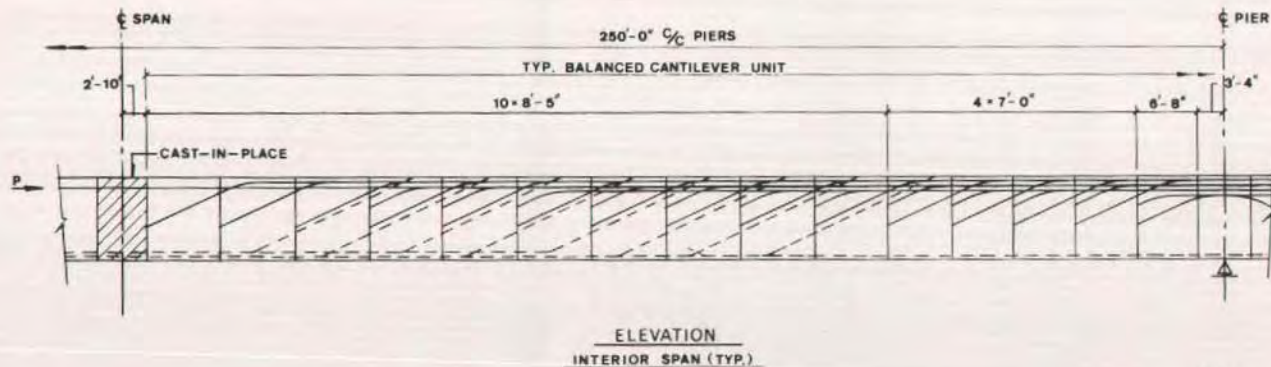
Fig. 5. Details of span segments showing location of post-tensioning.

The bridges were designed for all normal AASHTO¹ loads. The longitudinal analysis of the box girders was carried out using the BC computer program.² Three groups of tendons (19/0.6 strands) were used for longitudinal post-tensioning (Fig. 5). The function of the first group, where the tendons are draped and anchored in the webs, was to resist the negative moments during construction by the balanced cantilever method. The tendons for the second group, located in the girder bottom to resist the positive moments for the continuous structure, are draped and anchored in the deck slab. The third group of tendons, located in the top slab, were provided to resist negative moments along the span arising from live load in adjoining spans.

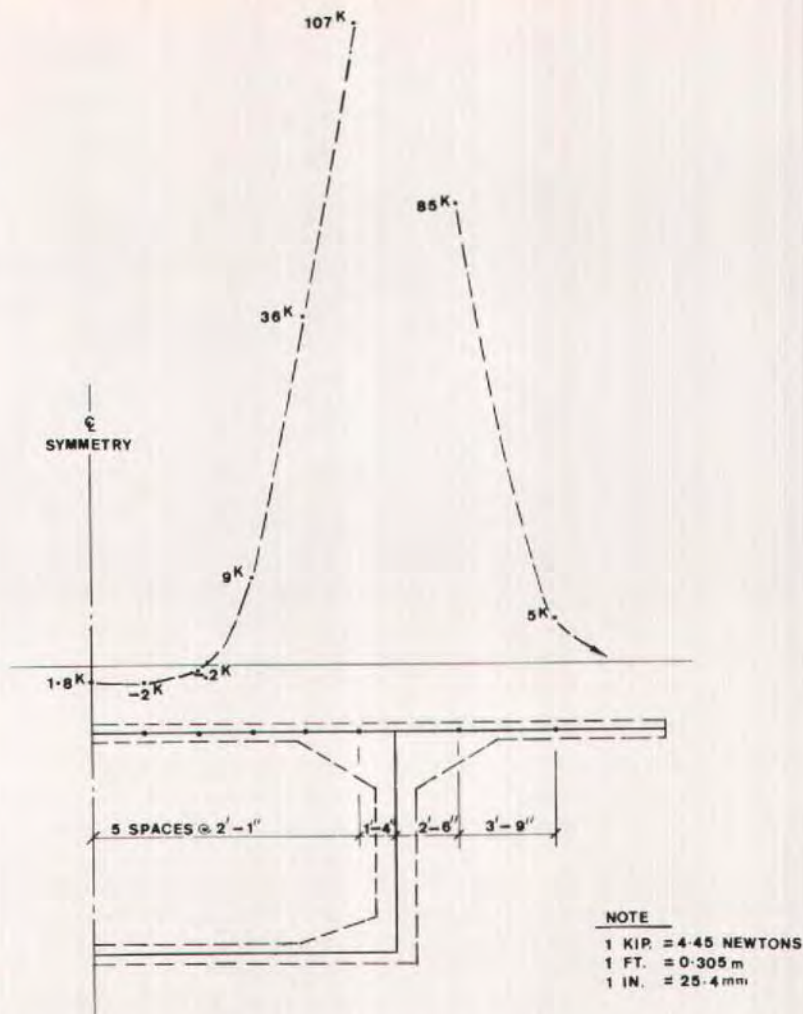
Fig. 6. Shear distribution due to segment weight and construction load.

Most of the damaged shear keys were in the webs. A finite element analysis was used to check the shear distribution at the remaining keys located in the top and bottom slabs and is shown in Fig. 6. The analysis confirmed that only about 20 percent of the shear force was transferred through these keys. It was, therefore, decided to hold the segments with the damaged keys in place until the epoxy cured since the keys could not be relied upon to transfer shear forces across the joint. This resulted in a slow-down of segment erection.

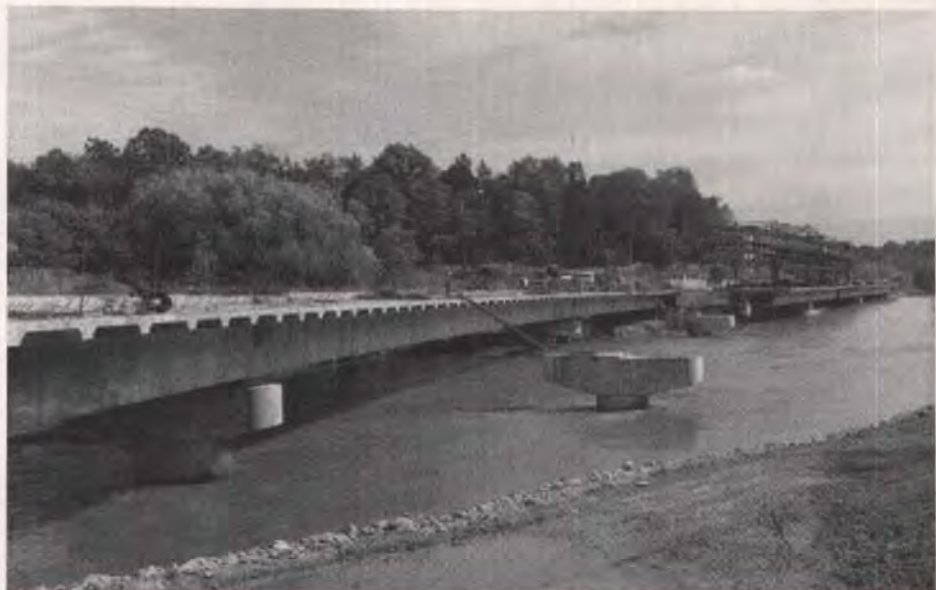
Fig. 7. Completed northbound bridge with southbound bridge under construction. Note mislocated Pier 4 with Pier 5 in the foreground.

A serious problem on this project was the discovery of a survey error, which had located Pier 4 of the southbound lanes structure about 3 ft 6 in. (1.07 m) east of its correct location, as the cantilevers at Pier 3 were nearing completion (Fig. 7). Since the alignment of the bridge was curved, the problem could be resolved by altering the horizontal alignment of the bridge between the forward cantilever at Pier 3 and the north abutment. By allowing some tension in the top of the post-tensioned pier caps and reassessing the pier column and footing design, it was possible to shift the pier segment at Pier 4 eastward from its theoretically correct location by 1 ft 9 in. (0.63 m) with a further easterly

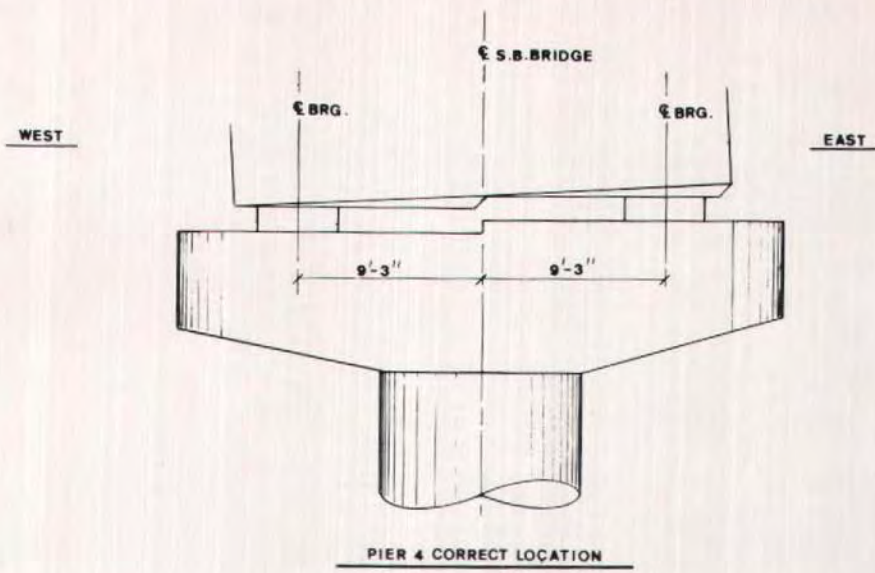
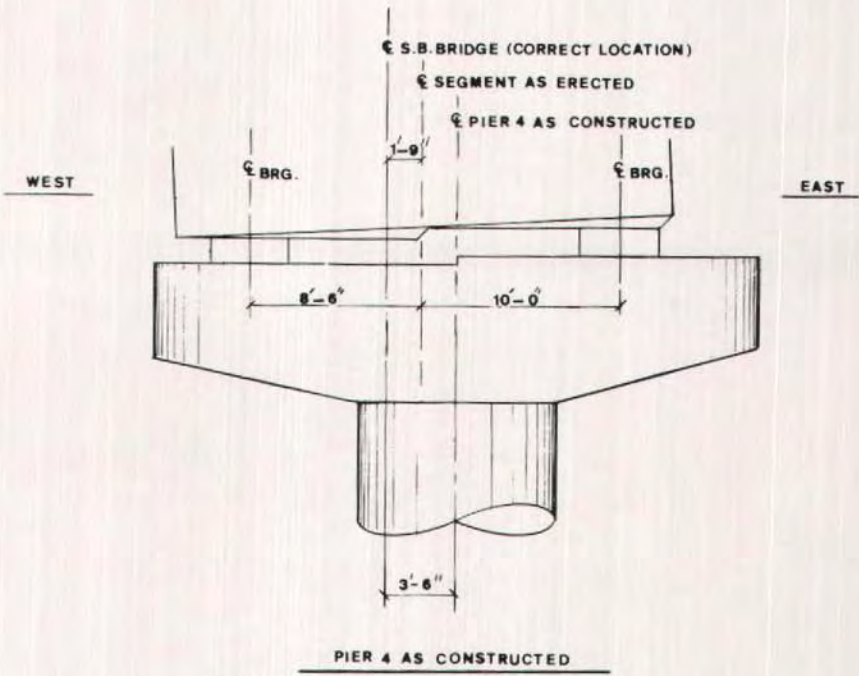
Fig. 9. Pier segment and bearings at mislocated Pier 4.

bearing shift of 9 in. (0.32 m) relative to the segment and completing the balanced cantilevers as usual, as shown in Figs. 8 and 9.

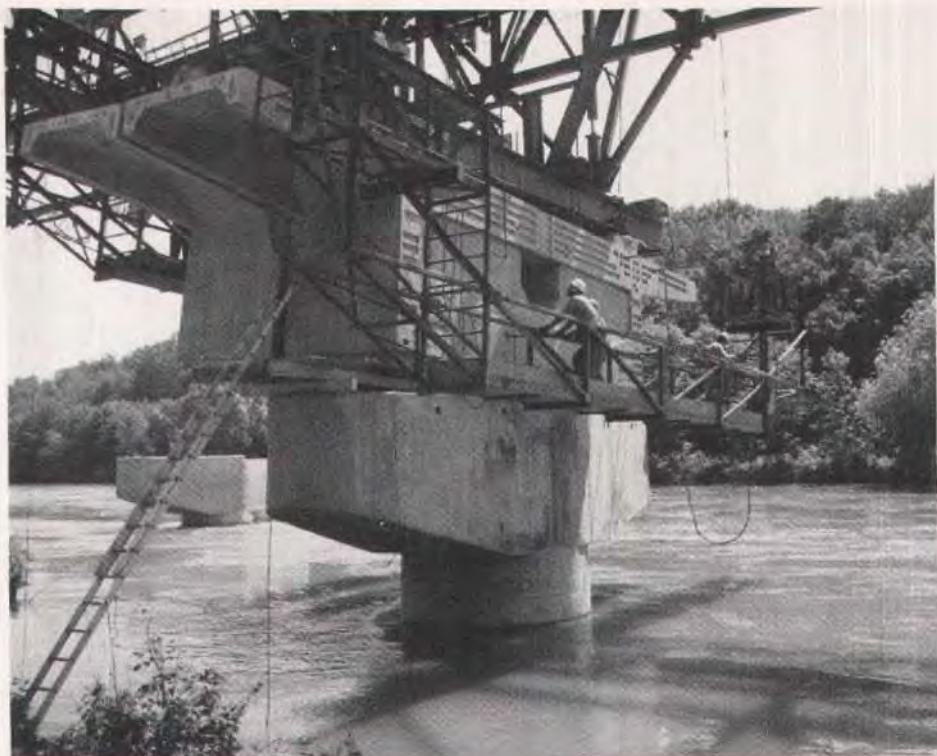
Fig. 10. Typical pier segment with cast-in-place diaphragm and erection of adjacent segment.

The abutment and pier segments include transversely post-tensioned solid diaphragms with access openings. The concrete in the diaphragms was placed after erection of these segments to keep the segment weights within the capacity of the launching truss.

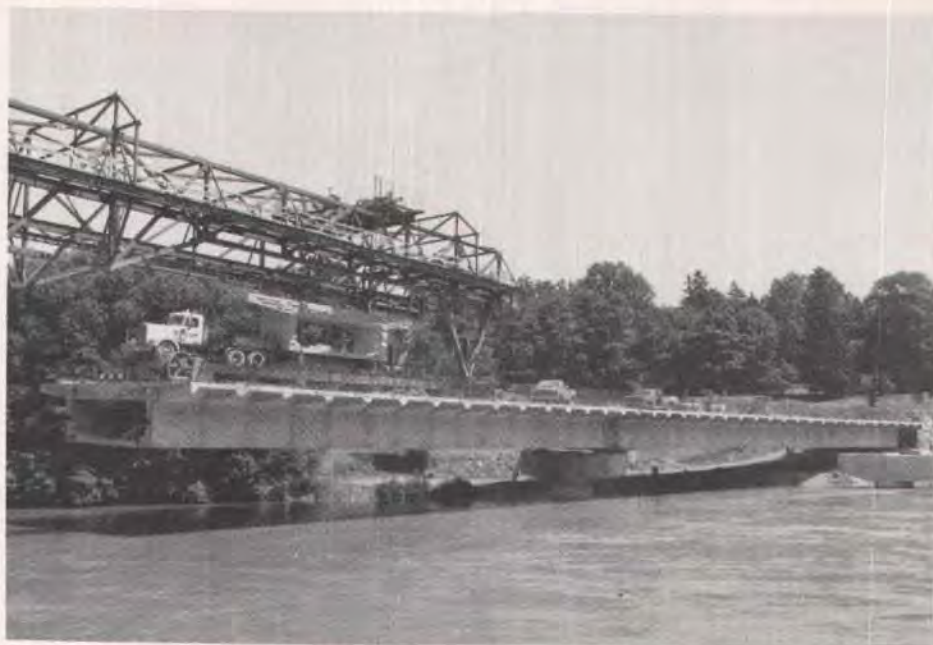
Fig. 11. Delivering segment on completed cantilever for erection by launching truss.

The remaining segments were erected by a launching truss. The steel launching truss which had previously been used on two other straight segmental bridges in Ontario had a length of 377 ft (114.9 m) and an approximate weight of 463 tons (420 t).

Major modifications were required to enable the truss to travel and erect segments on the horizontally curved bridges. The launching truss stabilized the balanced cantilevers, delivered segments, and supported the work platforms and post-tensioning hardware.

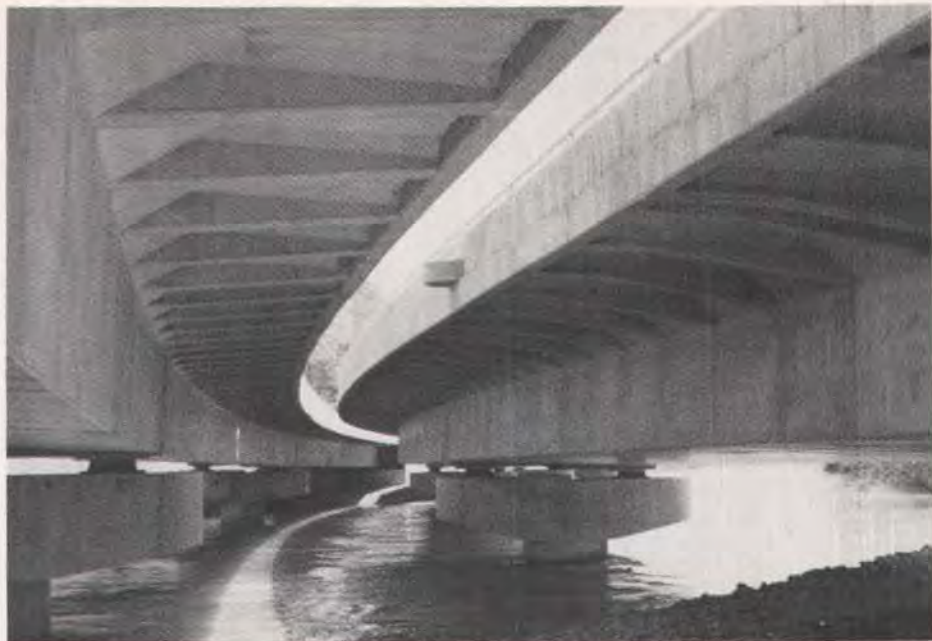
Fig. 12. Underside view of completed bridges showing the transverse ribs.

where the normal deck cantilever overhang of 10 ft 5 in. (3.17 m) increases to a maximum of 14 ft 8 in. (4.47 m). The transverse post-tensioned ribs with a 7 in. (178 mm) thick top slab were extended to accommodate the deck flare and resulted in a 10 percent reduction in the segment weight. Without the ribs, the deck flare would have required a considerably thicker top slab.
