Fatigue Tests on Prestressed Concrete Beams Made With Debonded Strands

Six fatigue tests were performed on pretensioned concrete beams containing debonded strands to determine if their behavior would be similar to the behavior observed from statically loaded companion beams. Each initially "precracked" beam specimen was subjected to at least one million cycles of equivalent service load. Periodically, large static overloads were applied to each specimen to simulate the relatively large permit loads that some structures may be required to resist, and to increase strand bonding requirements. Loads, deflections, and strand slips were measured at significant intervals and beam behaviors were observed. After completion of fatigue testing, the beams were loaded statically until failure. The tests demonstrated that although repeated loading may cause some additional slippage, the strand slips remained quite small and did not affect the overall beam behavior. Furthermore, the ultimate behavior of these beams verifies that the prediction for bond failure is dependent on the propagation of cracking through the transfer zone of a debonded strand, confirming similar results obtained from stat

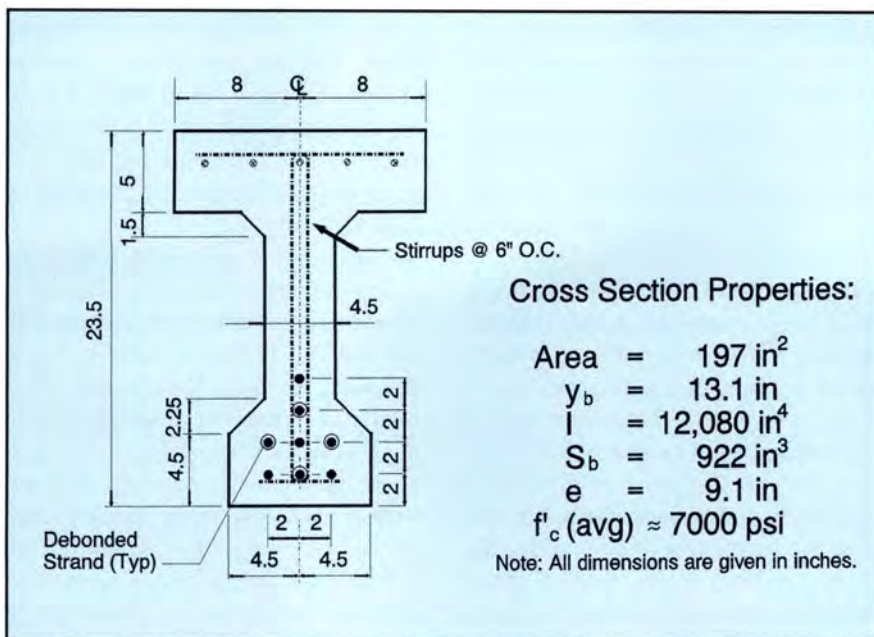
Fig. 1. Cross section details.

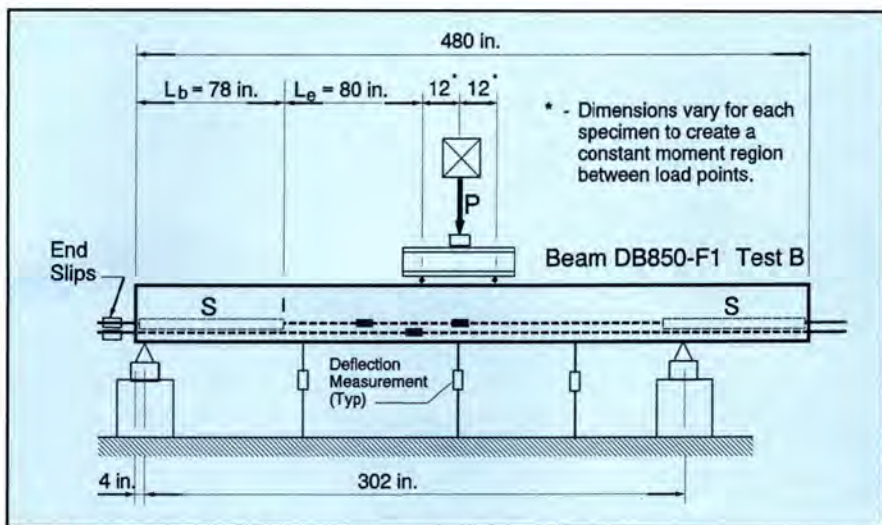
Fig. 3. Typical test setup for beams with debonded strands.

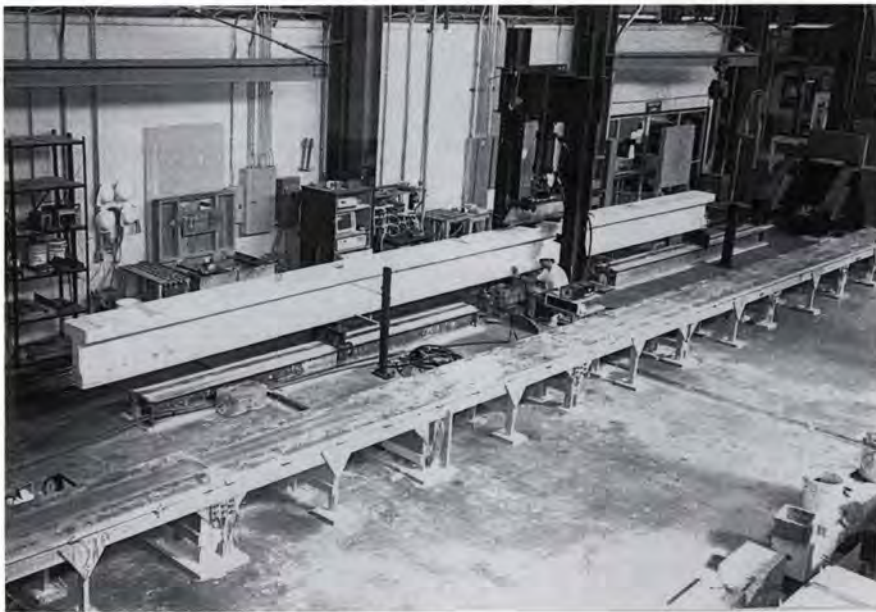
Fig. 4. Test setup showing Beam DB850-F1.

The embedment length, L_e , and span were varied for each test. A constant moment region 24 in. (610 mm) long was assured for each test by choosing the appropriate geometry. Fig. 4 shows Beam DB850-F1 in position to be tested.

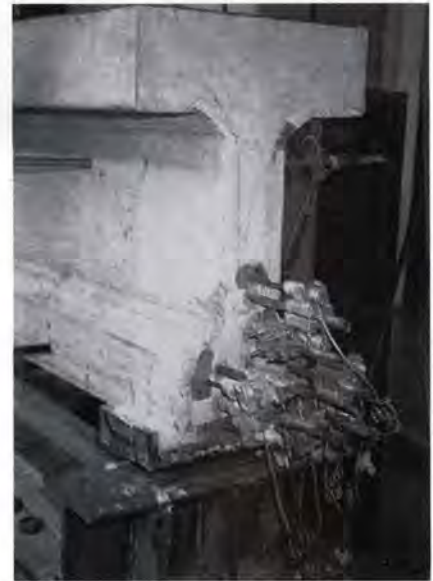
Fig. 5. Electronic potentiometers to measure end slip.

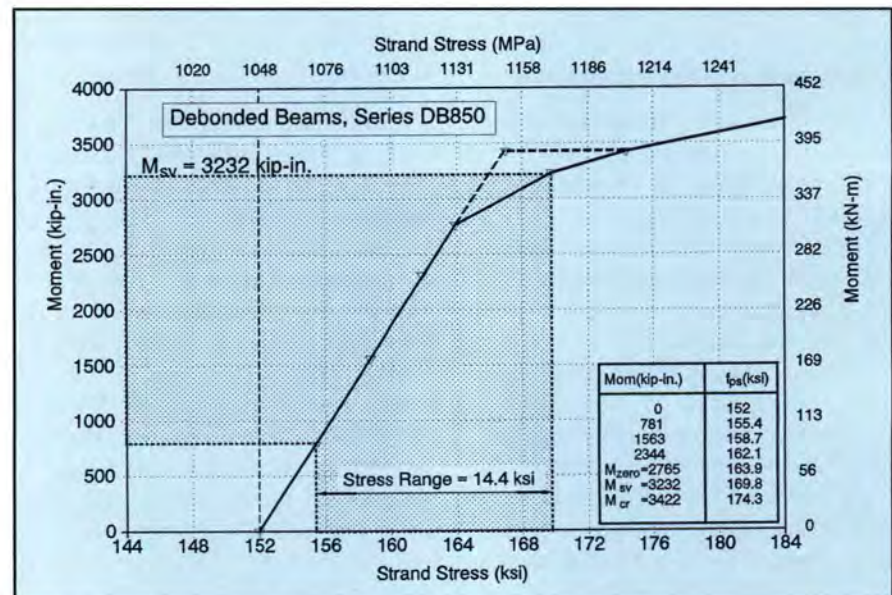
Fig. 6. Stress range for fatigue tests.

The strand stress range for these tests is illustrated in Fig. 6, where applied moment is plotted vs. strand stress. Strand stresses were computed using the compatible strains method, assuming pure flexural behavior for both cracked and uncracked beam sections. The effective prestress, f_{se} , was computed to be approximately 152 ksi (1050 MPa) based on elongation mea-

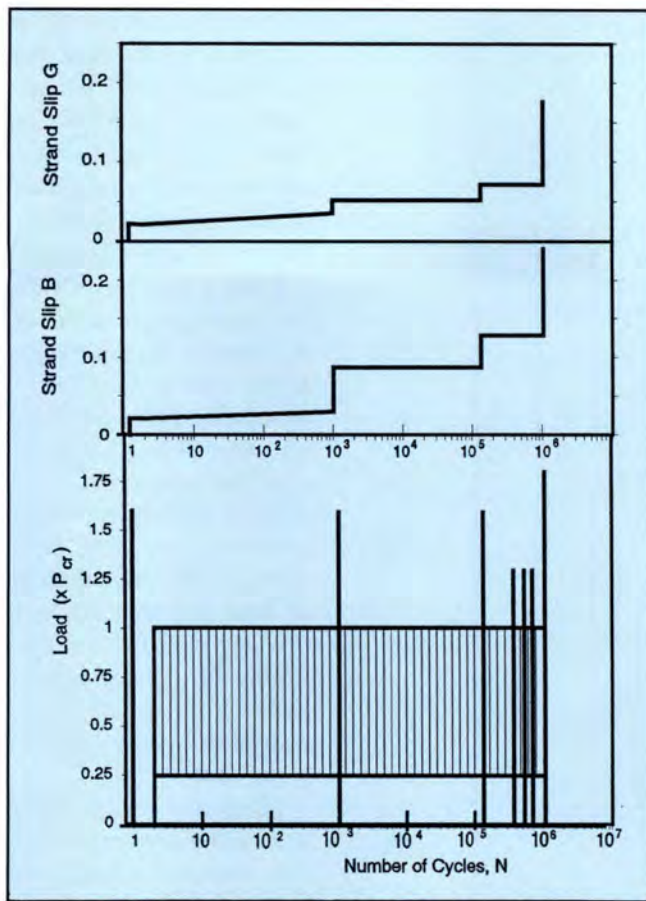
Fig. 7. Strand slips vs. number of load cycles and loading history for Beam DB850-F1, Test A.

Fatigue loading commenced after completion of the initial static test. The loading history and strand slips are plotted in Fig. 7. These data are also summarized in Table 3. Load was varied between a maximum load equal to the service load, P_{sv} , and a minimum load approximately equal to 25 percent of P_{sv} . End slips increased slightly through the early repeated load cycles, from 0.02 in. (0.05 mm) to about 0.03 in. (0.08 mm) through the first 1000 cycles.

At load cycle 1023, a second static overload test to $1.6 P_{sv}$ was conducted and end slips increased from 0.03 to 0.09 in. (0.08 to 2.3 mm) for Strand B and to approximately 0.05 in. (1.3 mm)

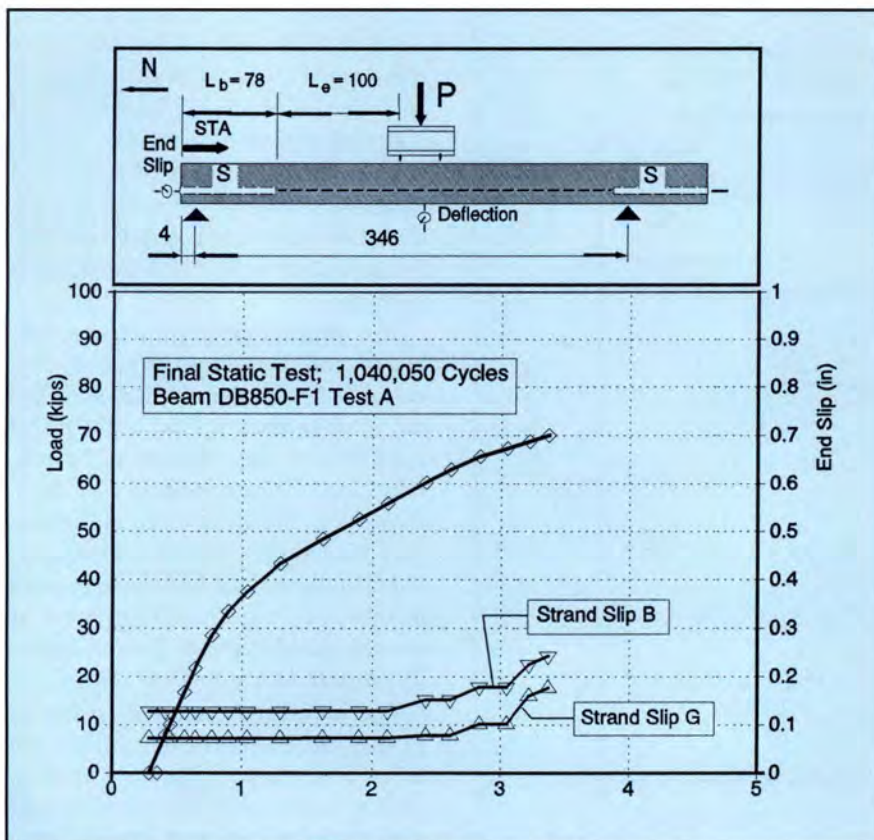
Fig. 8. Load vs. deflection and end slips for Beam DB850-F1, Test A.

After 1,040,000 cycles, the beam was loaded statically until it failed at an applied load of 70.1 kips (312 kN) with end slips of 0.24 in. (6.1 mm) on Strand B and 0.18 in. (4.6 mm) on Strand G. Load vs. deflection is illustrated in Fig. 8. Measured end slips for Strands B and G are also shown in the figure.

The applied ultimate moment at failure of 5602 kip-in. (633 kN-m) was calculated from the ultimate load and the load geometry. The beam failed from flexure with crushing of the concrete in the top compression fibers. However, the failure moment was only 93 percent of the ultimate capacity of its statically tested companion beam, and only about 93 percent of the calculated nominal flexural capacity, $M_n = 6010$ kip-in. (679 kN-m).

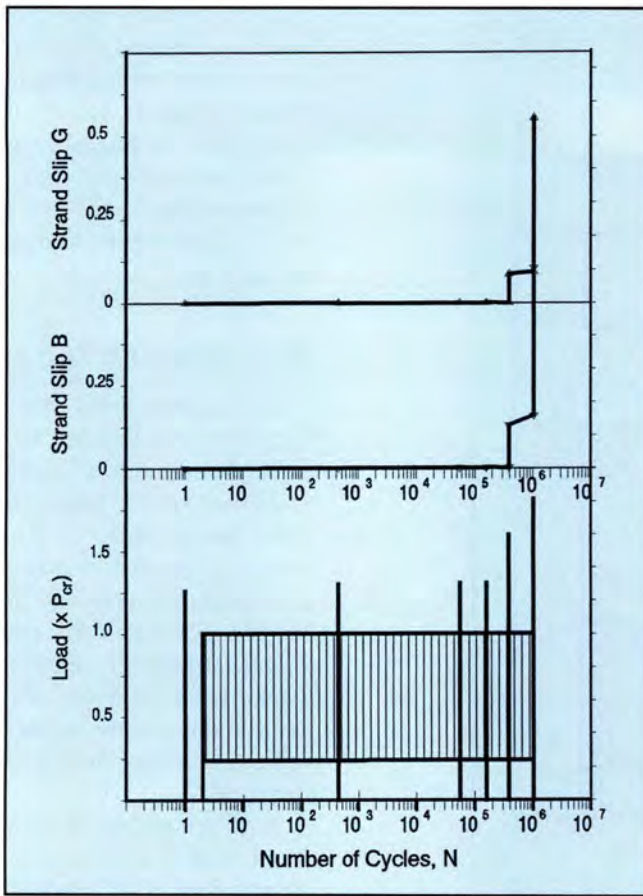
Fig. 9. Strand slips vs. number of load cycles and loading history for Beam DB850-F1, Test B.

For this test, an embedment length equal to 80 in. (2.03 m) was chosen. A statically tested companion beam, Beam DB850-3A reported in Ref. 1, also with an embedment length of 80 in. (2.03 m) and staggered debond length of 78 in. (1.98 m), failed in bond (anchorage failure). The relatively short embedment length was selected to determine if anchorage failure could be caused by the application of repeated service loads. The initial static load and subsequent intermediate loads were limited to $1.3 P_{sv}$ to prevent extensive cracking. The loading history and end slips are shown in Fig. 9. Values for end slips and beam deflections are listed in Table 4.

After 386,878 load cycles, the beam was loaded to $1.6 P_{sv}$. At this loading, flexural cracking propagated through the transfer zone of the debonded strands at Station 88, well within the debond/transfer zone. Upon formation of this crack, strand slips were initiated and measured to be about 0.13 in. (3.3 mm) on Strand B and 0.086 in. (2.2 mm) on Strand G. Application of additional repeated loading caused only slight increases in strand slip.

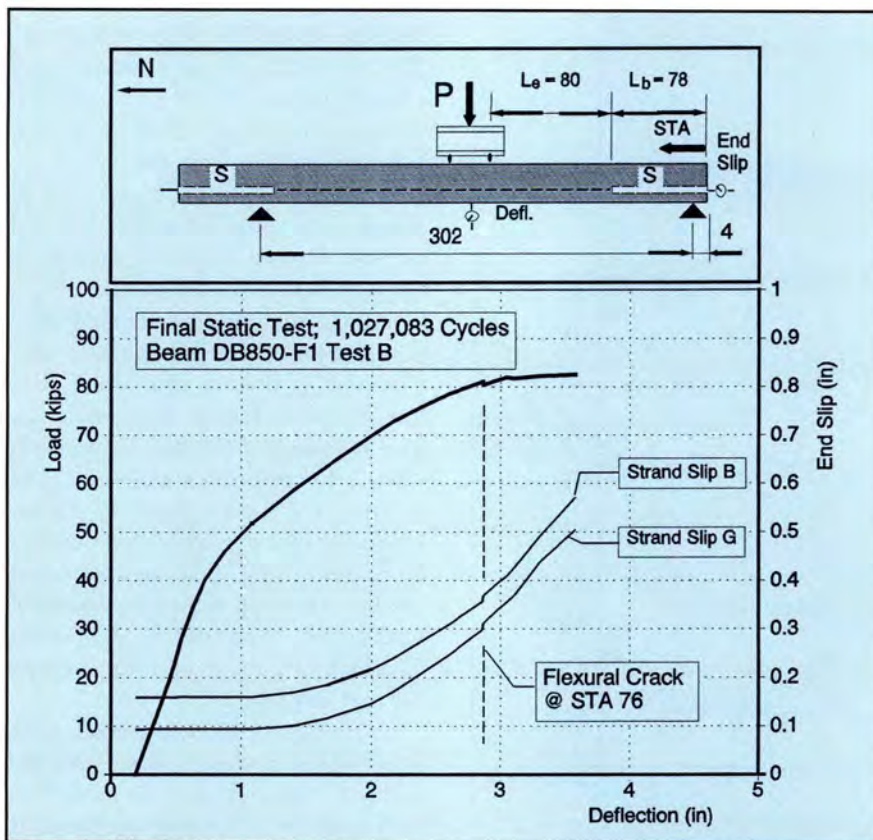
Fig. 10. Load vs. deflection and end slips for Beam DB850-F1, Test B.

The final static test was performed after 1,027,083 cycles. Load vs. deflection and end slips are illustrated in Fig. 10. Note that after the decompression load was reached [around 45 kips (200 kN) and indicated by the beam's change in stiffness], increases in strand slip corresponded with increased loading until failure. The

beam failed at a load of 82.6 kips (367 kN). The applied moment at failure was 5670 kip-in. (641 kN-m), approximately 94 percent of the calculated flexural capacity. Bond slips at failure were relatively large and, overall, the beam failure must be considered a bond failure. However, the beam behavior was surprisingly similar to a flexural failure, indicated by measurable ductility with final failure brought about by concrete crushing at an average strain of 2470 microstrains.

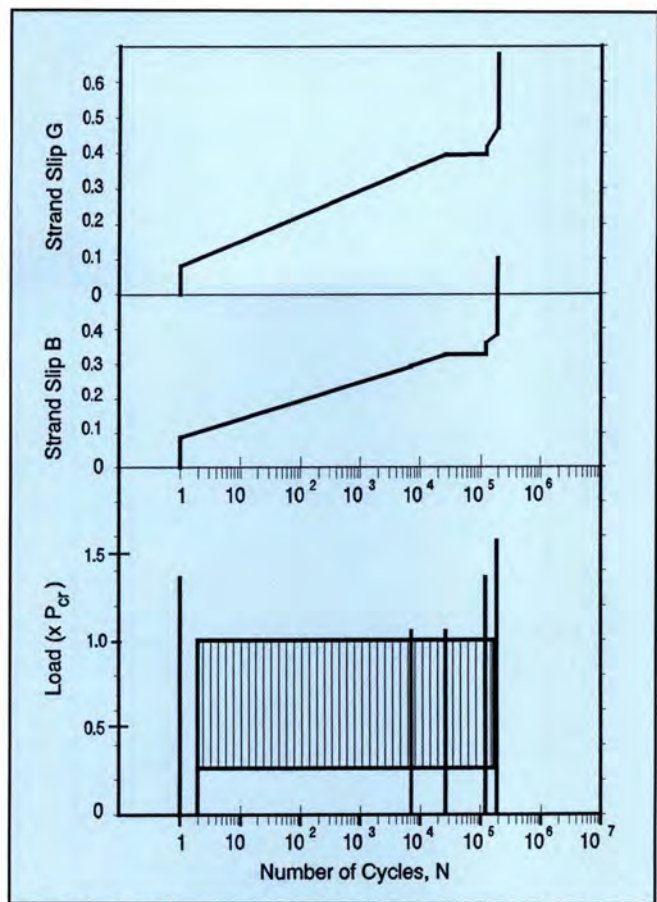
Fig. 11. Strand slips vs. number of load cycles and loading history for Beam DB850-F2, Test A.

At the initial static test, flexural cracking extended to Station 106, initiating strand slippage that measured approximately 0.09 in. (2.3 mm). The initial static test was followed by fatigue loadings where strand slips increased under the influence of repeated loads. This was the only test in this series where large increases of strand slip occurred as a result of repeated loadings at service load. Strand slips increased from 0.09 in. (2.3 mm) to approximately 0.4 in. (10 mm), resulting only from the action of the repeated load tests.

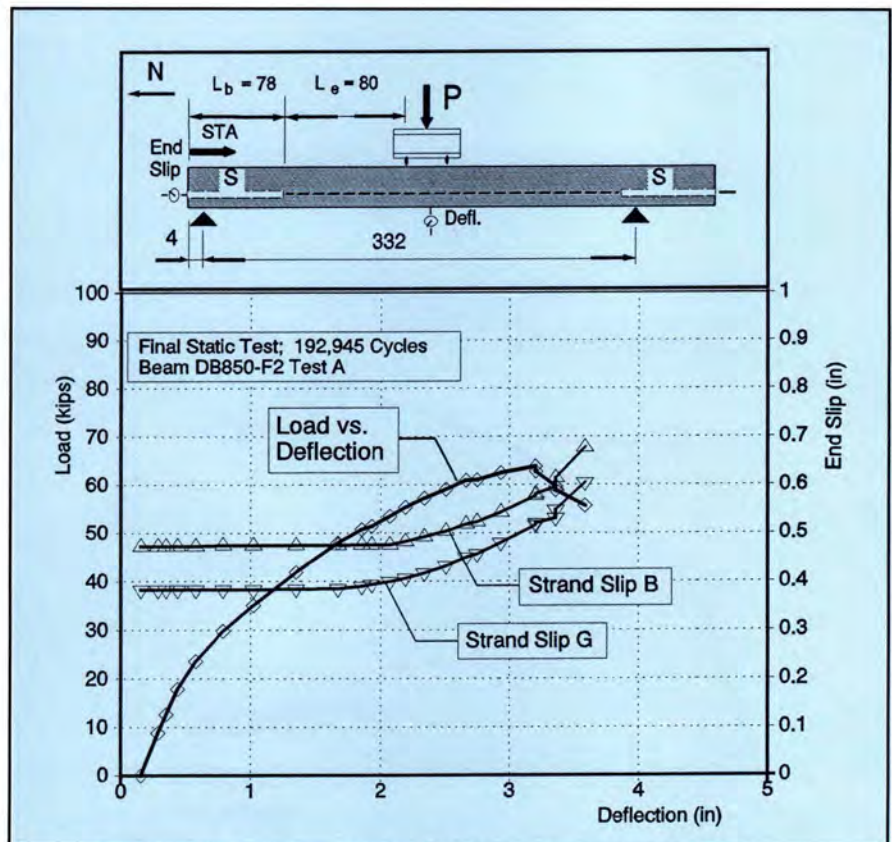
Fig. 12. Load vs. deflection and end slips for Beam DB850-F2, Test A.

In the final static test, the beam clearly failed from the loss of bond and strand anchorage. Load vs. deflection and end slip for the final test are shown in Fig. 12. End slips were quite large at the beginning of the test and strand slips increased until failure of the beam. Failure occurred at 63.8 kips (284 kN) and a moment of 4910 kip-in. (555 kN-m), only 82 percent of the calculated ultimate load.

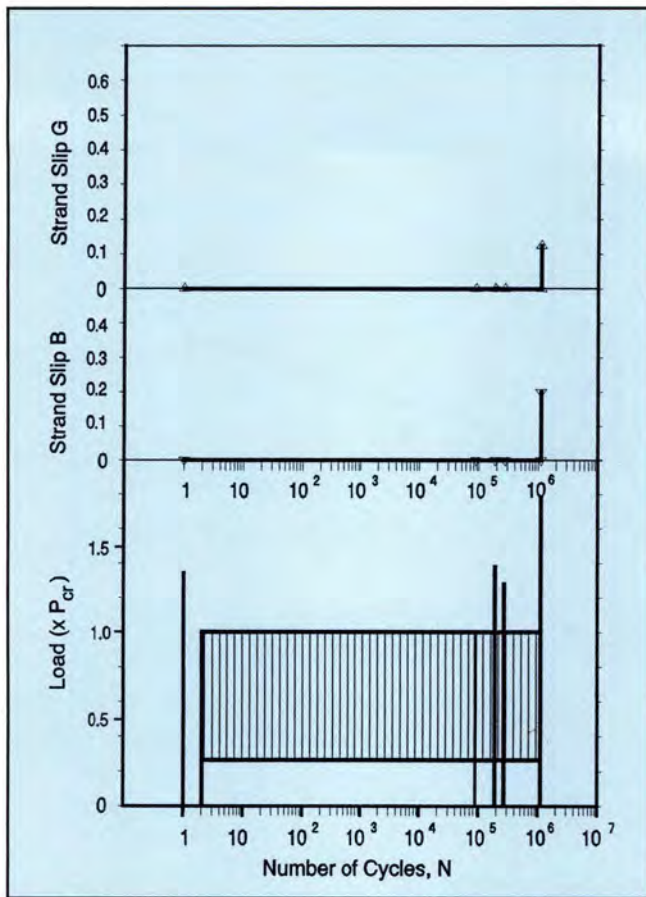
Fig. 13. Strand slips vs. number of load cycles and loading history for Beam DB850-F2, Test B.

During testing, two static overloads were applied to the beam: $1.4 P_{sv}$ at 184,410 cycles and $1.3 P_{sv}$ at 271,194 cycles. No new flexural cracks were formed during application of either load. From examining Table 6, it is seen that the strands did not slip during either the repeated loading or during the intermediate static overloads.

When this crack formed, strand slips were initiated as shown in Fig. 14. As load was increased to 81 kips (360 kN), another flexural crack formed at Station 94. This crack is shown in Fig. 20. Strand slips increased dramatically, initiated by the new crack propagating through the debond/transfer zone at Station 94.

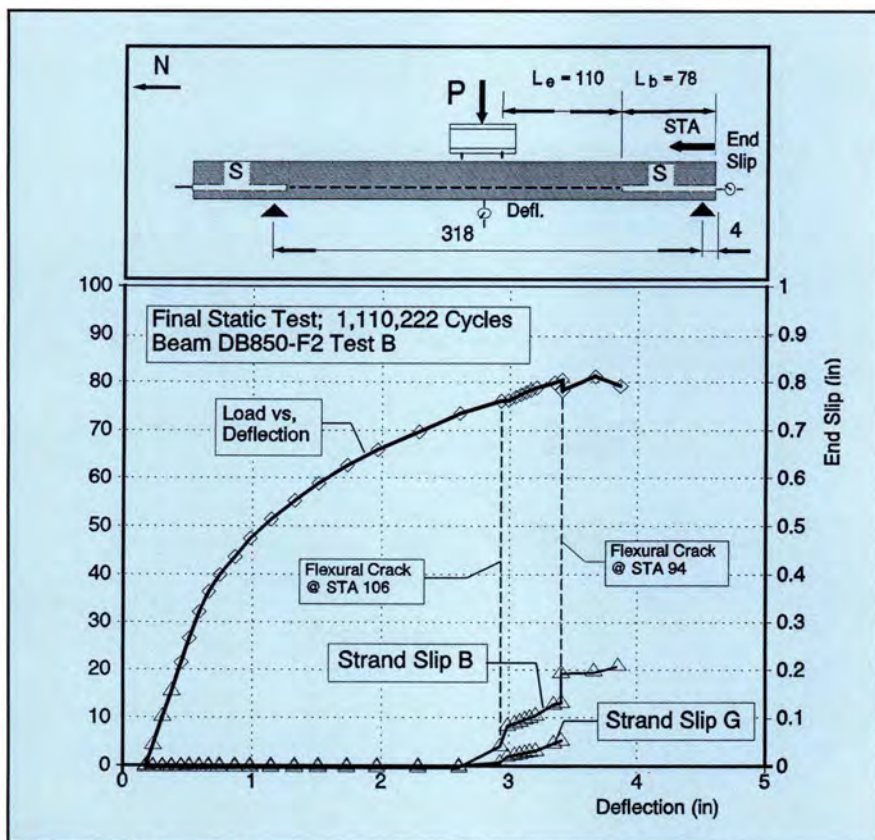
Fig. 14. Load vs. deflection and end slips for Beam DB850-F2, Test B.

The beam was loaded to failure after 1,110,222 cycles, as shown in Fig. 14. The beam failed at a load of 81.4 kips (362 kN) by crushing of the concrete at the top compression fiber. Strand slips occurred during the final test, coinciding with flexural cracking in the debond/transfer zone. At a load of 76.1 kips (338 kN), a flexural crack formed at Station 106 causing initial strand slips. At 80.9 kips (360 kN), another flexural crack formed at Station 94, causing the strands to slip even more. The beam continued to resist increased loads until failure at 81.4 kips (362 kN), corresponding to a failure moment of 5600 kip-in. (633 kN-m), or 93 percent of the calculated flexural capacity. Concrete strain at crushing was 2416 microstrains.

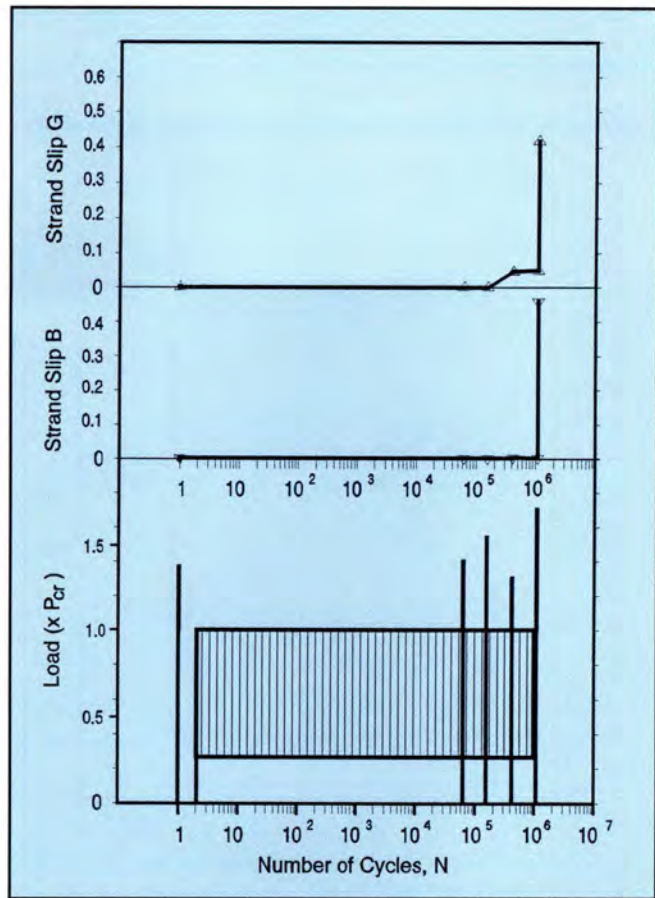
Fig. 15. Strand slips vs. number of load cycles and loading history for Beam DB850-F3.

The embedment length for Beam DB850-F3 was chosen to be 120 in. (3.05 m). In the companion beam, Beam DB850-5A, an embedment length of 120 in. (3.05 m) with concurrent debonding caused bond failure.¹ The loading history for this beam is illustrated in Fig. 15. Values for load magnitude, strand slips and deflection are presented in Table 7.

The initial static load of $1.3 P_{sv}$ caused little or no damage to the anchorage zone of the debonded strands; flexural cracking was limited to 161 in. (4.09 m) from the end of the beam. Repeated loading of 152,000 cycles produced no significant strand slips. At 152,538 cycles, the specimen was loaded to $1.5 P_{sv}$, increasing the load over the previous overloads. Consequently, new flexural cracks formed at Stations 140 and 150; however, measured strand slips from this loading were less than 0.01 in. (0.3 mm).

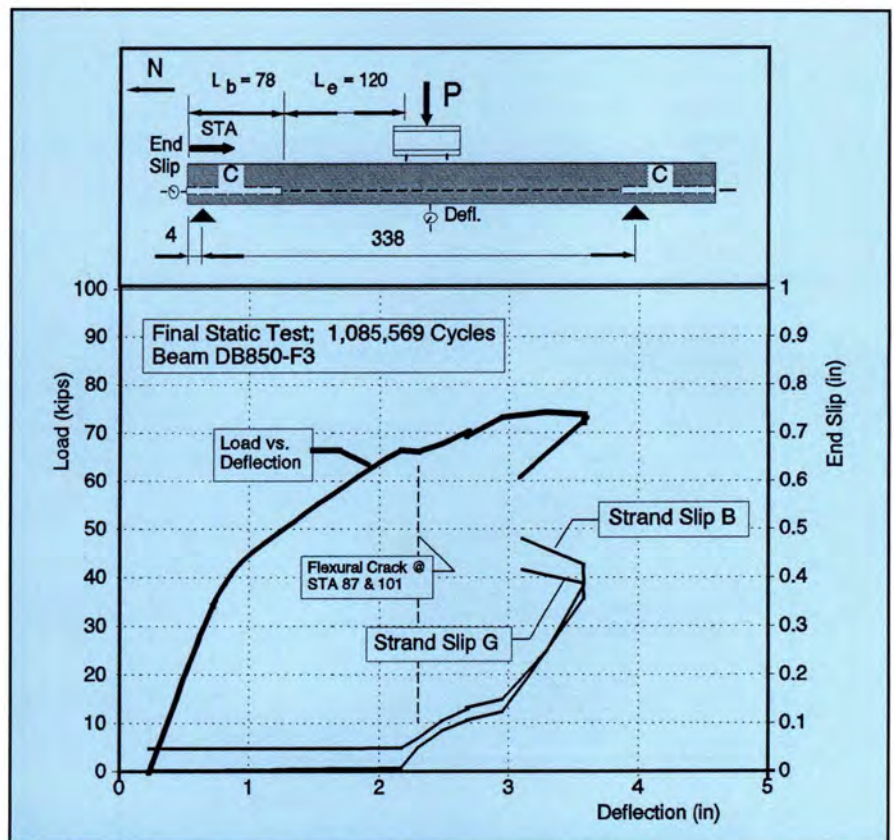
Fig. 16. Load vs. deflection and end slips for Beam DB850-F3.

After 1,085,569 cycles, the beam was tested statically until failure. Load vs. deflection and end slips are shown in Fig. 16. At a load of 67.8 kips (302 kN), flexural cracks formed at Stations 87 and 101. Upon formation of these cracks, strand slips increased dramatically. Additional loading brought about further strand slips until the beam finally failed at a load of 74.2 kips (330 kN), approximately 92 percent of the calculated flexural capacity.

At beam failure, strand slips were measured to be 0.46 in. (11.7 mm) on Strand B and 0.42 in. (10.7 mm) on Strand G. It is interesting to note that the beam did fail in flexure due to the ductility available from the fully bonded strands. However, the evi-

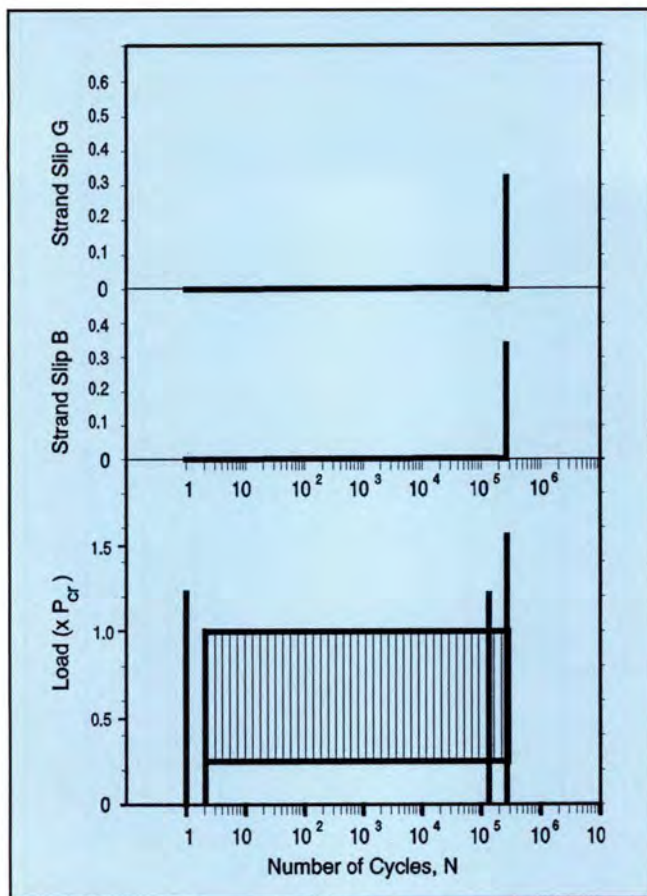
Fig. 17. Strand slips vs. number of load cycles and loading history for Beam DB850-F4.

loads and the intermediate static loads were relatively small at $1.3 P_{sv}$ to prevent cracking through the anchorage zone through the early portion of testing, and to investigate whether strand slips can occur solely through the action of repeated service loads. The load history and end slips are plotted in Fig. 17 and listed in Table 8. As the figure and table indicate, there were no significant strand slips before the static load to failure.

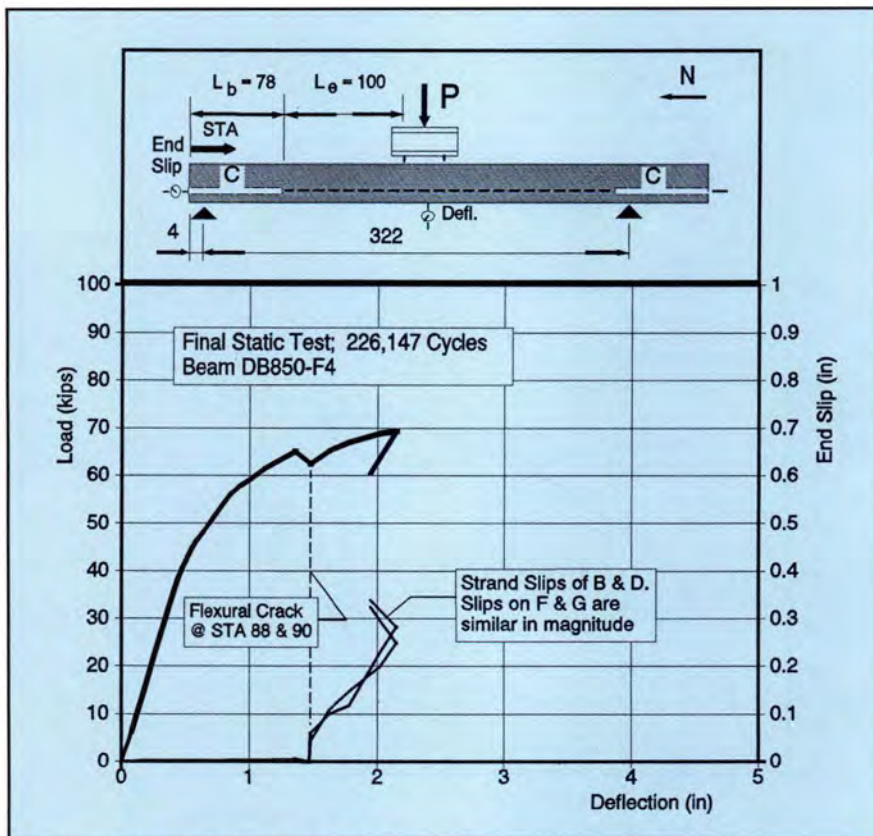
Fig. 18. Load vs. deflection and end slips for Beam DB850-F4.

intended to be an intermediate load to $1.6 P_{sv}$; however, the beam failed before this load was achieved. The load vs. deflection and end slips are illustrated in Fig. 18. As noted in the figure, strand slips were initiated by propagation of flexural cracking at Stations 88 and 90 at an applied load of approximately 65 kips (289 kN). Flexural cracks also formed at Stations 102, 103 and 111. Strands D and F, which were also debonded for a length of 78 in. (1.98 m), had strand slips similar in magnitude to Strands B and G.

Beam DB850-F4 failed at an applied load of 69.3 kips (308 kN), approximately $1.5 P_{sv}$ and 87 percent of its calculated flexural capacity. After the initial flexural cracking in the transfer zone of debonded strands, strand slips increased with increasing load and the beam failed in flexure due to a loss of anchorage of the debonded strands. Concrete strains were not measured during this test.

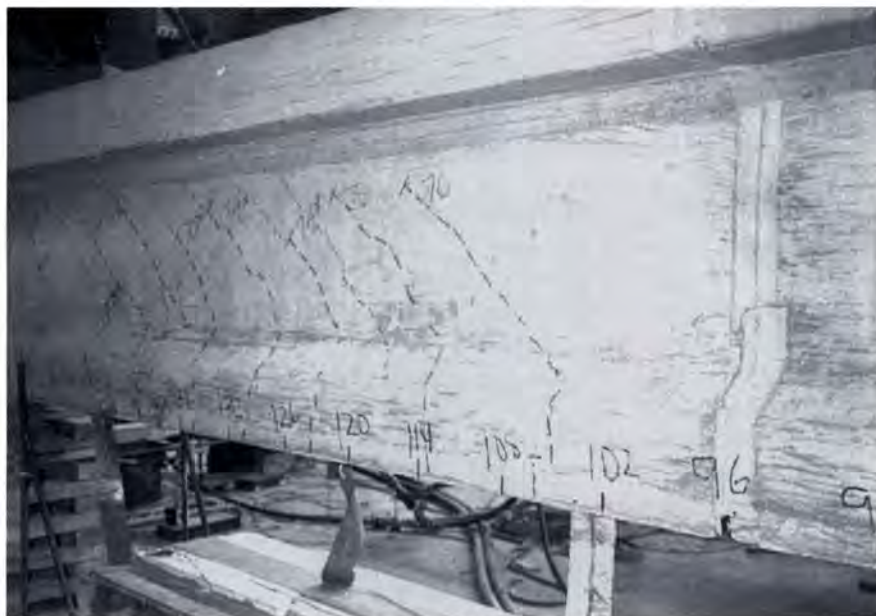
Fig. 19. Test DB850-F2B at load equal to 76 kips (338 kN).

For example, consider Test B performed on Beam DB850-F2. Table 6 indicates that no end slips occurred until the final static test. During the final static test to failure, a flexural crack formed at Station 106, as shown

in Fig. 19. As indicated by the marking on the beam, the crack formed at an applied load of 76 kips (338 kN). The load of 76 kips (338 kN) exceeded all previous loads, thus causing new flexural cracks to develop nearer to the end regions.

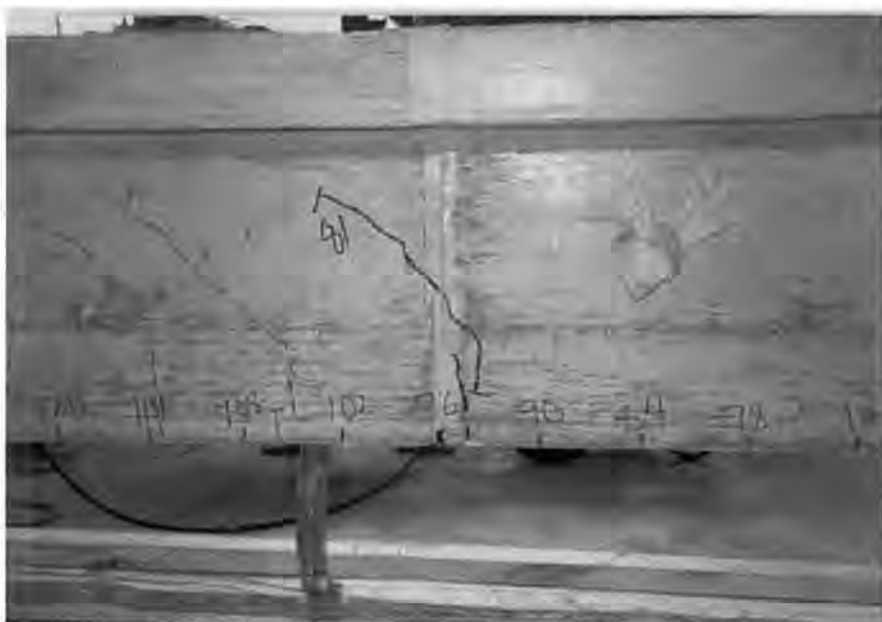
Fig. 20. Test DB850-F2B at load equal to 81 kips (360 kN).

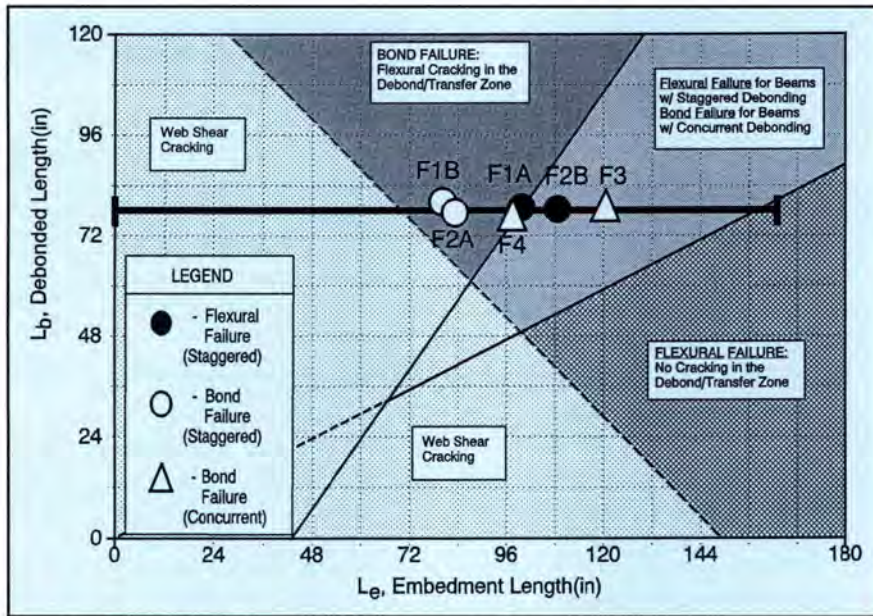
Fig. 21. Comparison of test results to predicted failures.
