Predicting the Bond Behavior of Prestressed Concrete Beams Containing Debonded Strands

Static flexural tests were performed on prestressed concrete beam specimens made with debonded strands. A behavioral model based on the prediction of cracking in regions of the transfer zone of debonded strands was used to predict strand anchorage failures. Agreement between the test results and the prediction is excellent, demonstrating that a rational design method can be developed for prestressed beams with debonded strands. This research also shows that the currently required multiplier of 2.0 for the development length of debonded strands can be significantly reduced for some cases. Conversely, some dangerous and unsafe designs may be allowed by the current code. More appropriately, the provisions for anchorage of debonded strands may need revision.

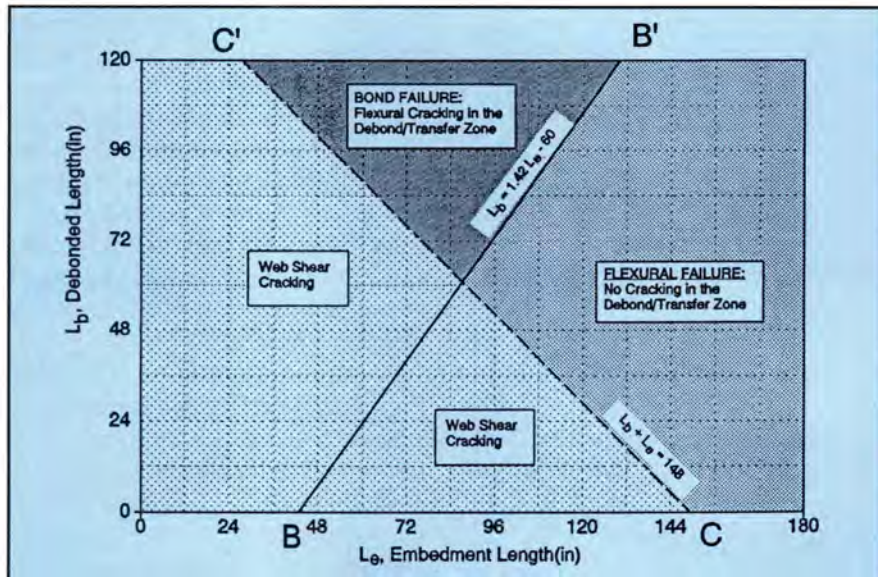
Fig. 6. Prediction of cracking and bond failure for beams with staggered debonding patterns (DB850 Test Series).

This relationship is illustrated by the Line BB' in Fig. 6. Areas to the left of the line, with shorter embedment

lengths, result in bond failures while regions to the right of Line BB' result in flexural failures.

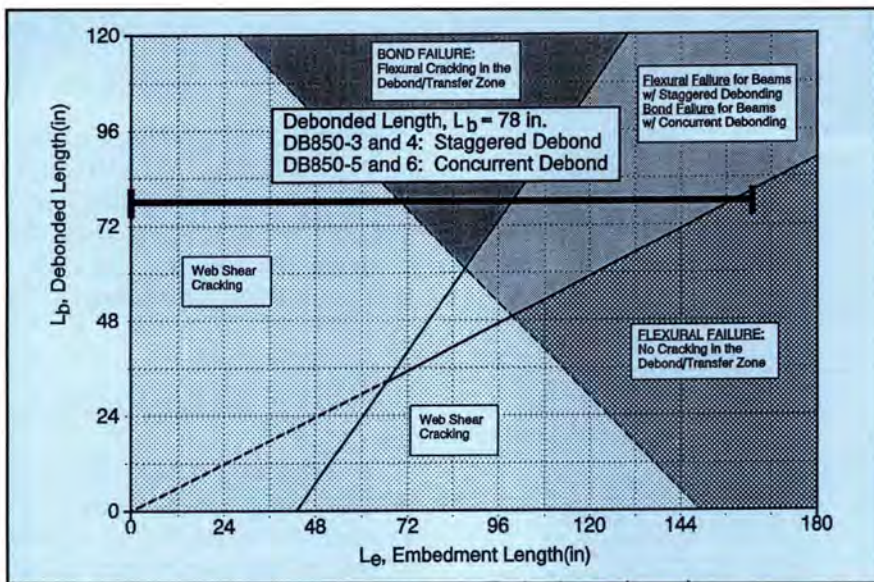
Fig. 7. Range of possible embedment lengths for beams with debonded strands.

Fig. 7 also clearly illustrates the embedment length that is required to develop flexural failures in the test series. From the figure, an embedment length of approximately 100 in. (2.5 m) is required to develop adequate tension in debonded strands from a staggered debonding pattern. An embedment length of approximately 160 in. (4.0 m) is required to develop debonded strands that are part of a concurrent debonding pattern.

Finally, the figure helps to illustrate the predicted differences between staggered and concurrent debonding patterns. It clearly shows that debonded strands in a staggered debonding pattern should require less strand embedment to develop flexural failures than debonding patterns that are concurrent. From this model, beams with staggered debonding patterns should demonstrate superior bond performance compared to beams with concurrent debonding patterns.

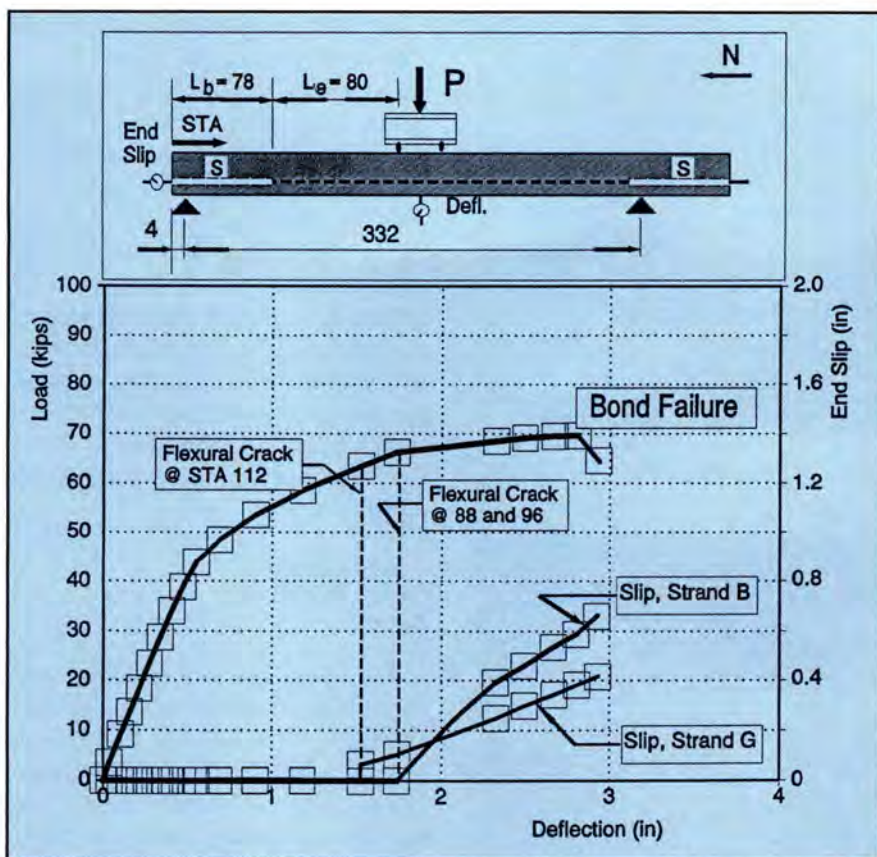
Fig. 12. Beam DB850-3, Test A.

Beam DB850-3 contained four debonded strands in a staggered cut-off pattern. Strands B and G were debonded to the full debonded length of 78 in. (1.98 m); Strands D and F were debonded to only 39 in. (0.99 m). Fig. 12 plots the load vs. deflection for

Test DB850-3A, and demonstrates a typical bond failure for beams with debonded strands. Note that the embedment length, $L_e = 80$ in. (2 m), approximates 1.0 times the basic development length given by AASHTO Eq. (9-32) and ACI 12.9. Fig. 12 also shows the test dimensions.

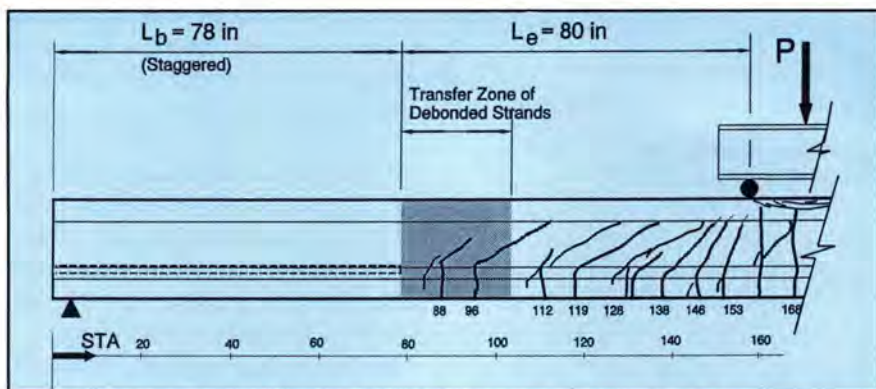
Fig. 13. Cracking pattern for Test DB850-3A depicting flexural cracking in the transfer zone of debonded strands.

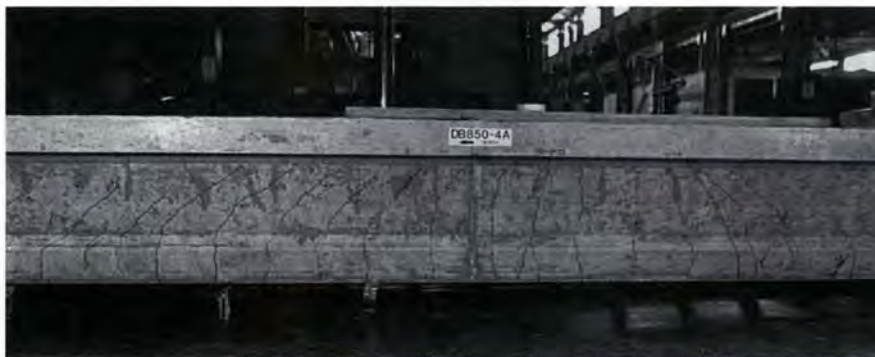
Fig. 16. Cracking pattern for Test DB850-4A — Typical for flexural failures.

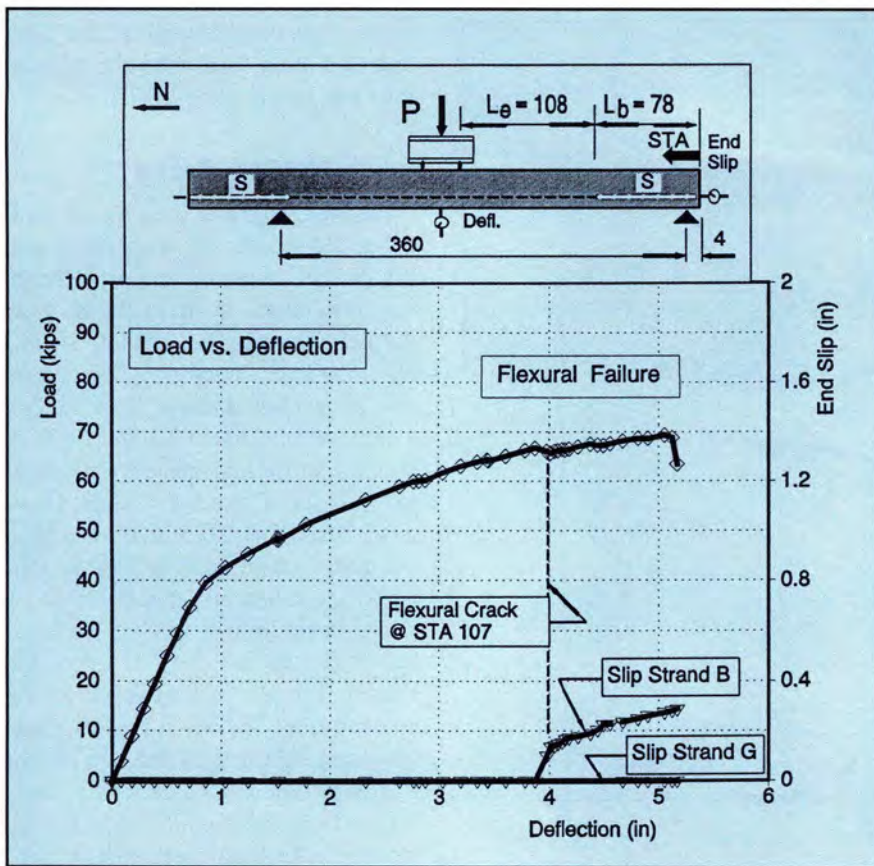
Fig. 17. Beam DB850-3, Test B.

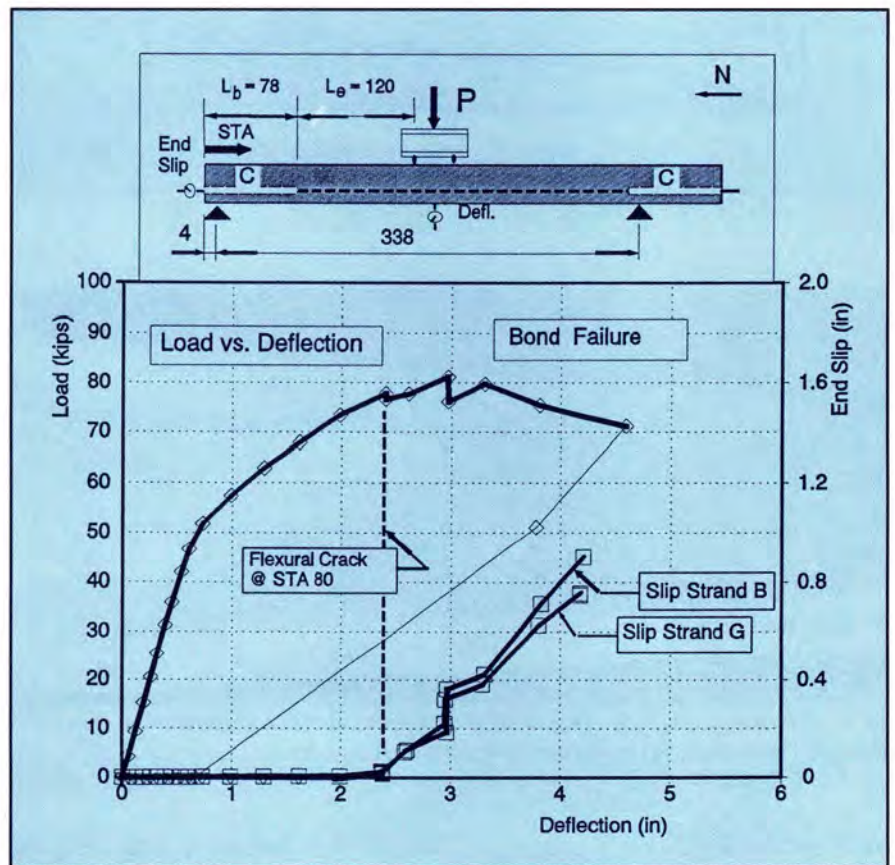
Fig. 19. Beam DB850-5, Test A.

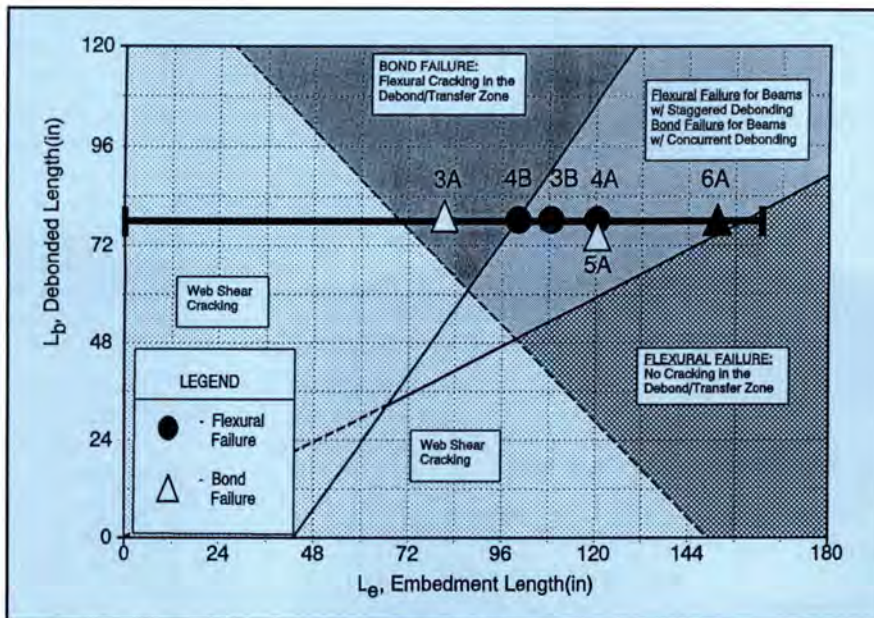
Fig. 22. Overlay comparing test results to predicted failure modes.
