Interface Horizontal Shear Strength in Composite Decks With Precast Concrete Panels

Six stay-in-place precast, prestressed deck panels were tested to evaluate the horizontal shear strength between the precast panel and the cast-in-place portion of the bridge deck. Presently, the Indiana Department of Transportation requires a minimum of 20 shear connectors regardless of panel dimensions. The shear connectors are placed across a broom finished deck panel surface. Broom finish with approximately 0.05 to 0.075 in. (1.27 to 1.91 mm) total amplitude deformations is specified instead of a raked finish with 0.25 in. (6.35 mm) total amplitude because of the reduced 2.5 in. (63.5 mm) thickness of the panels used in Indiana. In this study, composite behavior at ultimate, including horizontal shear and interface slip characteristics, was evaluated. It is concluded that stay-in-place precast, prestressed deck panels with a broom finished surface do not require horizontal shear connectors if the nominal average horizontal shear stress at the interface is less than 116 psi (0.8 MPa).

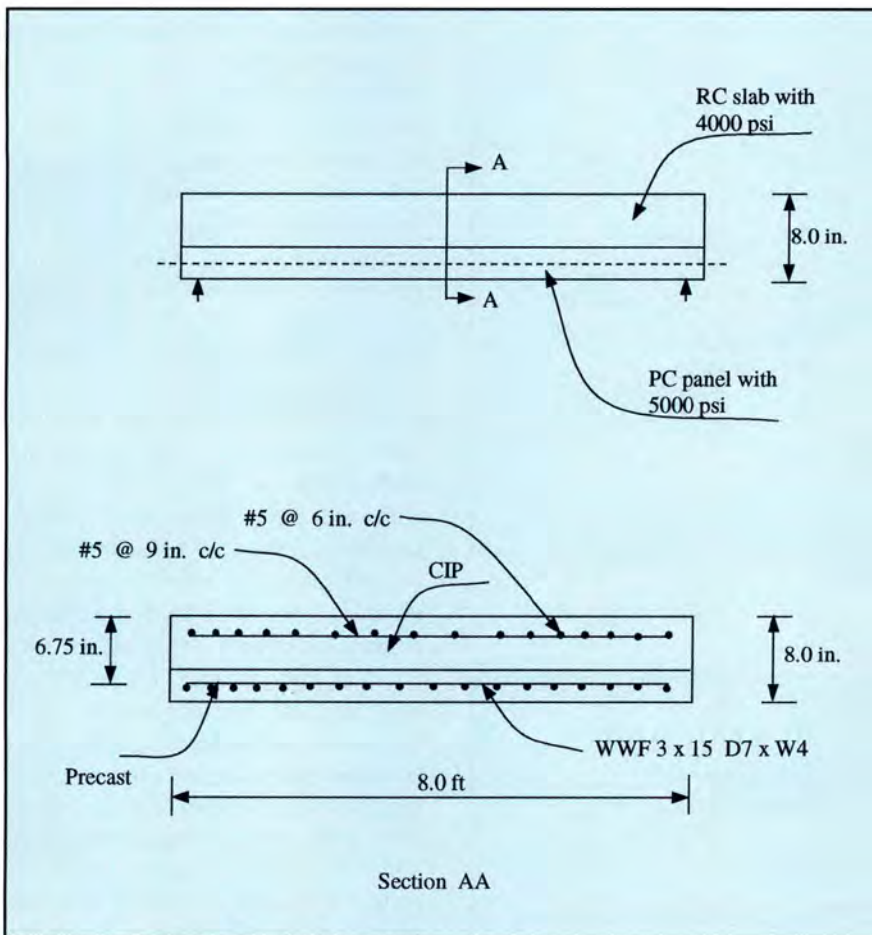
Fig. 1. Geometrical characteristics of deck slab.

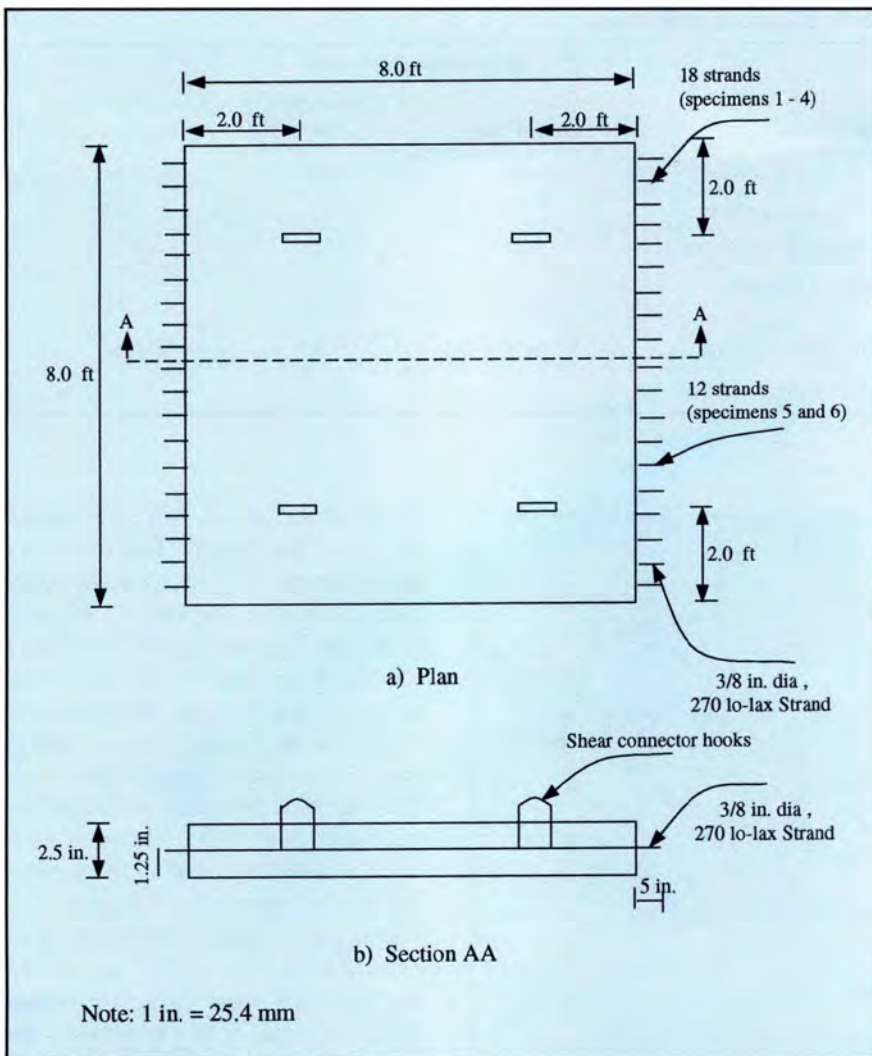
Fig. 2. Typical details of a panel with four stirrups.

All six composite specimens consisted of a 2.5 in. (6.35 mm) thick precast, prestressed panel with an additional 5.5 in. (13.97 cm) thick cast-in-place reinforced concrete topping slab. Thus, an 8 in. (203.2 mm) standard total deck thickness, as commonly used in Indiana, is provided. The details of the various specimens are given in Table 1. Fig. 1 shows the geometrical characteristics of the composite specimens. Deck panel plan and elevation details are shown in Fig. 2. Locations of shear connectors are also indicated in Fig. 2.

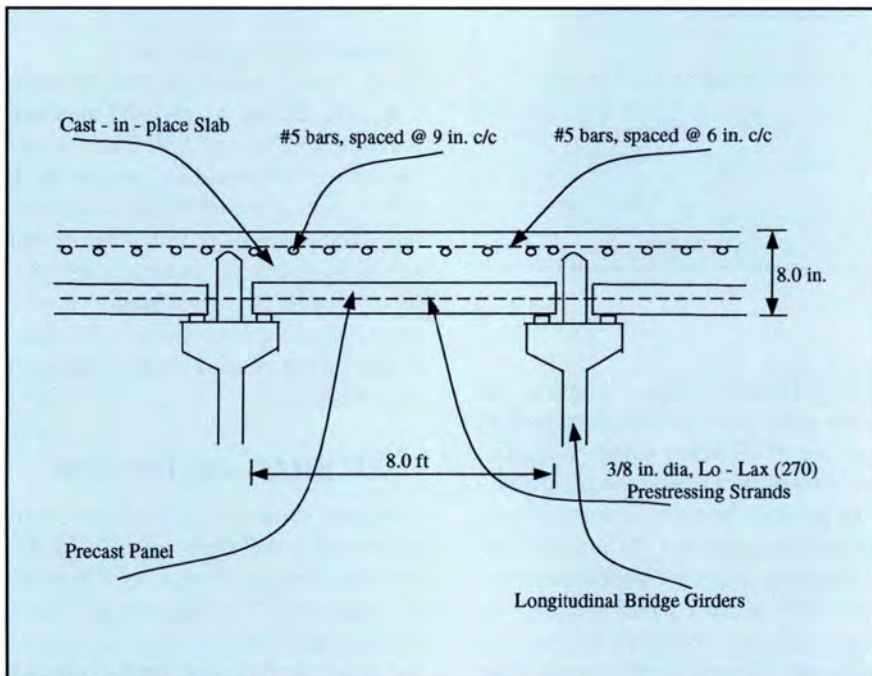
Fig. 3. Cross section details of bridge deck.

A typical transverse section of a bridge superstructure is shown in Fig. 3. The precast panels rest on top of longitudinal bridge girders with some

form of bearing material in between, and then the topping slab is placed on top of these deck panels. Strand extensions are typically used to anchor these deck panels¹⁵ and the entire positive moment reinforcement is kept in

the precast panels. The topping slab contains nominal reinforcement to take care of the temperature and shrinkage stresses.

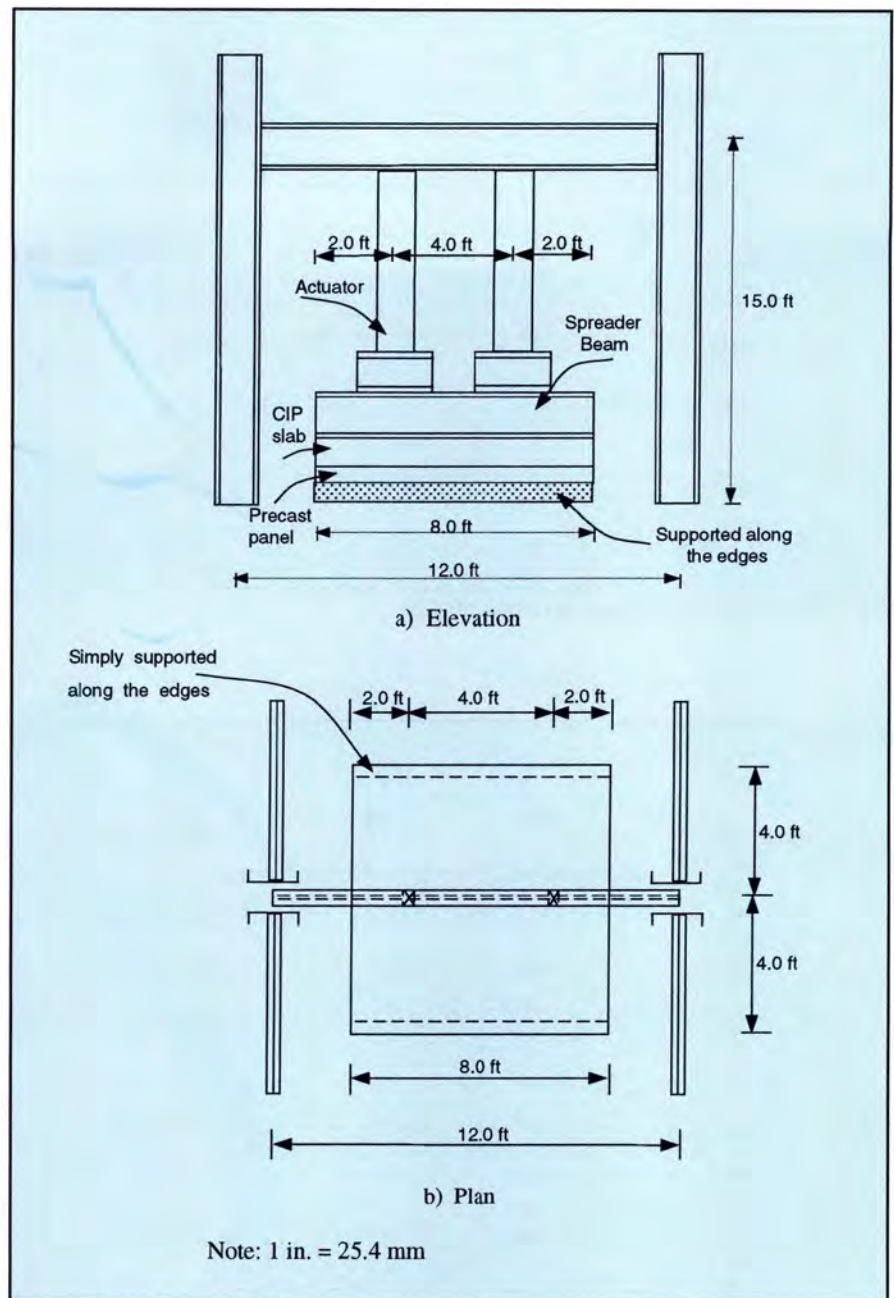
Fig. 4. Loading frame details.

The test setup is shown in Fig. 4. The two columns are 12 ft (3.66 m) apart and support a cross beam. The cross beam in turn supports two hydraulic actuators. The load is distributed to the specimen by means of a spreader beam, which distributes the load as a uniform load applied over the entire width of the panel. The load was distributed over an area of 10 x 96 in. (254 mm x 2.44 m).

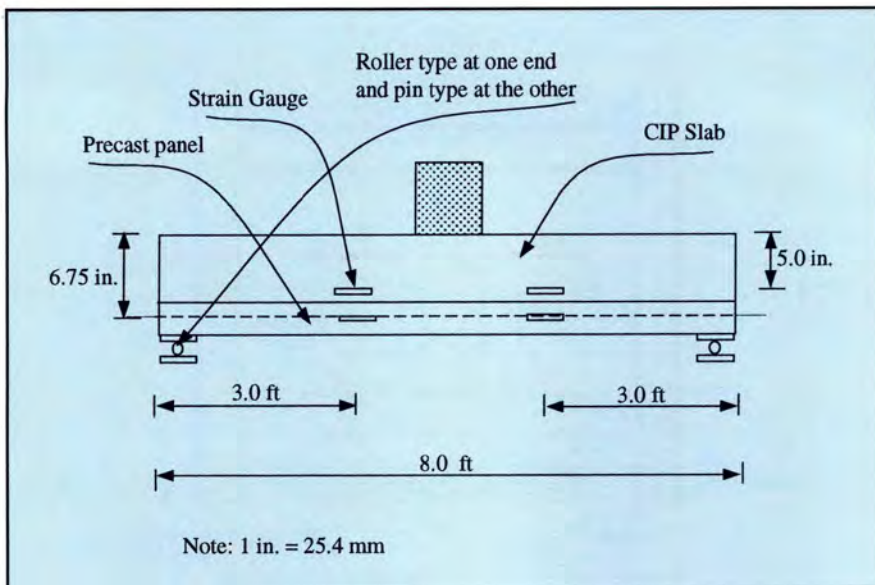
Fig. 5. Strain gauge locations on sides of deck.

Strain gauges were used to measure strains on the sides of the specimen (EA-06-20CBW-120) (see Fig. 5) and also to measure strains in the prestressing strands (EA-06-062DN-350). Strain gauges (EA-06-20CBW-120) were also placed on top of the cast-in-place slab, as shown in Fig. 6. On the prestressing strands, gauges were placed at the mid-section of the deck panel, as shown in Figs. 7 and 8.

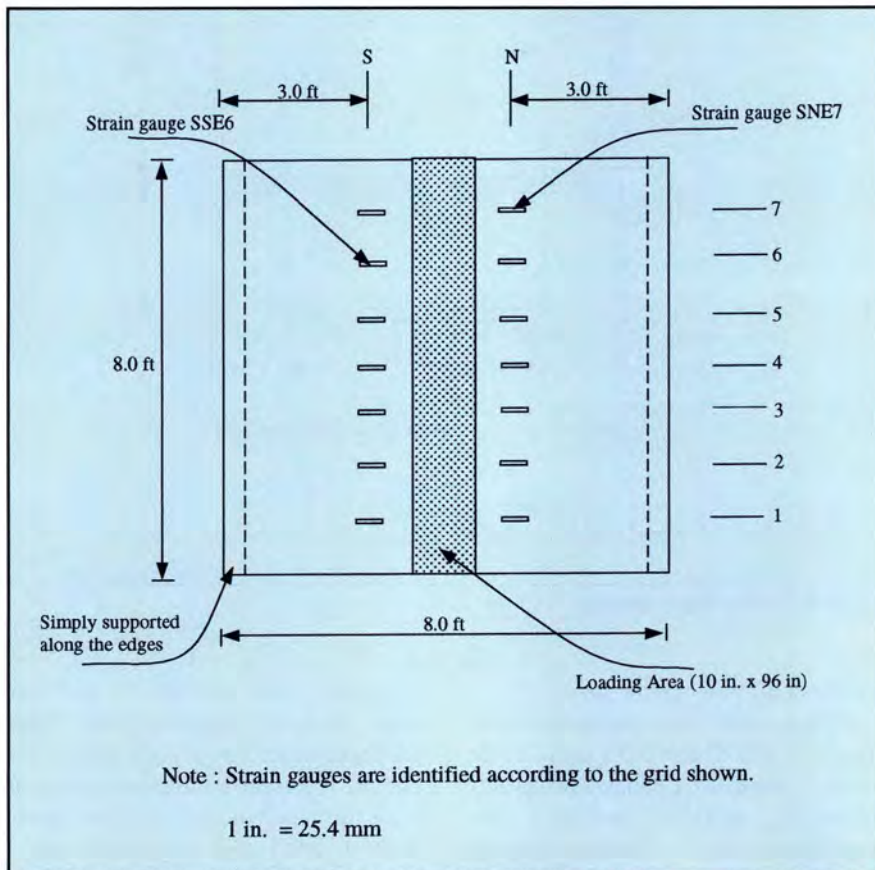
Fig. 6. Strain gauge locations on top of cast-in-place slab.

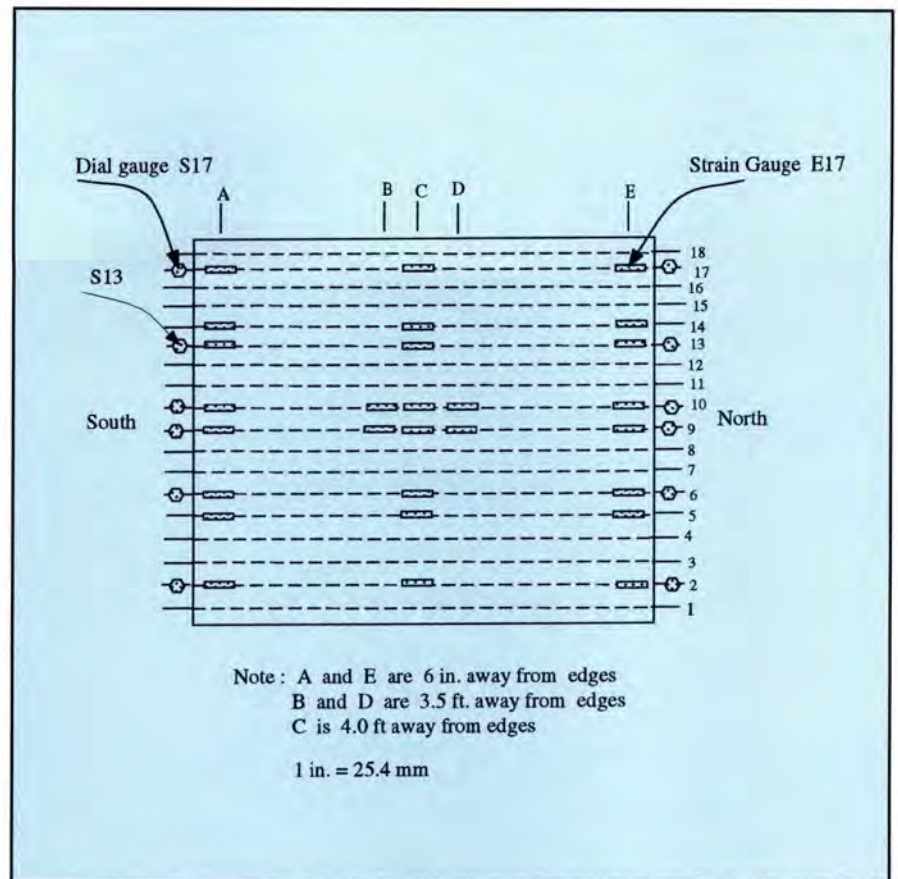
Fig. 7. Strain gauge and dial gauge locations on prestressing strands of Specimens 1 and 2.

To determine the amount of strand slip, dial gauges were placed on selected strand extensions, as shown in Figs. 7 and 8. To determine the slip between the cast-in-place concrete slab and the prestressed panel, LVDTs were used as slip gauges. Slip between the cast-in-place slab and the prestressed panel is usually associated with diminishing composite behavior between the cast-in-place slab and the precast panel.

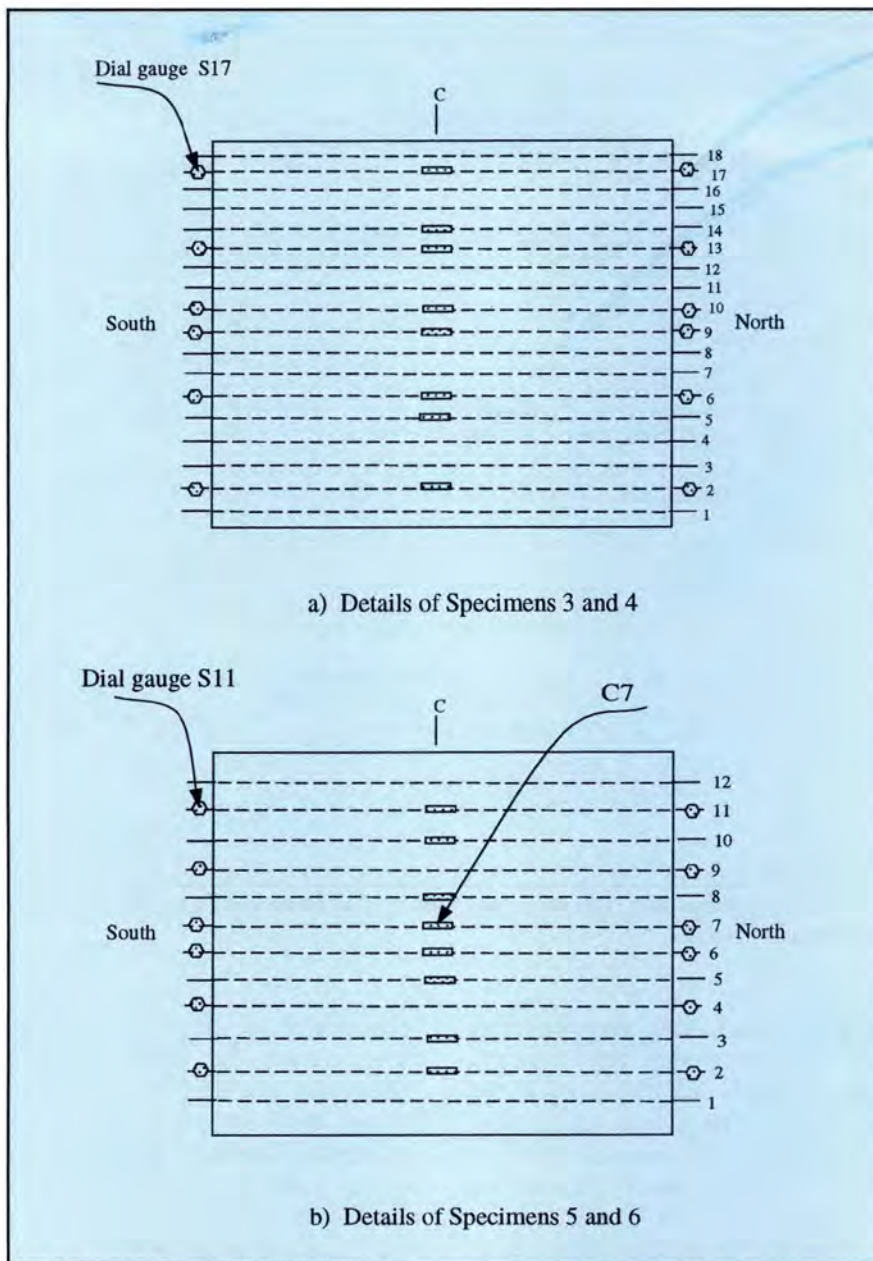
Fig. 8. Strain gauge and dial gauge locations on the prestressing strands.

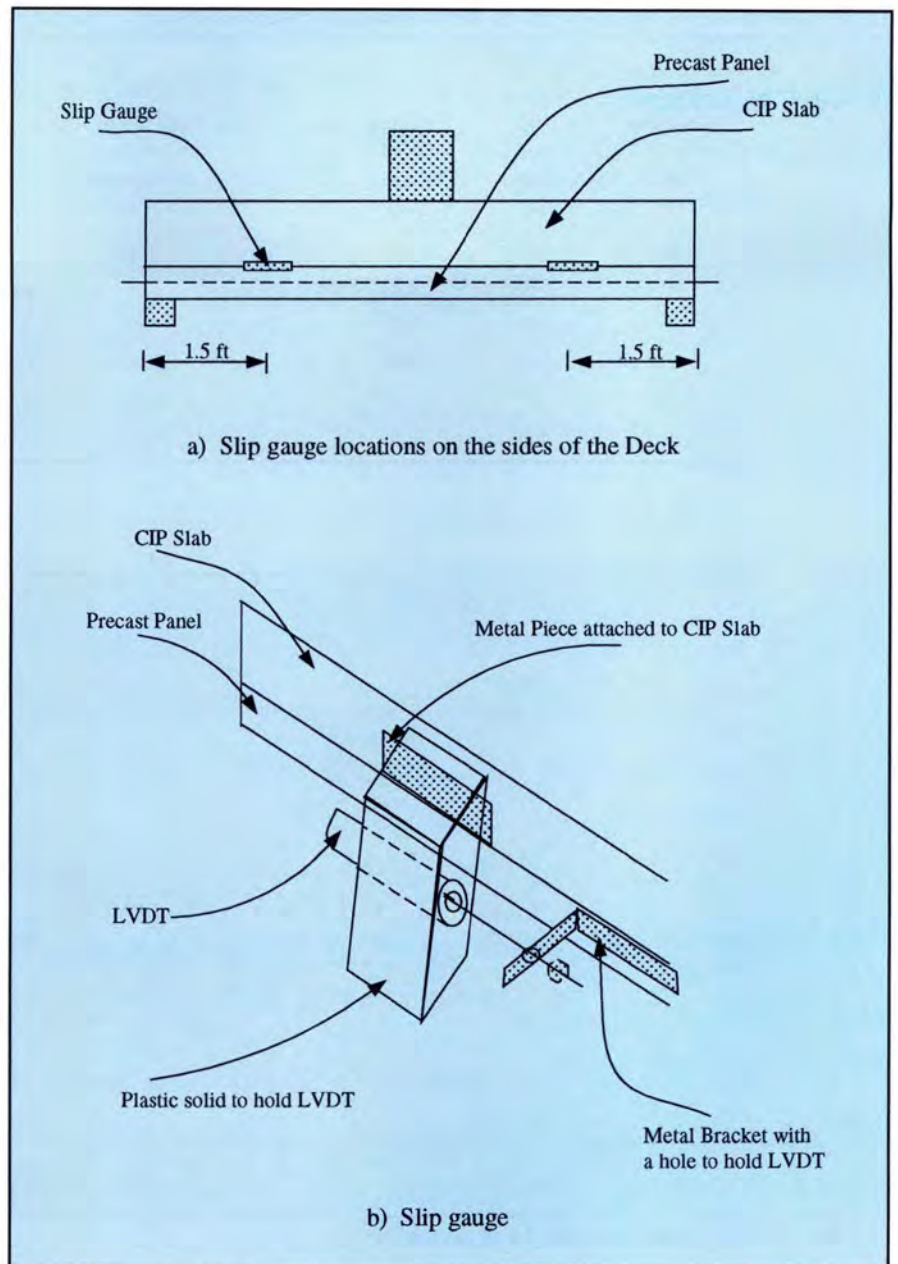
Fig. 9. Slip gauge details.

point due to the compressive stress flow. Hence, the separation and thereby slip would only take place in between the points which are d effective depth of the slab, away from the loading point and the support reactions. To measure this slip, slip gauges were placed, as shown in Fig. 9.

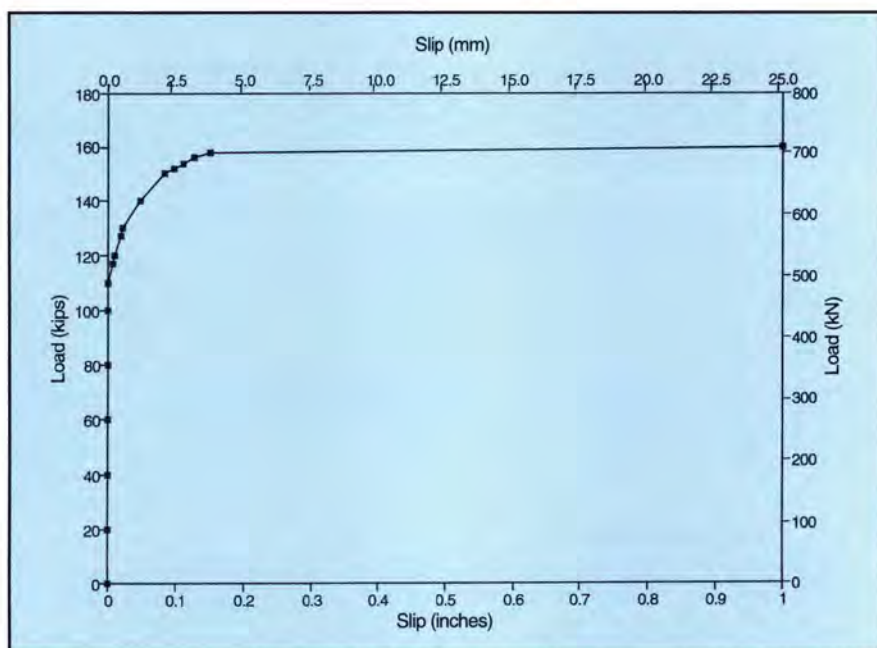
Fig. 10. Load vs. strand slip at #S13 of Specimen 1.

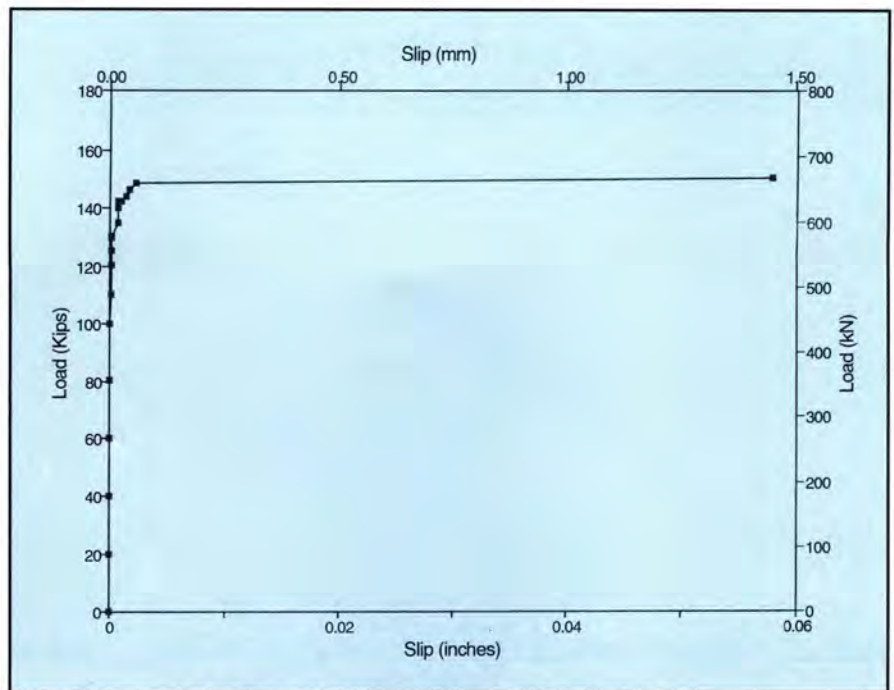
Fig. 11. Load vs. slip at interface (Gauge LVDT4) of Specimen 1.

Interface slip was not observed until the loads approached failure levels in the first four specimens. In Specimens 5 and 6, significant interface slip was not observed even at failure levels. In the first four specimens, at the ultimate loads, interface slip occurred in the critical region mentioned earlier. This typical behavior is illustrated in Fig. 11 for Specimen 1.

5. The lowest load at which interface slip was recorded in these specimens was 150 kips (668 kN), as seen

in Fig. 11. Based on this minimum load, an upper limit for the average horizontal shear stress of 116 psi (0.8 MPa) is recommended in deck panels with a broom finished surface and

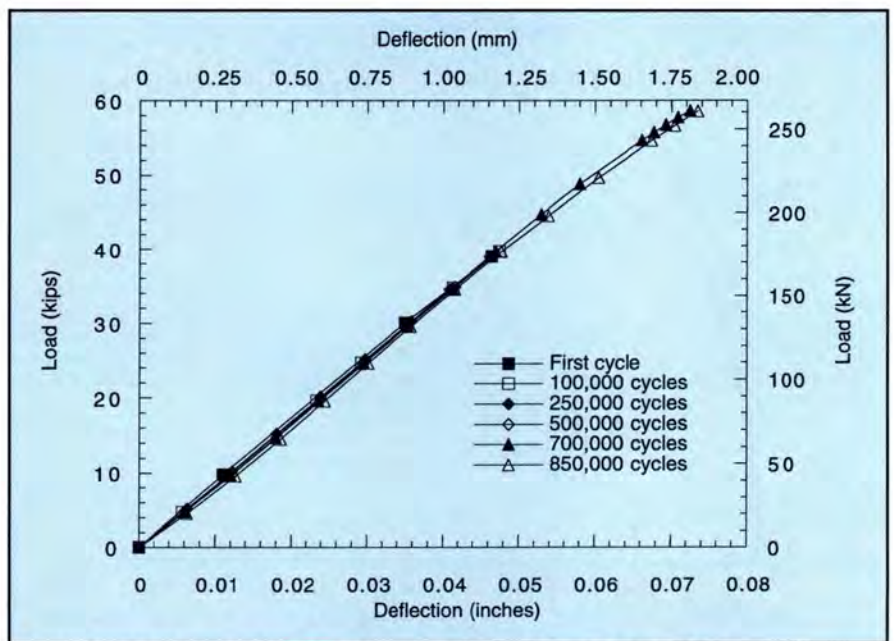
Fig. 12. Effect of cyclic loading on midspan deflection of Specimen 1.

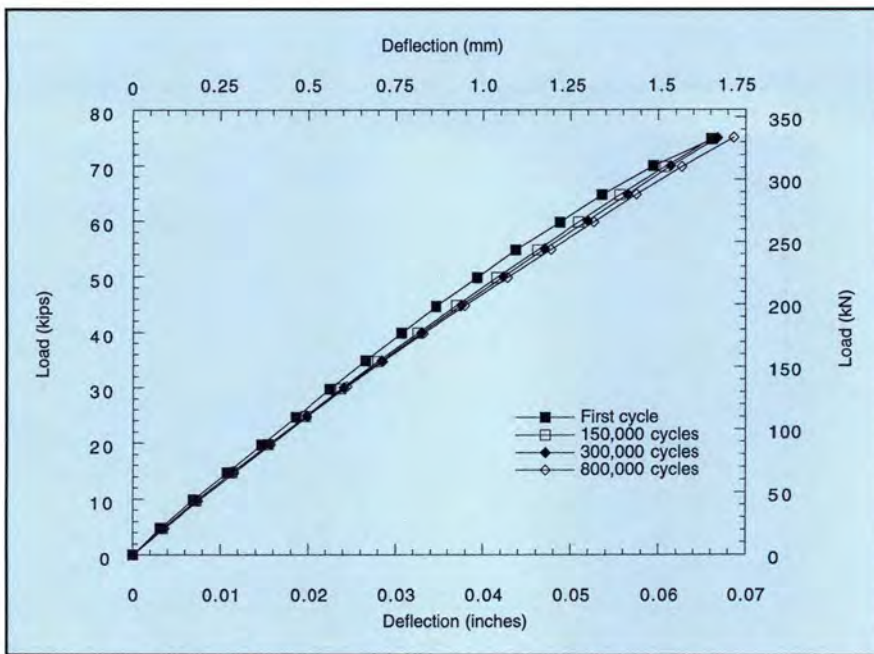
Fig. 13. Effect of cyclic loading on midspan deflection of Specimen 6.

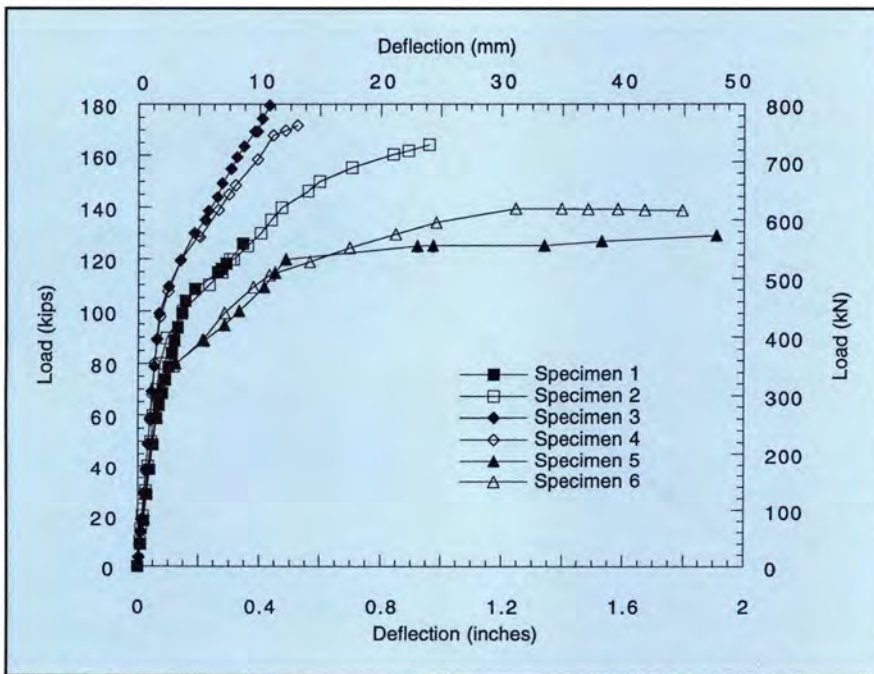
Fig. 14. Comparison of load vs. midspan deflection characteristics during final monotonic load phase.

As the load increased, further reduction in the stiffness of the deck slab was observed. Deflection varied with a very flat slope (very large increase in deflection was observed for relatively small increase in load) until the LVDTs were removed due to excessive deflection of the deck slab as it reached its ultimate capacity. Load vs. deflection characteristics of all specimens are shown in Fig. 14 up to the loads corresponding to LVDT removal. The actual failure loads are listed in Table 4. Specimens with shear connectors were stiffer near ultimate loads than specimens without shear connectors or with a lubricated interface. Due to the reduction in the number of strands and, hence, the prestressing in Specimens 5 and 6, there was a decrease in the stiffness and an increase in the ductility (see Fig. 14).

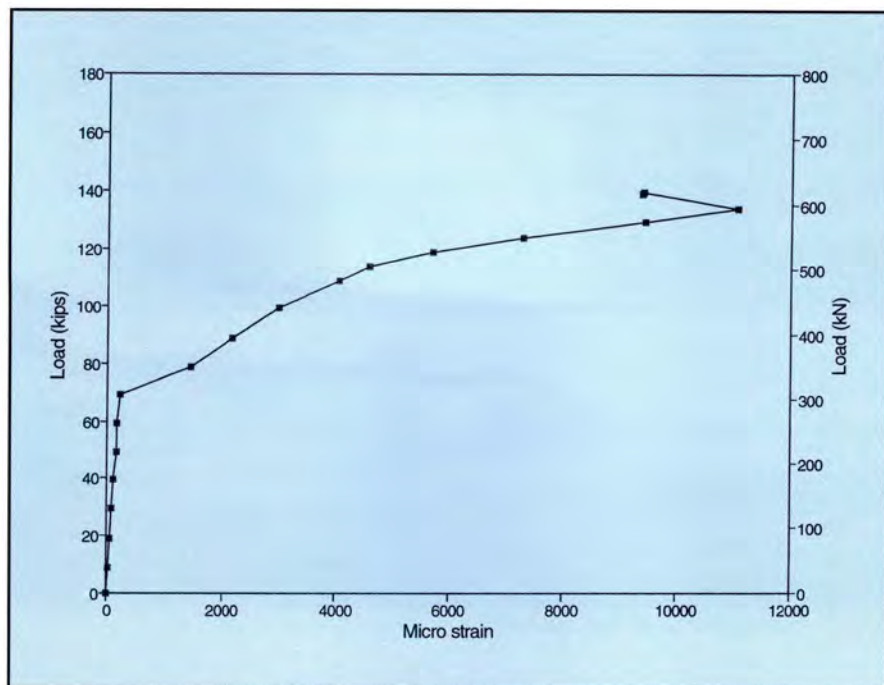
Fig. 15. Load vs. strain in strand at #C7 of Specimen 6.

stress loss was about $200\mu\epsilon$. In Fig. 15, this initial strain along with other prestress losses was deducted to show the effect of applied load only.

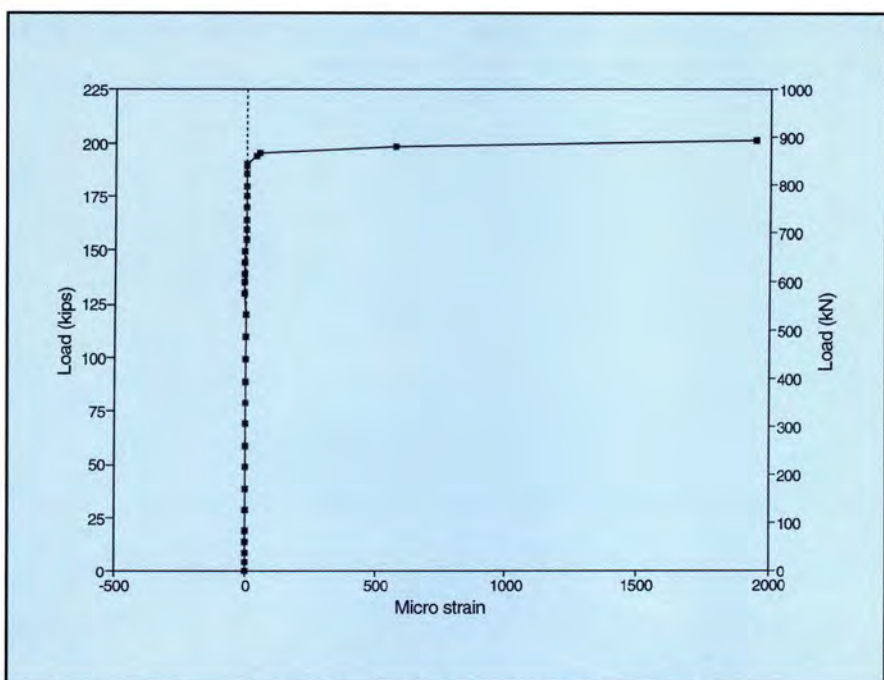
Fig. 16. Load vs. strain in horizontal shear connector (STIR #2) of Specimen 3.

Specimens 1 and 5 did not contain horizontal shear connectors. All the other specimens contained four shear connectors, a practical minimum number required for handling purposes. Strain in shear connectors did not show significant deviation until specimens reached failure. Before failure, the strain recorded in the shear connectors was about $40\mu\epsilon$. Just at the instant of failure, strain increased suddenly and, in some cases, it reached yield levels. This behavior is illustrated in Fig. 16.

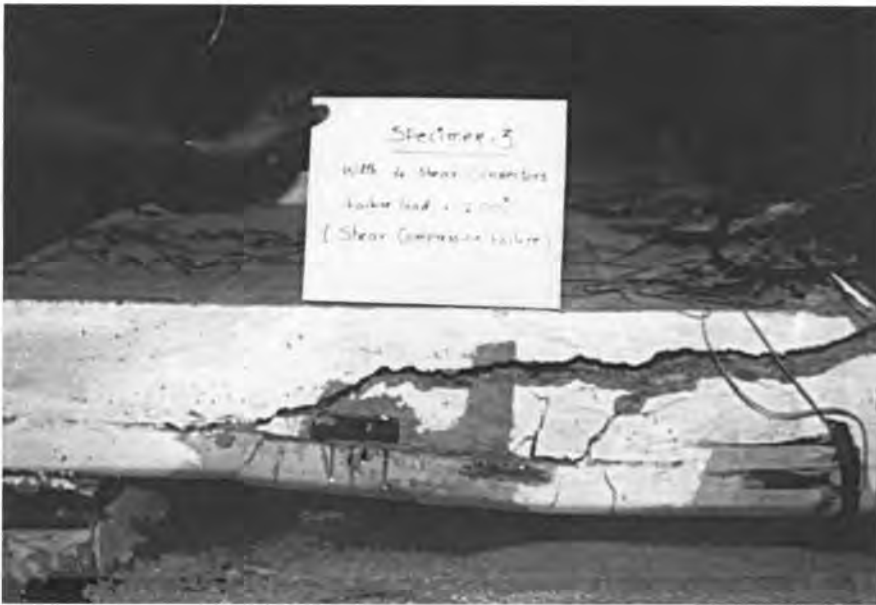
Fig. 17. Failure mode of Specimen 3.

reached their yield capacity in the specimens with 18 strands. These specimens failed in beam shear, as can be seen in Fig. 17. In Specimens 5 and 6 with 12 strands, there was not a significant change in the strain from its initial value. Specimens 5 and 6 failed in flexure without significant diagonal cracking.
