# Innovative Design and Erection Methods Solve Construction of Rock Cut Bridge

*Transportation difficulties, elimination of the center pier and environmental restraints presented a major design-construction challenge for this nearly 200 ft (61 m) long bridge in a mountainous region of Washington State. The solution was to divide the girder into three 63 ft (19.2 m) pretensioned bulb-tee girder segments and transport them 150 miles (240 km) to a staging area near the bridge site. There, the segments were spliced and post-tensioned to give a total girder length of 190 ft 6 in. (58.1 m). The girders were then hauled to the bridge site where they were guided into position with a launching truss and two cranes. Construction time took only 3½ months. This article discusses the project constraints, structural design, production, transportation, splicing and final erection. The highlights of the project are narrated from the perspective of the structural designer and precaster.*

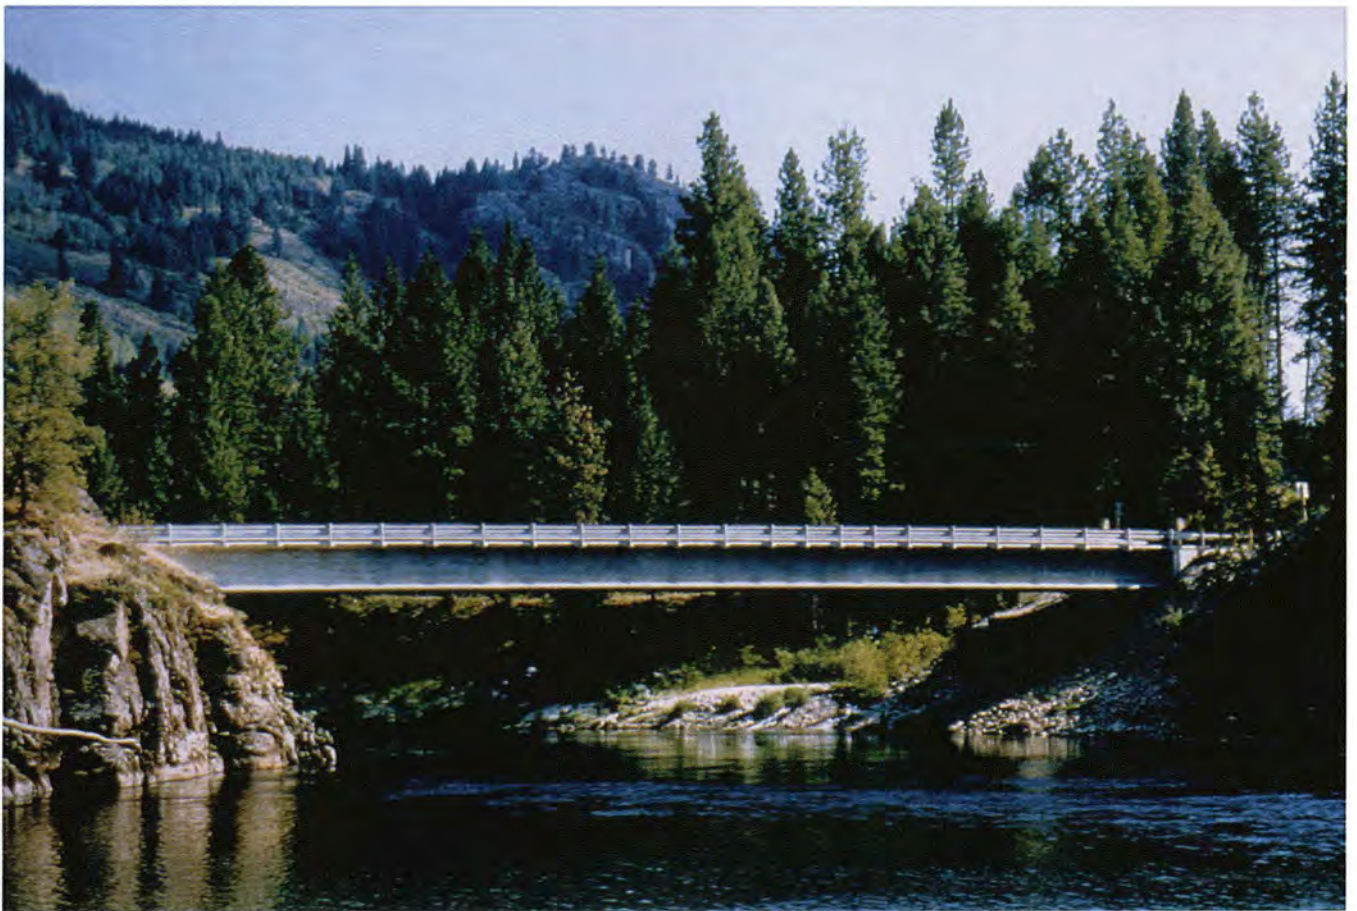
Fig. 1. Panoramic view of new Rock Cut Bridge.

**T**he new Rock Cut Bridge (see Fig. 1) is a spliced, single span 190 ft 6 in. (58.1 m) precast, prestressed concrete structure. The bridge is situated in a ruggedly beautiful mountainous region just 6 miles (10 km) south of the Canadian border over the Kettle River in Washington State. It provides a link between the area east of the river and the main state highway.

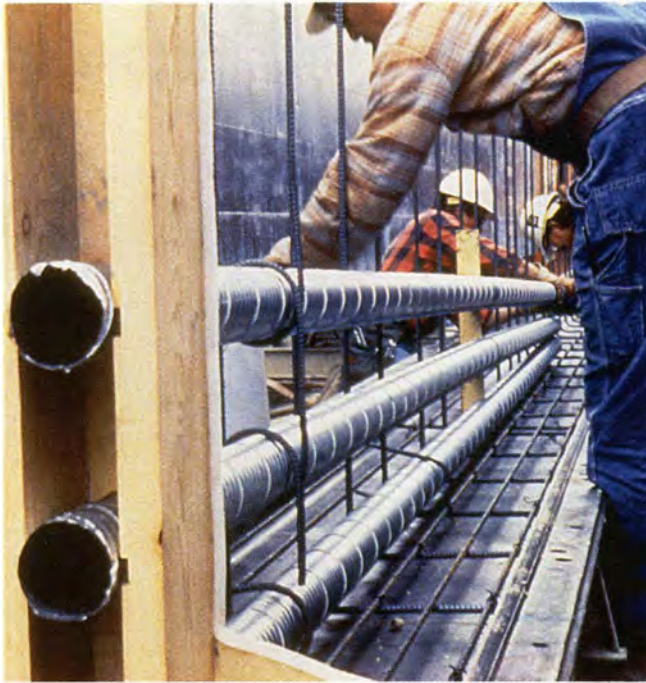
Fig. 7. Positioning post-tensioning ducts in one of the 63 ft (19.2 m) girder segments.

Figs. 7 through 10 show various stages of the fabrication of the girder segments at the plant.

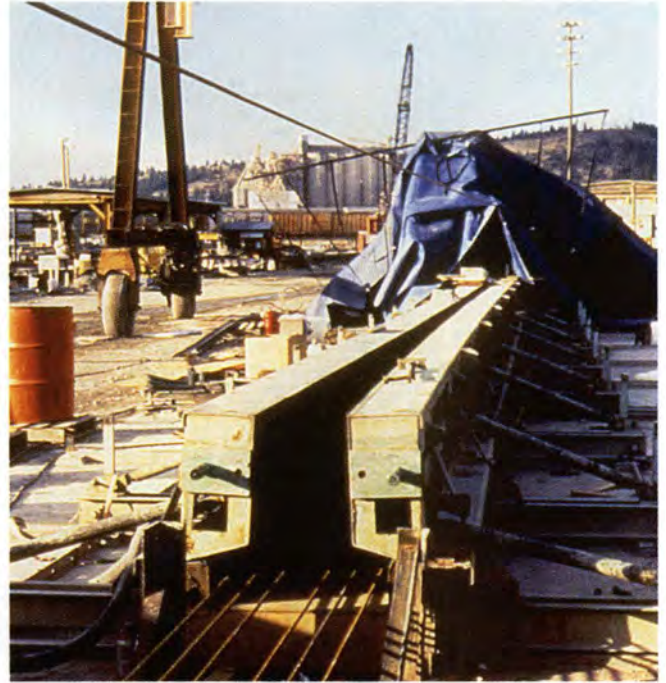
Fig. 8. Curing one 63 ft (19.2 m) girder segment after concrete was cast.

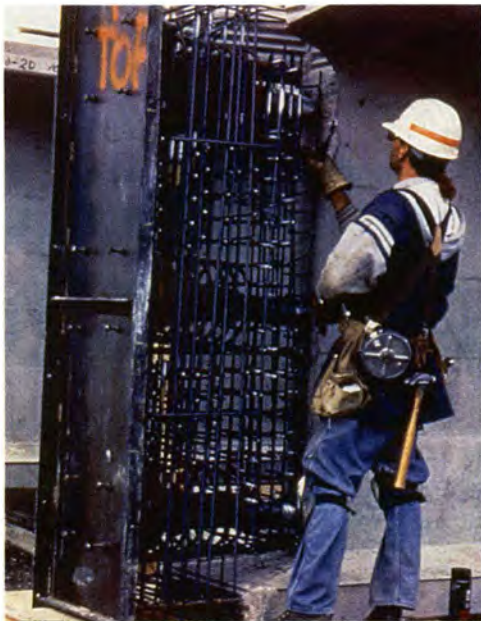
Fig. 9. Constructing girder and jacking cage after girder casting and curing.

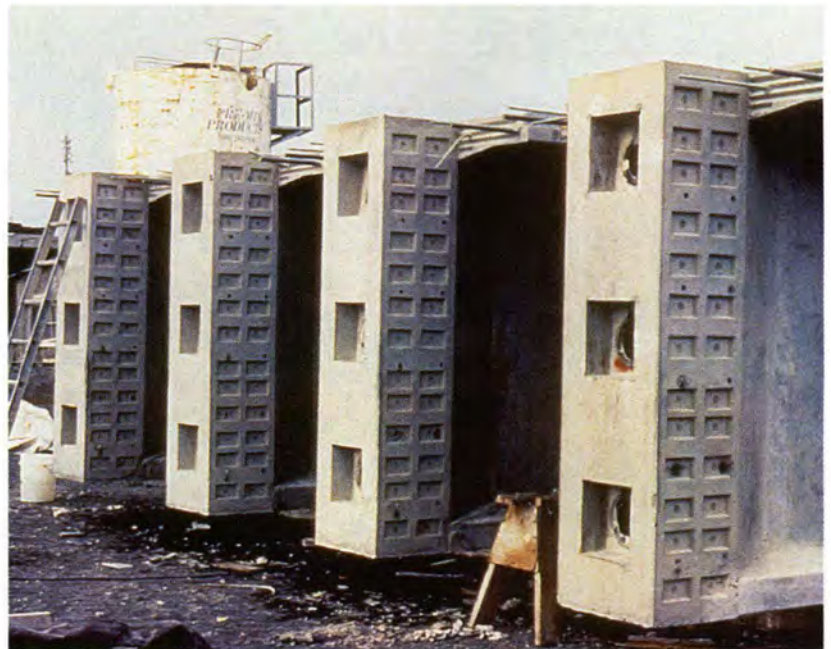
Fig. 10. Four girder end segments ready for shipment.

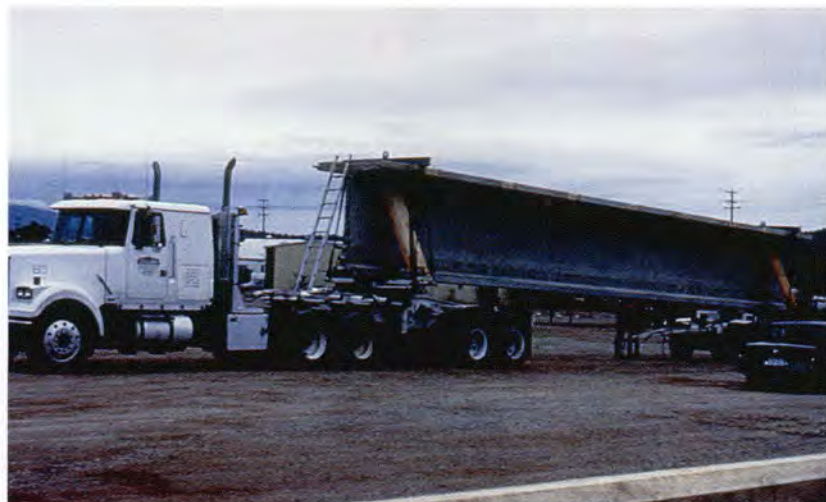
Fig. 11. Girder segment [63 ft (19.2 m) long and weighing 40 tons (36 t)] leaving precasting plant.

The girder segments were hauled (see Fig. 11) by truck trailer 150 miles (240 km) north to the staging area which was close to the bridge site. After unloading, the segments were set on temporary concrete bunks prepared by One Way Construction.

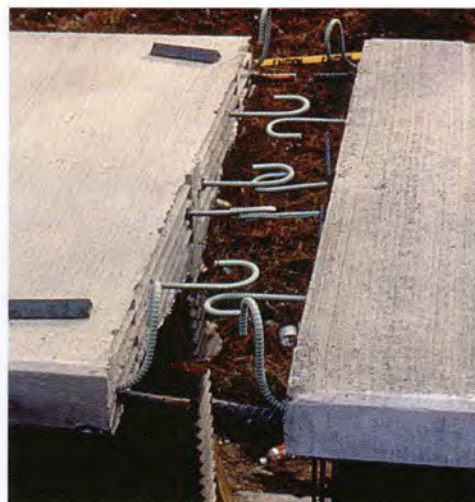
Fig. 12. Girder segments aligned at staging area near construction site.

Figs. 12 through 14 show how the girder segments were spliced and post-

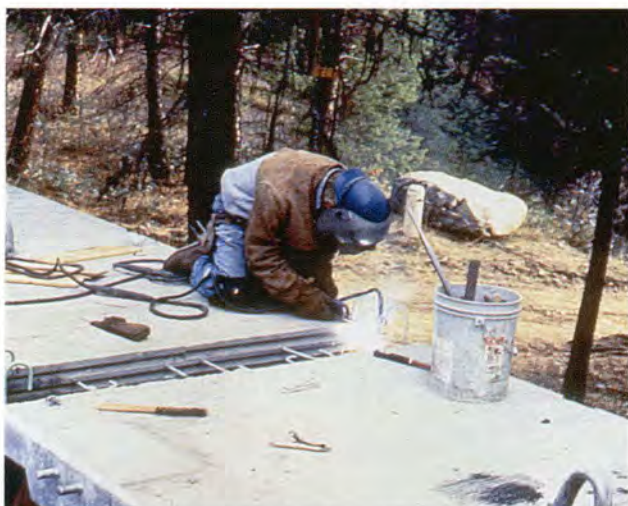
Fig. 13. Welding the outside #8 reinforcing bars at the closure segment.

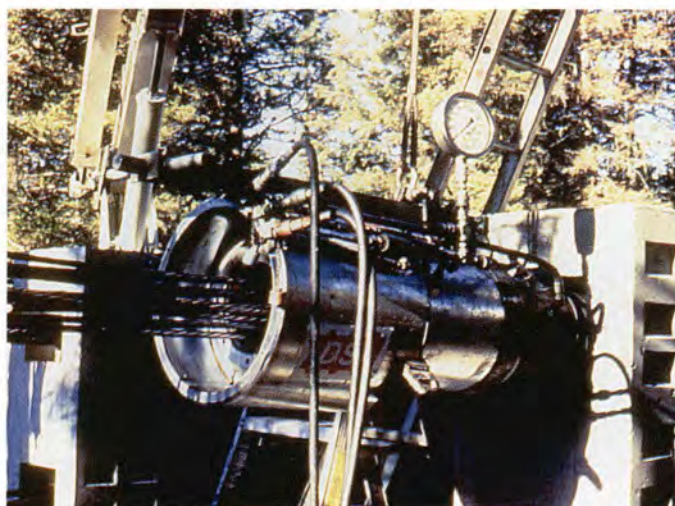
Fig. 14. Jacking the 190 ft 6 in. (58.1 m) girders after curing of closure pour.

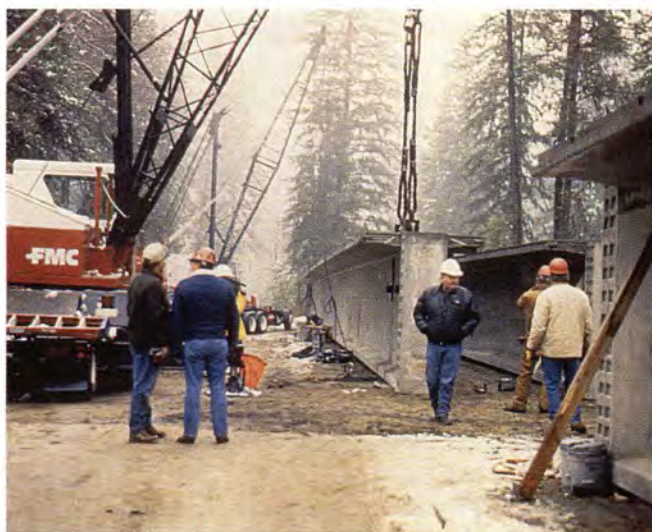
Fig. 15. Picking spliced girder in staging yard.

tensioned. Figs. 15 through 18 show the care in which the assembled girders were hauled to the bridge site.

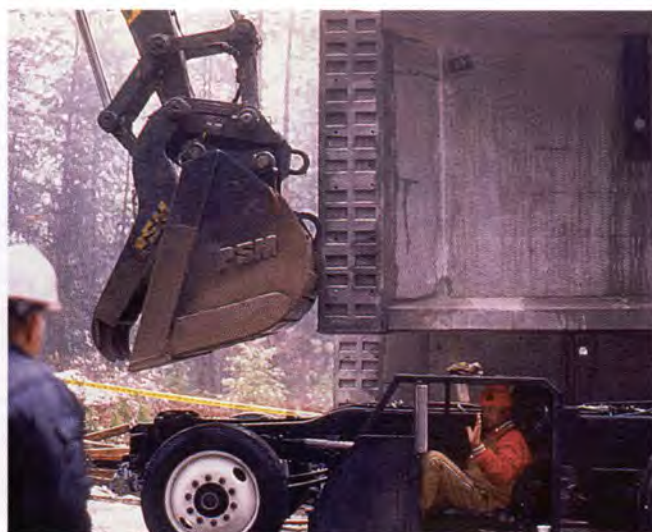
Fig. 16. Positioning spliced girder on seven-axle, 26-tire carrier.

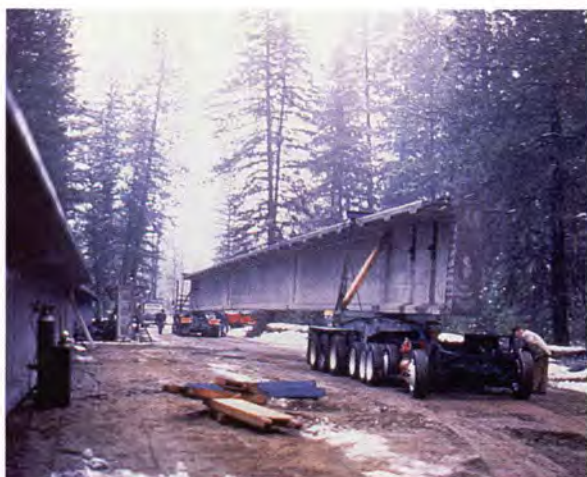
Fig. 17. Spliced girder [190 ft 6 in. (58.1 m) long and weighing 120 tons (110 t)] on the road and ready for the haul.

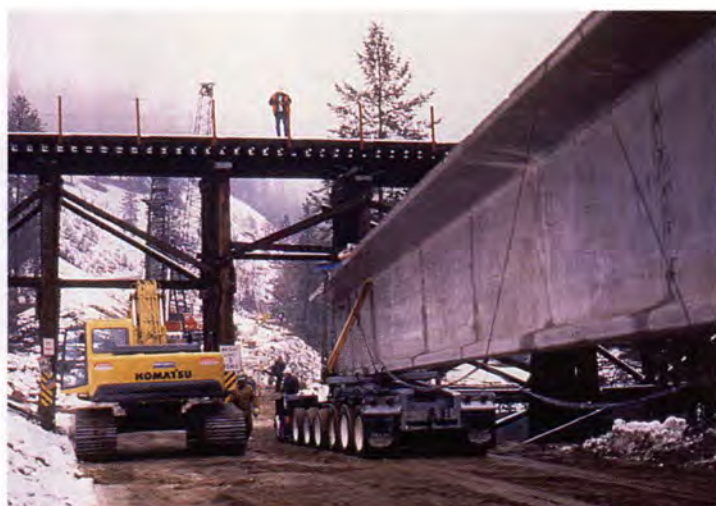
Fig. 18. Girder heading for bent opening specially modified for these girders.

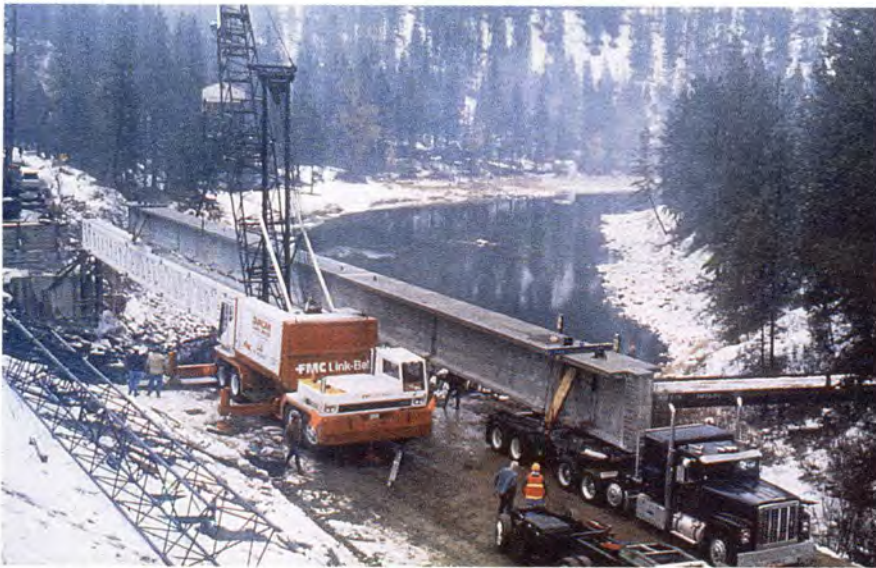
Fig. 19. At bridge site, end of girder placed on launcher trolley and pushed across by truck unit.

Figs. 19 through 22 show the launching of the girders.

Our second worst nightmare was that the portion of the road that was straightened with fill would fail when the girder went through the railroad bridge and take the railroad bridge out when it fell. This fill did not shift in the end, so everything worked out as planned with all parties in radio contact with each other for coordination. The girder was lifted from the steering car and placed on the trolley on top of the launching truss.

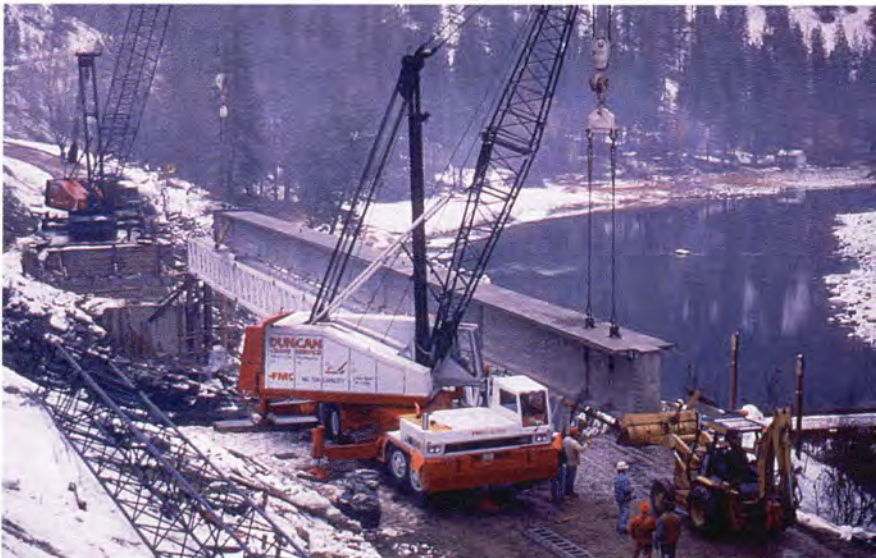
Fig. 20. Girder, weighing 120 tons (110 t), being lifted by a 200 ton (180 t) crane at one end and a 140 ton (127 t) crane at the other end.

The trolley moved across smoothly until the far side 200 ton (181 t) crane could reach the girder. Then it and the near side 140 ton (127 t) crane, working together, swung the girder into place. It was really a sight to behold! Despite the frigid air and long wait, a large crowd of people gathered to watch this dramatic moment. It took most of one day to set the first girder. Now that the launching crew knew the procedures, the next three girders were set in place routinely the following day.

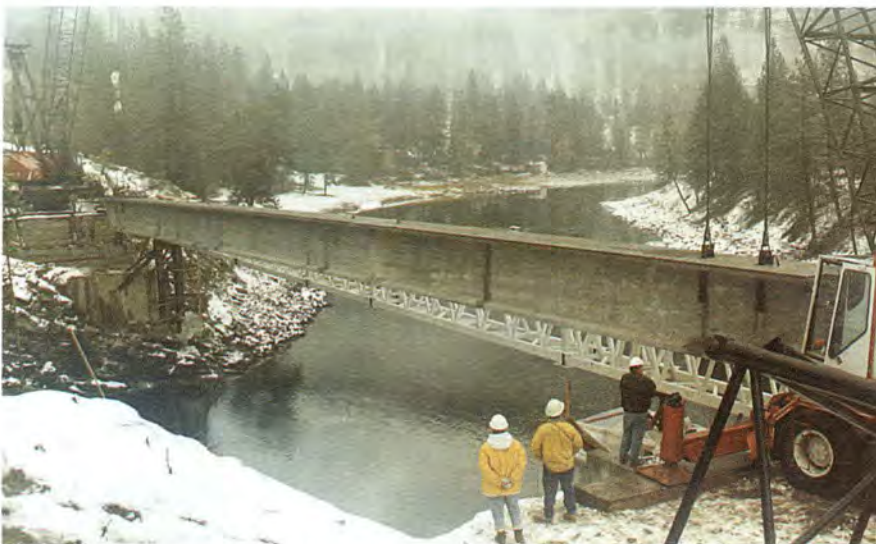
Fig. 21. Girder gently lowered into position on abutments.

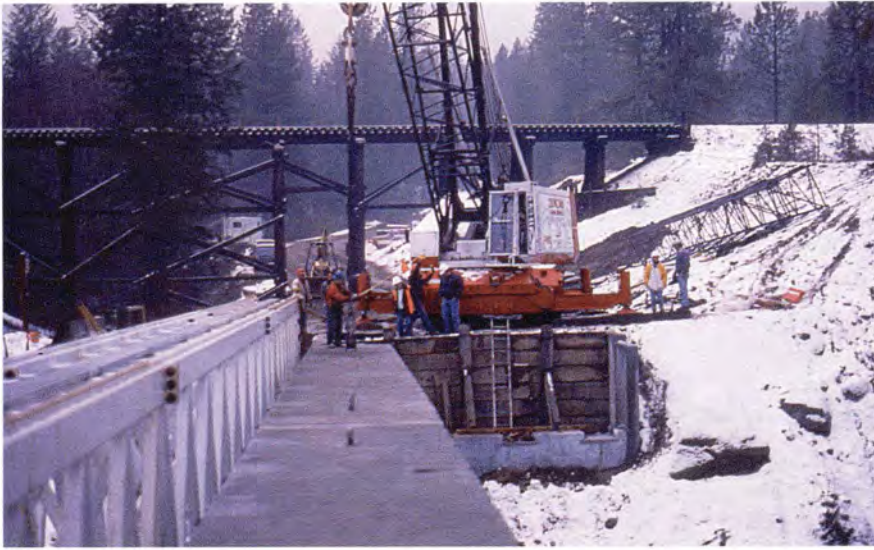
Fig. 22. Girder clear of launching truss being set in place.
