The Cause of Cracking in Post-Tensioned Concrete Box Girder Bridges and Retrofit Procedures

Walter Podolny, Jr.

Bridge Division
Office of Engineering
Federal Highway Administration
Washington, D.C.

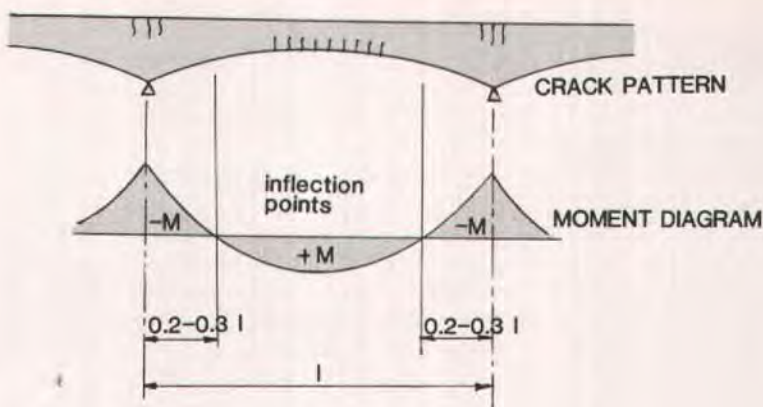
Fig. 1. Flexural cracking zones.

Flexural cracking is associated with tensile stresses that exceed the tensile capacity of concrete. They are generally found, in continuous girders, at the bottom of the girder in positive moment areas and at the top of the girder in negative moment areas (Fig. 1). In box girders, positive moment flexure cracks will traverse the bottom flange (soffit) width and if severe enough will propa-

gate in the webs. Flexure cracks in the top of the section, in the negative moment area, occur less often since there is generally a moment redistribution that occurs which reduces the tensile stresses in this area.

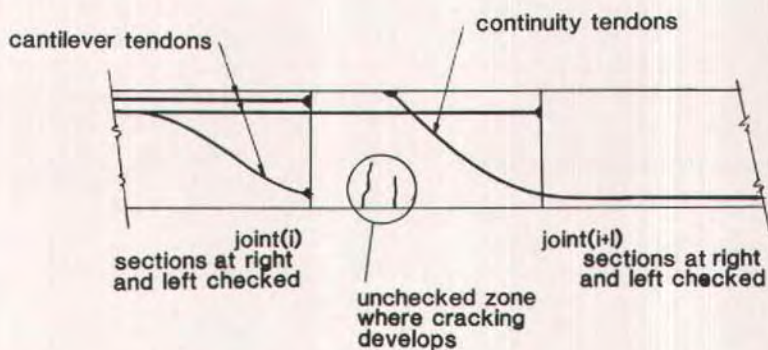
Fig. 4. Unverified zone of cracking.

1. Inadequate consideration of, or underestimation of, stresses resulting from moment redistribution.
2. Underestimation of thermal stresses (expansion or contraction).
3. Lack of consideration of, or underestimation of, thermal gradient.
4. Overestimation of initial prestress resulting from optimistic coefficients of friction and wobble.
5. Underestimating relaxation loss in prestressing.
6. Selection of a tendon profile whereby a large variation of prestress eccentricity occurs (Fig. 4), and not checking the stresses at critical locations.²

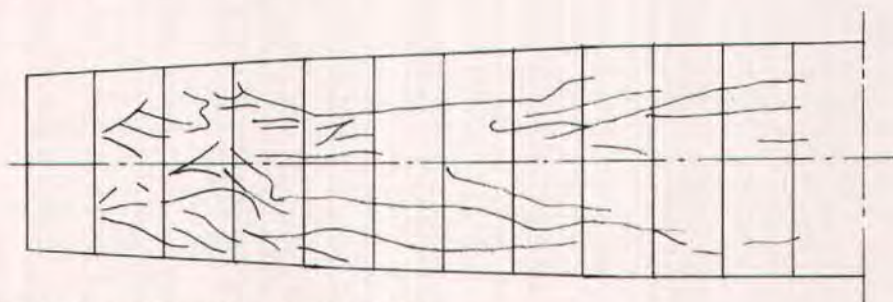
Fig. 10. Cracking pattern in bottom flange.

vertically curved tendons in the bottom flange. Vertical prestress was applied in the webs to control shear stresses. Diagonal cracking was observed in the center web, only near the intermediate diaphragms, with a maximum crack opening of 0.02 in. (0.6 mm). In addition there was cracking in the bottom flange.

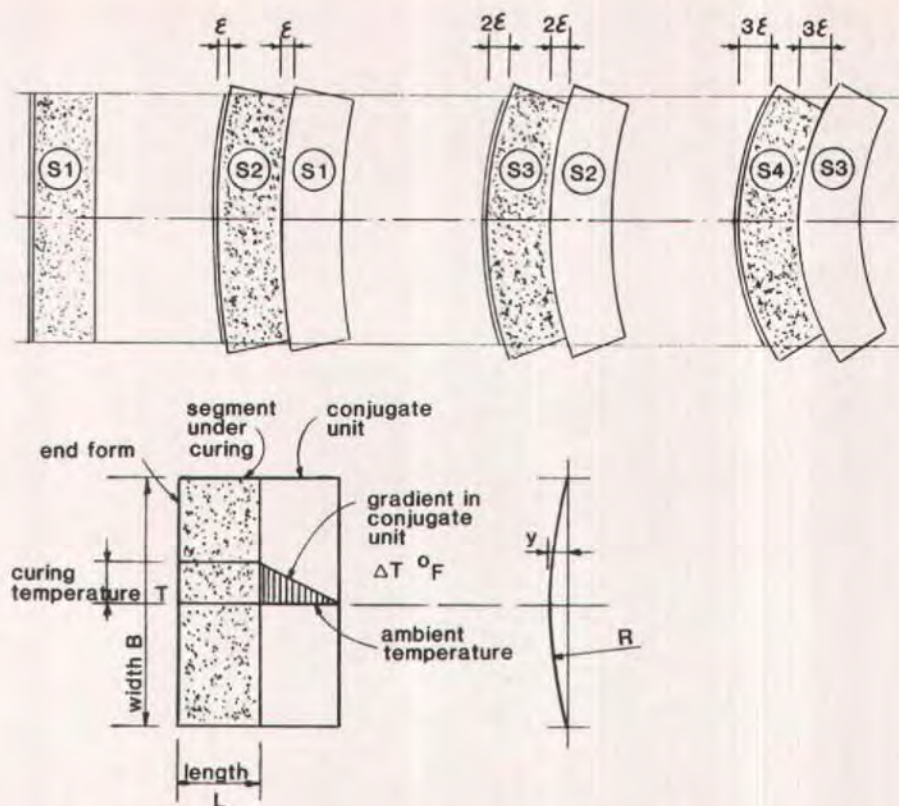
Fig. 25. Effect of improper curing of segments in short-line casting.

Another difficulty during curing is that resulting from large temperature differences between the curing environment of the segment being cast and the outside environment of the cast-against segment (Fig. 25). If a temperature gradient exists across the cast-against segment, its shape will change. The segment will return to its original shape when the temperature gradient falls back to zero.

This will result in match cast surfaces that are not necessarily parallel full length. This condition is evidenced in the top slab joints; the joints will be tight at the curbs and a small gap may be noticed at the center. The problem becomes cumulative if this condition exists for subsequent castings. With the tremendous prestressing force, the segments develop longitudinal cracks as the segments are seated against each other.

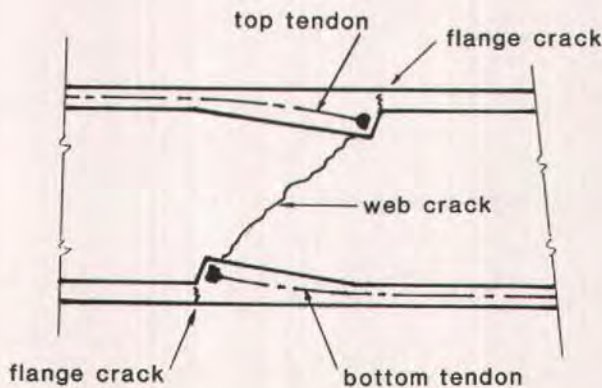
Fig. 30. Insufficient lap between anchorages.

It is possible that this type of cracking from continuity tendon anchorages in the bottom flange may join with similar cracks originating from cantilever tendon anchorages in the top flange (Fig. 30). In this situation, the center portion of the span may become an inverse "key-stone" (Fig. 31) and immediate measures are required to prevent collapse of the structure.¹

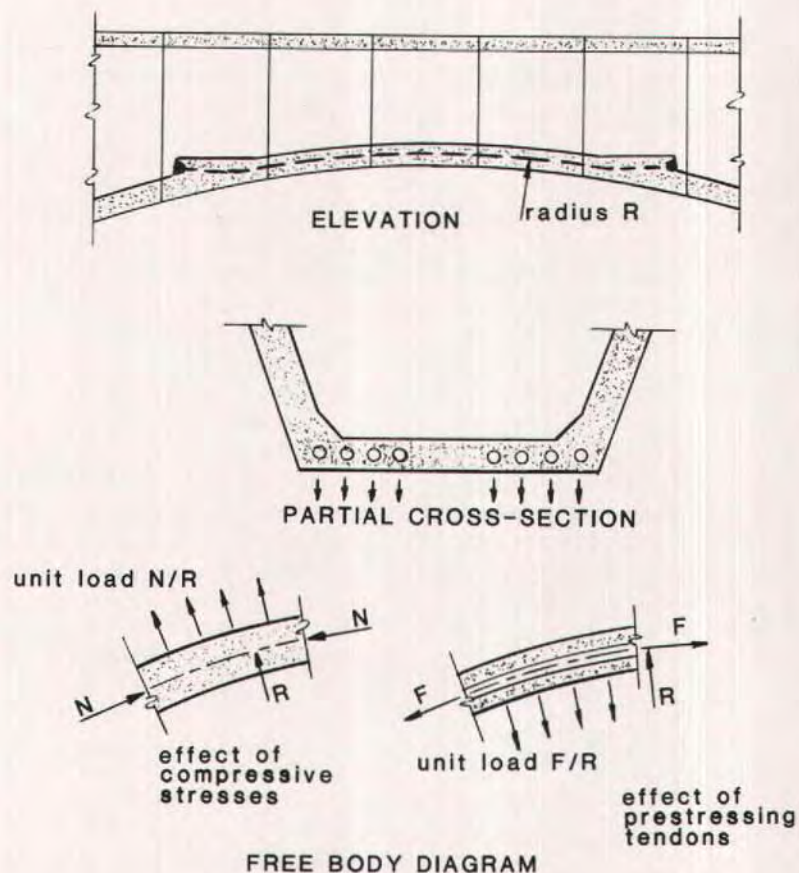
Fig. 35. Vertically curved tendon.

flange proper. When a variable depth girder is used, the bottom flange has a curvature in the vertical plane, which must be followed by the prestressing tendons (Fig. 35).

Unless careful consideration is given to that fact at the concept and detailed design stages, difficulties are likely to develop. This is indicated in Fig. 35, which shows the free-body diagrams of stresses in the bottom flange due to the curvature. Curvature of a tendon induces a downward radial force, which must be resisted by transverse bending of the bottom flange between the webs.³

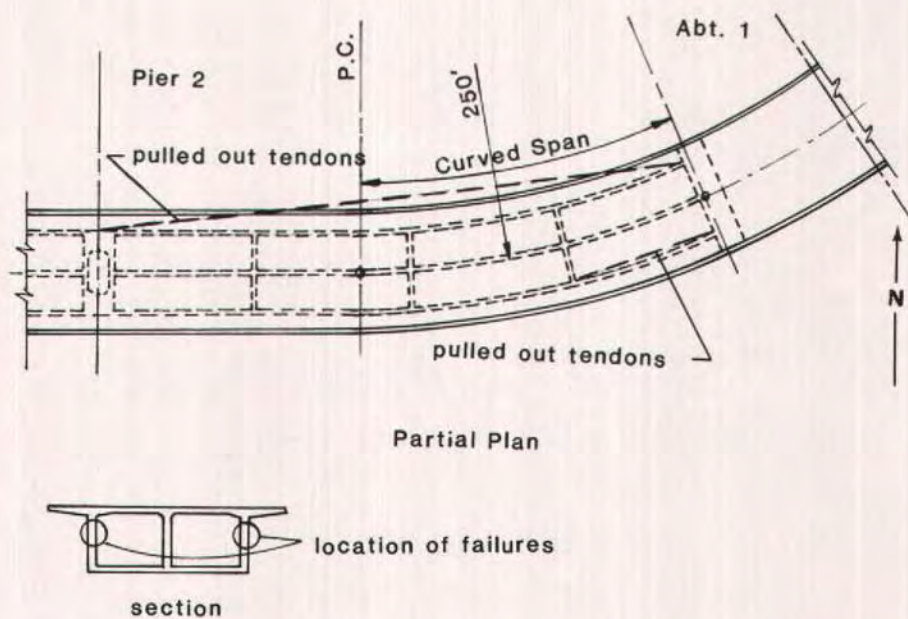
An immediate inspection of the structure indicated that the horizontally curved tendons, exerting a radial horizontal pressure, had overloaded the reinforced concrete webs. This overload

Fig. 40. Zones of web failure.

had caused the concrete to fail, allowing the tendons to straighten out and pull away from the webs (Fig. 40). The failure was particularly evident in the inner (north) web, where the tendons had pulled well clear of the concrete. In the outer (south) web the failure (inside the box) had not progressed past the first quarter-span diaphragm. The center web was undamaged. Additional observations indicated that the tendons were continuing to pull away from the webs, and that failure had progressed several more feet towards the abutment and the pier (Fig. 41).

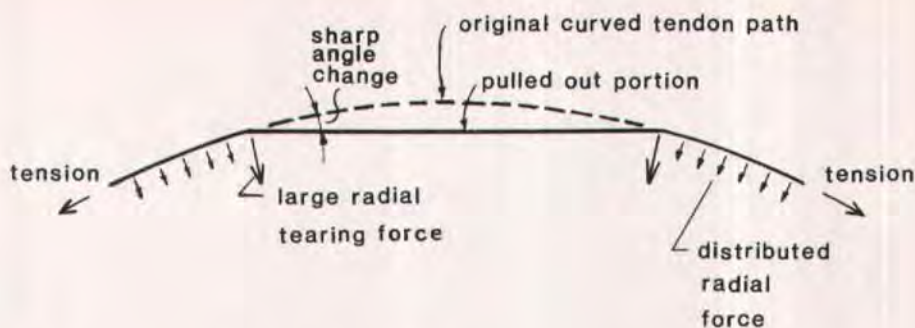
Fig. 41. Progressive failure along tendon.

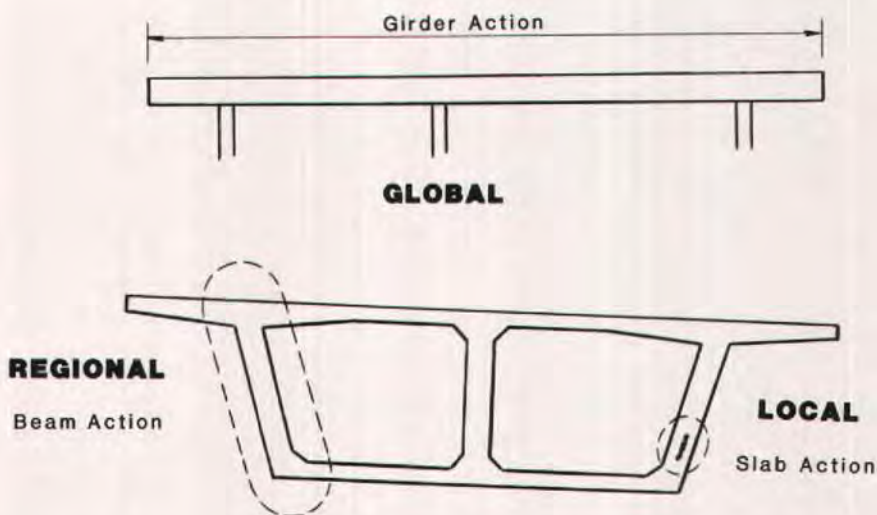
The analysis of the failure of these structures can be divided into three separate actions (Fig. 45) which need to be considered in design:

Fig. 45. Box girder actions due to horizontally curved tendons.

It therefore appears that, for both these structures, the local slab action was the primary cause of failure, but the regional beam action could have been a contributory cause, and could by itself have overstressed some of the stirrups, even if not to the point of failure. The global action had a relatively small effect upon these failures.

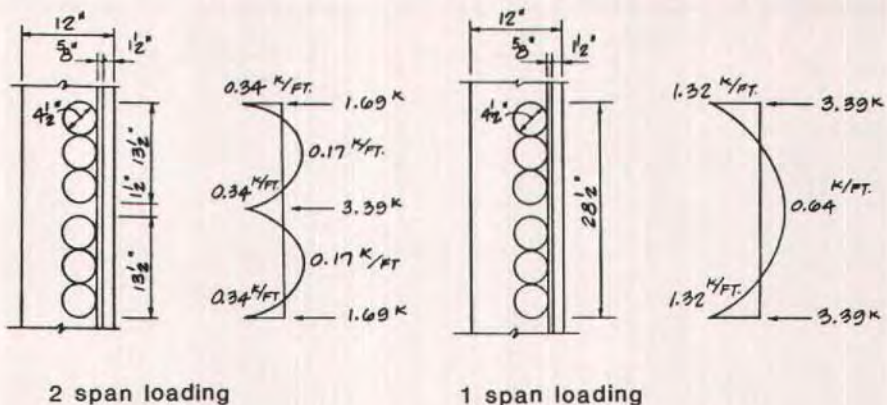
Local slab action is probably the most important item that actually caused the failure in both of these structures. The local slab action can be studied in different ways. First, consider the cover as a slab 2 in. (50 mm) thick (reinforced with #5 bars along the inside face only) acting as a two-span continuous beam with a central support furnished by the concrete between the two sets of bundled tendons, as shown on the left of Fig. 48.

The second analysis, shown to the right in Fig. 48, assumes that the concrete has cracked and is unable to supply tension for the support area between the bundled tendons. If this is the case, the slab will act as a single span fixed at the ends; however, the reinforcement is in one plane on the inside face only. This can offer very little resistance to the radial force from the tendons, both in bending and in shear. The stresses are exceedingly high.

An extraordinarily high percentage of reinforcing steel would be required to resist such moments. Unfortunately, the tendons were tied to the stirrups on the inside of the curvature; thus the stirrup reinforcement is in position next to the tendon ducts such that it does not function to resist positive moment produced by the radial forces. Therefore, the concrete cover essentially is a plain concrete slab and its resistance is nil.

Fig. 48. Slab action.

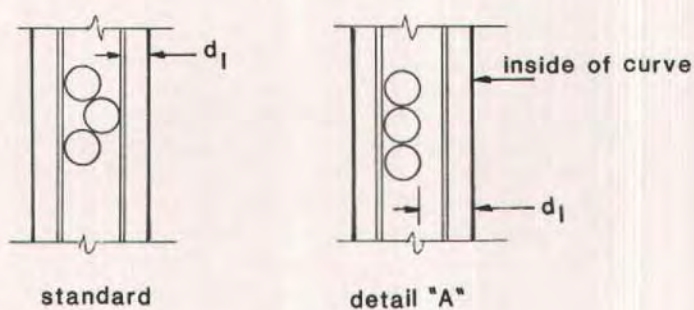
Fig. 51. Tendon placement details.

The "standard detail" indicated at the left of Fig. 51, as the name implies is a standard detail for bundled tendons. Detail "A", at the right of Fig. 51, indicates that the tendons are stacked vertically and placed against the outside stirrup with respect to curvature. This is done to provide a greater thickness for local slab action and to put the inside stirrup in a position to participate as active reinforcement in the slab action.

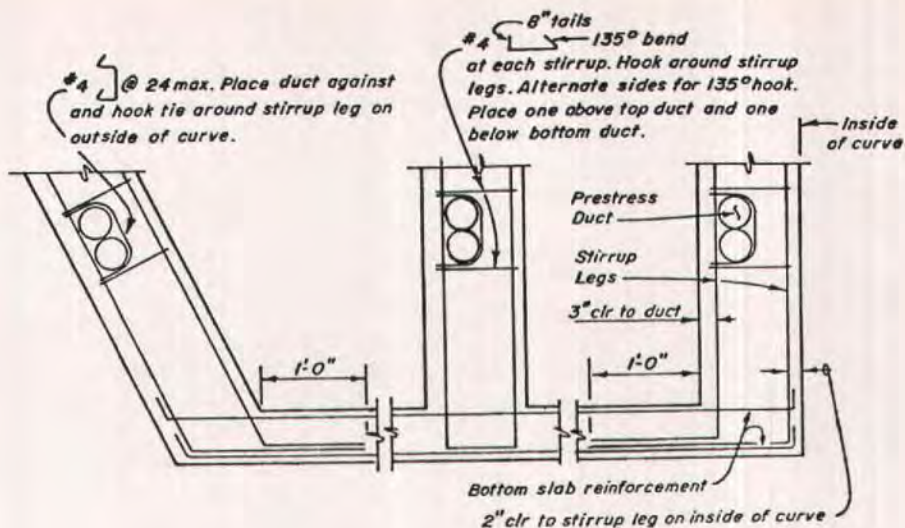
Fig. 52. Tendon placement Detail "A".

Further, Tendon Detail "A" requires #4 ties between the stirrups and adjacent to the bundled tendons, and a hoop around the bundled tendon hooked to the outside stirrup (Fig. 52). This then mobilizes the outboard stirrup and the central concrete area behind the inboard stirrup in participating to resist the pull-out of the tendons.

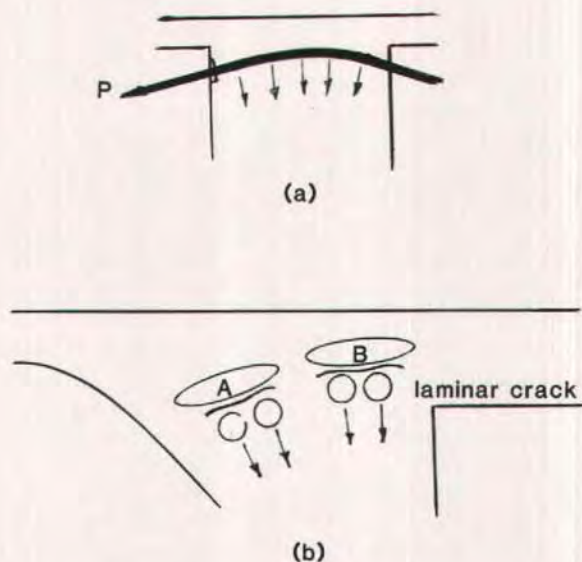
Fig. 55. Diaphragm cracking from tendon curvature.

54. The external tendons pass through the diaphragm along a vertically curved profile and are anchored in the diaphragm face which produces a radial pressure as indicated in Fig. 55a. As a result, a tensile stress field is set-up above the tendons (Fig. 55b) similar to the tension stress field behind an anchorage blister. This tension field may then cause a laminar crack above the tendons.

In addition, a splitting crack may develop as a result of multi-strand compaction in the zone of curvature as discussed above. It appears that the laminar crack either by itself or in conjunction with the splitting crack, over a period of time will propagate to the surface and produce spalling. Spalled areas of the deck have been as large as 3 x 3 ft (1 x 1 m). The spalled surface in two projects were located generally over the

tensile zone B in Fig. 55 b.

This is probably associated with the fact that there is less cover over the tendons in Zone B and that Zone B represents the jacking end of the tendons and thus a larger prestress force. Zone A is associated with the dead-end anchorages. It appears that tie reinforcement should be provided to not only confine the splitting crack but also to provide reinforcement to resist the tension generated above the tendons.

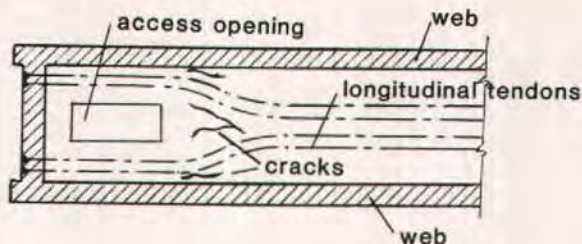
Fig. 56. Cracking at an access opening.

Where longitudinal tendons are flared or deflected around access openings in a bottom flange, there is a potential for severe cracking to occur as illustrated in Fig. 56. The flange in front of the opening is literally being torn or ripped apart as a result of the tension created by the tendon curvature.¹

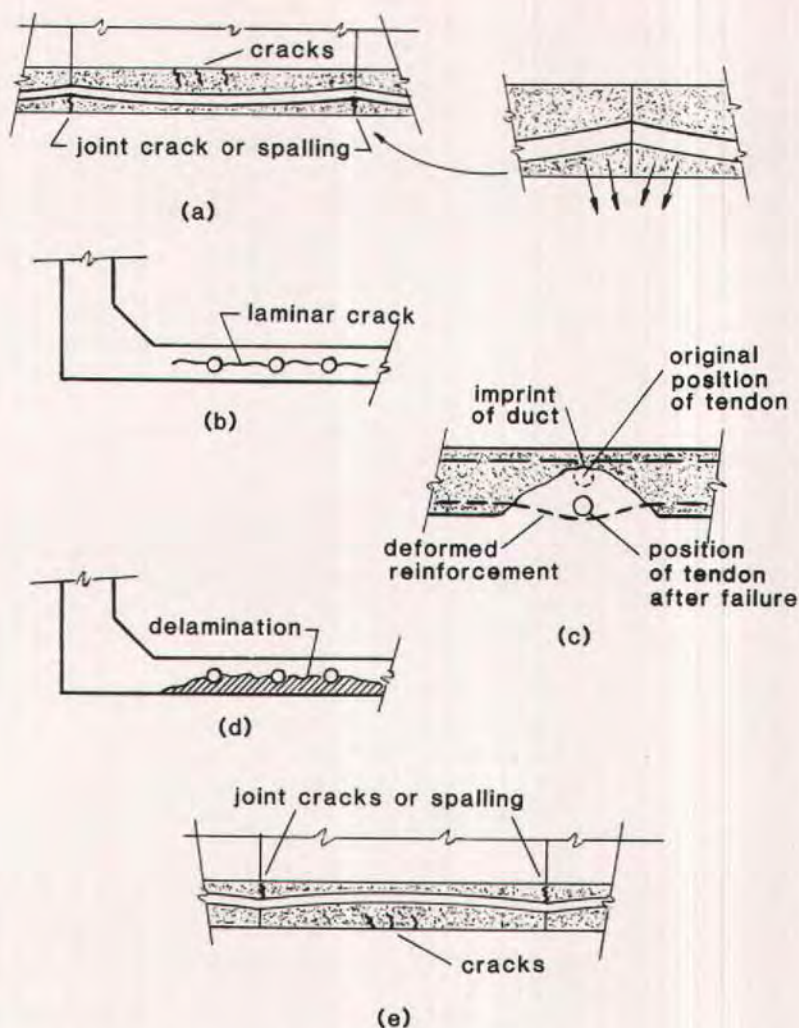
Laminar cracking may then propagate to a spalling failure during further tensioning of the tendon (Fig. 57c) which will produce a deformation in the reinforcing steel and displacement of the tendon. In some instances, spalling has occurred during water pressurization tests or during grouting, especially when all tendons in a group are tested or grouted simultaneously (Fig. 57d).

Occasionally, because of the wrong height chairs or mislocation, the profile will be inadvertently placed in an inverted profile as shown in Fig. 57e. Obviously, the cracking and/or spalling pattern will be inverted from that shown in Fig. 57a.

Fig. 57. Effects of misalignment of tendon ducts.

This problem can be avoided by the use of rigid ducts properly positioned and securely tied to the reinforcing cage, use of a rigid mandrel placed inside of the duct during casting, and providing work bridges for workmen so that they do not walk in the wet concrete.

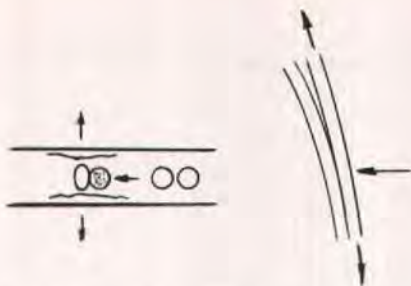
problem indicated that during construction the longitudinal tendons had been deflected downward because of an interference with the deflected profile of the transverse tendons.

The result of the upward components of the two curved tendon systems probably created a laminar crack upon tensioning of the tendons. Air pressure used to blow out the remaining unstressed tendon ducts probably propa-

Fig. 58. Lateral duct crushing.

gated the laminar crack initiated during stressing and precipitated the spalling. A factor closely associated with this failure was the numerous closely spaced longitudinal ducts.

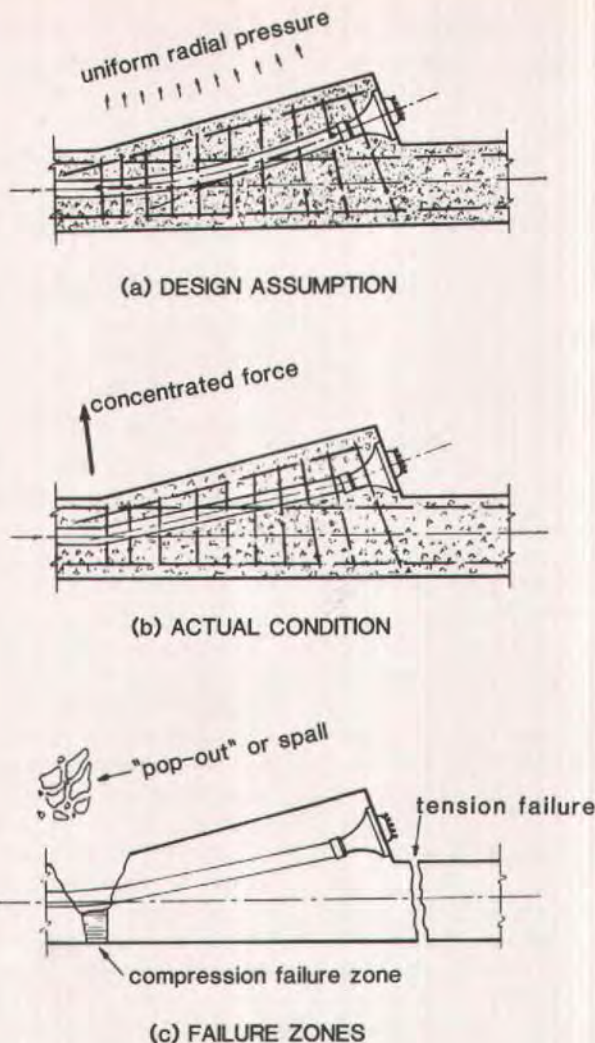
Another form of cracking, spalling and failure is associated with misplacement of a curved tendon in a blister anchorage. The design assumes that the tendon profile as it leaves the flange (or web) and enters the anchorage blister is a smooth curve (Fig. 59a) with a uniform pressure along the curve. In reality, this is seldom accomplished in construction. The duct usually has an angular "kink" instead of a smooth curve transition, which produces a concentrated force at the toe of the blister (Fig. 59b).

This then leads to a spalling or "pop-out" failure (Fig. 59c). The concrete area in the slab forward of the blister is then reduced, leading to a compression fail-

Fig. 59. Anchorage blister failure.

ure at that location, tension failure behind the blister and shearing along the longitudinal sides of the blister.

sile forces behind the blister, and adequate transverse reinforcement should be used to cater to shear forces along-side of the blister.

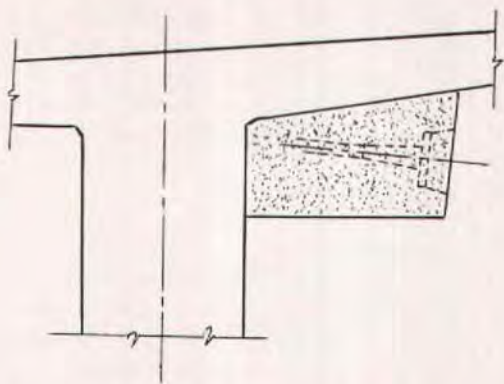
Fig. 66. Retrofit anchorage buttress at diaphragm.

A recent application of this system in the United States (Fig. 64) used the transverse distribution member at the abutments and a concrete buttress for a deviation saddle that was keyed and doweled into the existing flange and web (Fig. 65). Where tendons were anchored to existing diaphragms, the diaphragm was locally reinforced by a sim-

ilar buttress arrangement (Fig. 66).

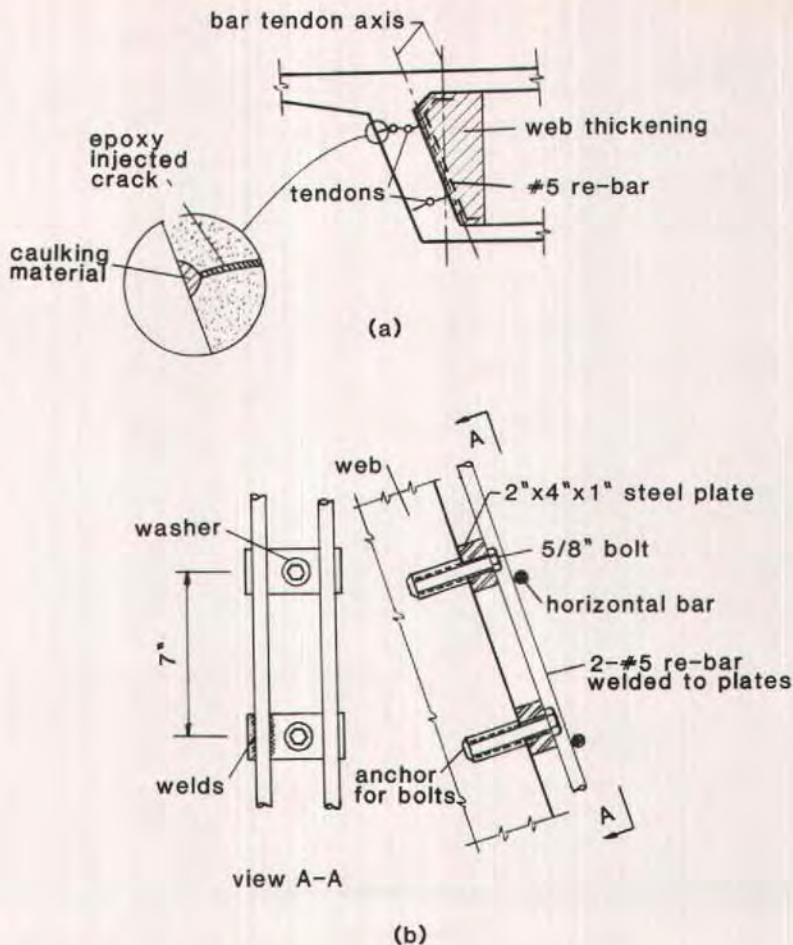
Boring through the external web was impossible because of the two side-by-side upper longitudinal tendons (Fig. 71a). Preliminary calculations indicated that placing tendons along the inside face of the web only would produce undesirable large tensile stresses in the outside surface of the web. Therefore, a decision was made to thicken the outside webs as shown in Fig. 71a.

Fig. 71. Retrofit of inclined external web.

weakening of the top and bottom flanges by the 2 in. (51 mm) diameter holes required, the tendons were staggered in a vertical and inclined orientation as shown in Fig. 71a. The shearing force produced at the interface of the existing web and the web thickening is largely resisted by bond. To prevent shearing at the interface, mechanical doweling was provided by ⅝ in. (16 mm) diameter bolts drilled into the web which supported a grid of conventional reinforcement (Fig. 71b).
