# Design and Construction of the Kishwaukee River Bridges

Presents the selection of bridge type, design approach and criteria, bidding procedures, design details, fabrication of segments, and erection of superstructure of the Kishwaukee River Bridges in Winnebago County, Illinois. During construction, cracking and other problems occurred in some of the segment joints. The cause of these problems is examined and a method of repair is described which was completed successfully.

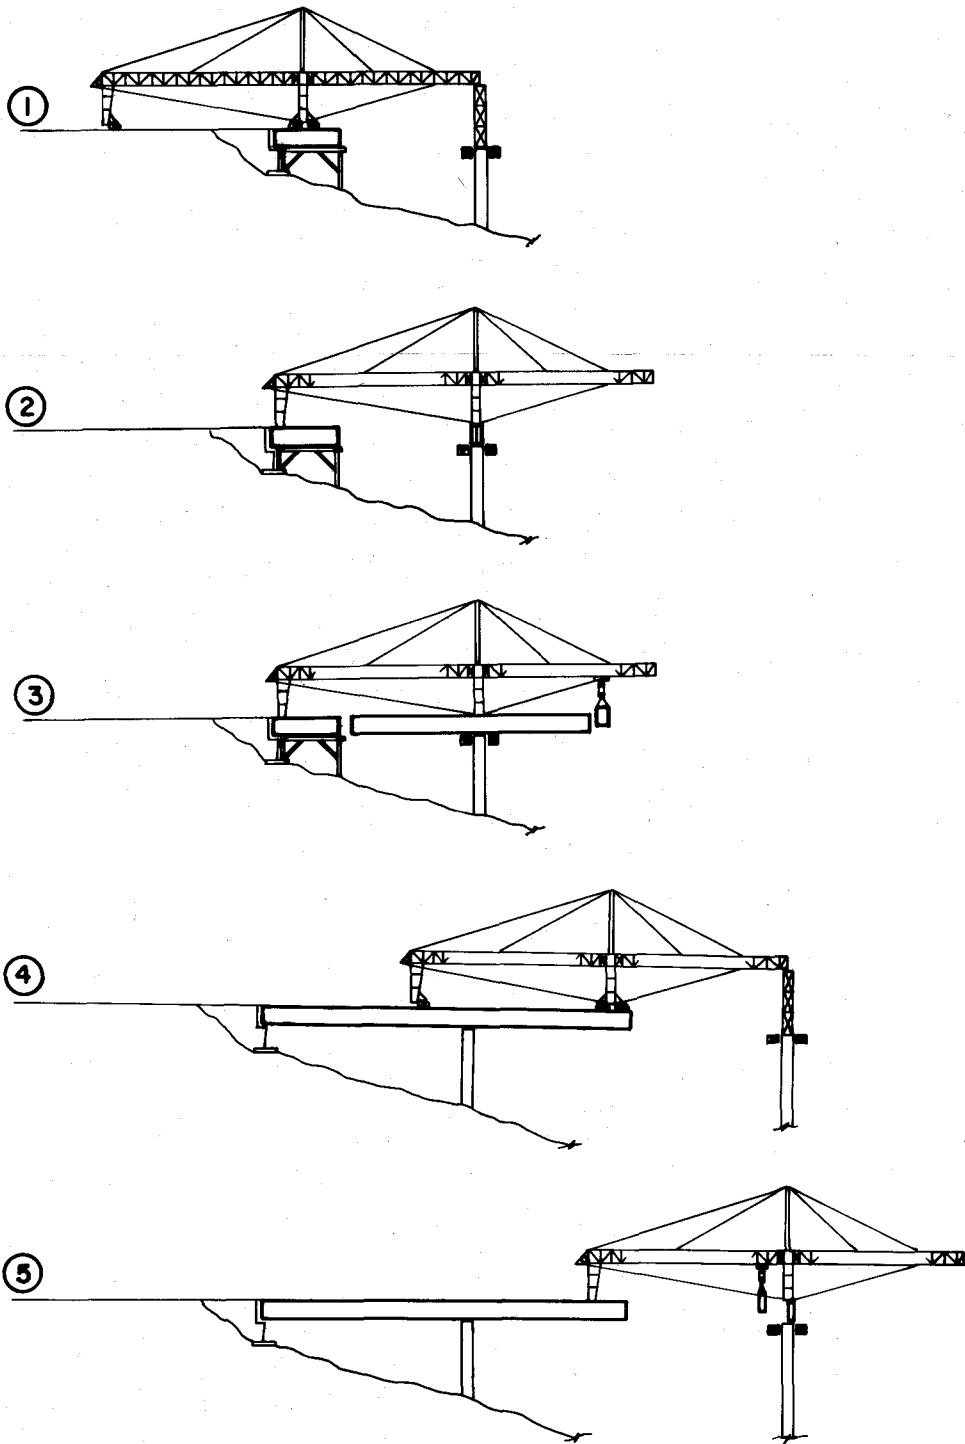
Fig. 15. Sequence of launching truss operations.

The box girder segments were erected using a launching truss. The manner of use of the launching truss and the procedure for moving the truss along the bridge are shown schematically in Fig. 15. The sequence of operations is as follows:

abutment are erected on falsework. Epoxy is used in the joints between segments; longitudinal prestress bars are installed and tensioned as erection proceeds. A steel tower is erected on the first pier. Rollers are installed on the legs of the launching truss and the truss is moved forward until its front end is over the pier tower.

2. With the truss supported on its rear leg and on the pier tower in front, the rollers are removed from the middle leg. The truss is moved forward until the middle leg is over the pier. The rollers on the rear legs are removed. The pier tower is partially removed and replaced with a strut that allows room on the pier top for installation of the pier segments. (The "pier segments" are the two diaphragmed box-girder segments located directly above each pier.) The launching truss is now used to erect the pier segments, which are installed on temporary bearings and

3. The segments in the first balanced cantilever unit are erected using the launching truss. Epoxy is used in the joints between segments. Longitudinal prestressing bars are installed and tensioned as erection proceeds.

4. The cast-in-situ "closure" is formed and poured between the end of the cantilever and the short length of bridge previously erected on falsework. Longitudinal post-tensioning is applied across the closure. The temporary vertical "tie-down" post-tensioning at the pier is released and the permanent bearings are installed. The steel pier tower is erected on the second pier. Rollers are installed on the legs of the launching truss and the truss is moved

forward until its front end is over the pier tower. (The moment on the cantilever will reach its maximum value at this time, before the front end of the launching truss has been picked up by the pier tower.)
